Brent Spence Bridge Replacement/Rehabilitation Project

Longworth Hall Impact Analysis Report Part Three: Potential Mitigation Measures

ODOT PID No. 75119
HAM-71/75-0.00/0.22
KYTC Project Item No. 6-17

June 2011

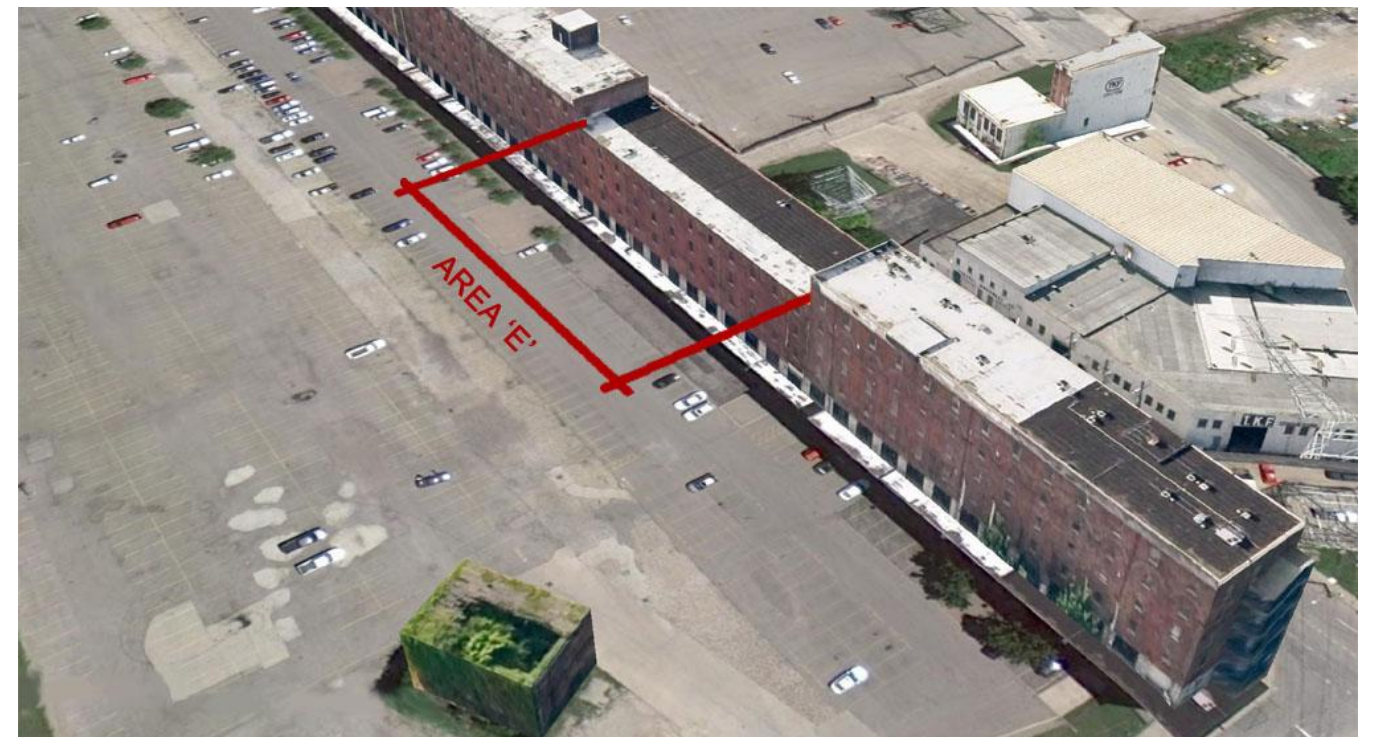
Photo 1: Aerial photo of Longworth Hall showing existing gap at Fifth Floor Area "E"

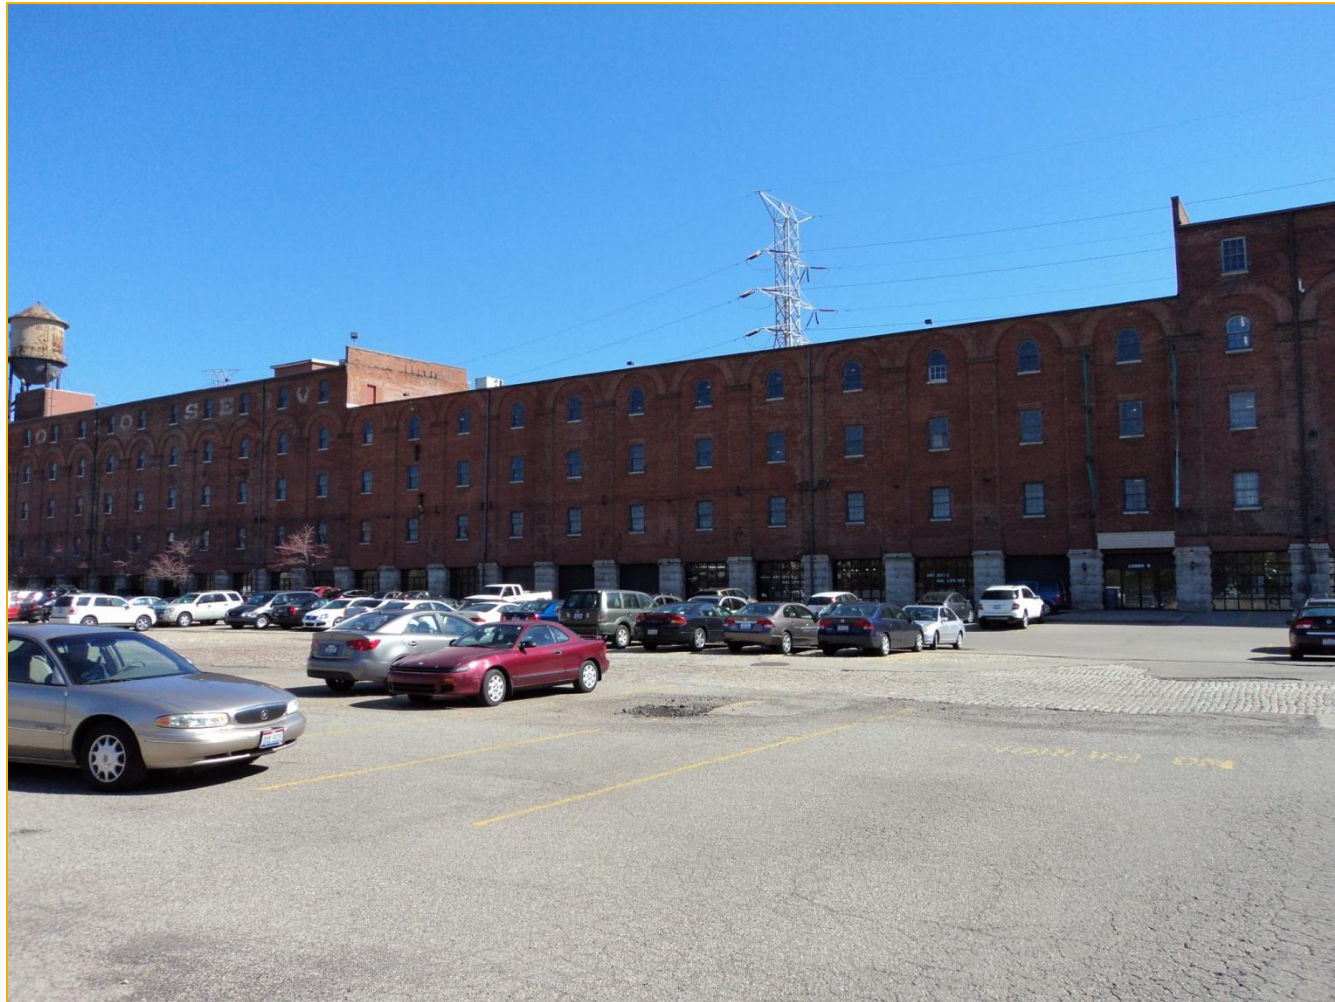
Photo 2: "Before" image of Longworth Hall showing gap at fifth floor Area "E"

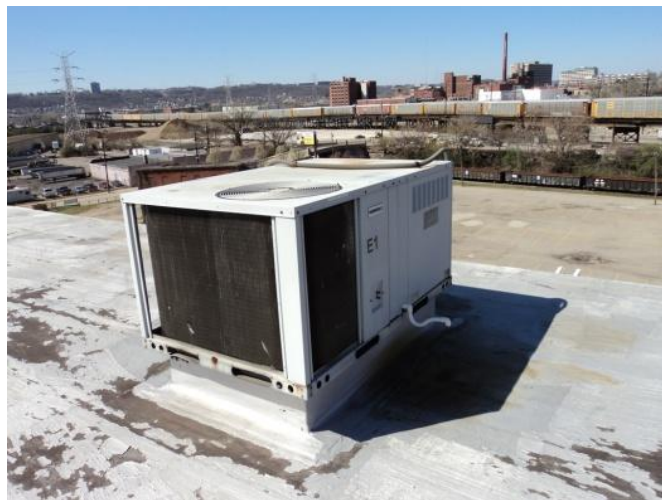
Photo 4: Packaged Rooftop Unit Condensing (noted Photo E-1 in Figure 4)

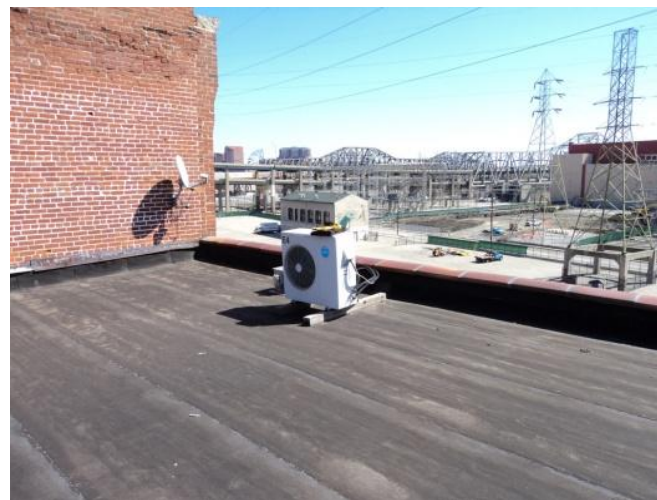
Photo 5: Computer Room Unit (noted Photo E-2 in Figure 4)

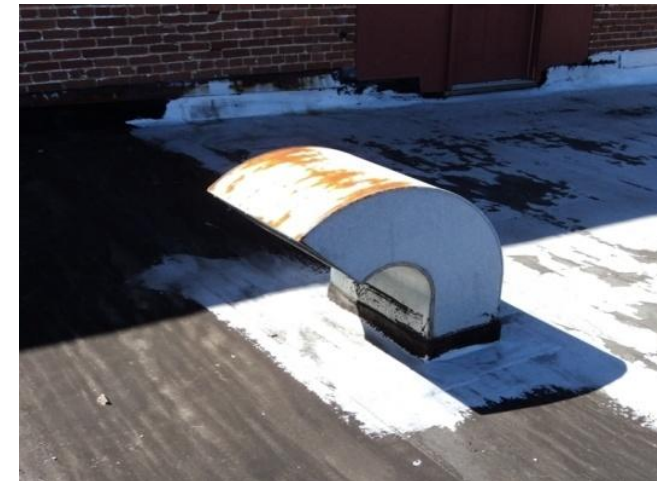
Photo 6: Elevator Ventilation Duct (noted Photo E-4 in Figure 4)

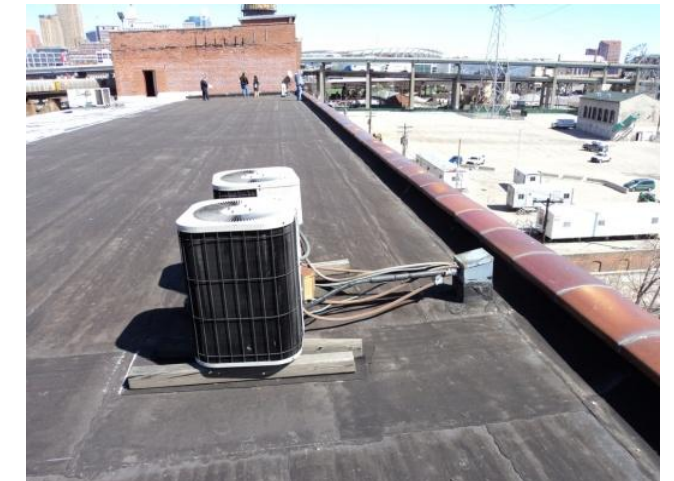
Photo 7: Condensing Units (noted Photo E-5 in Figure 4)

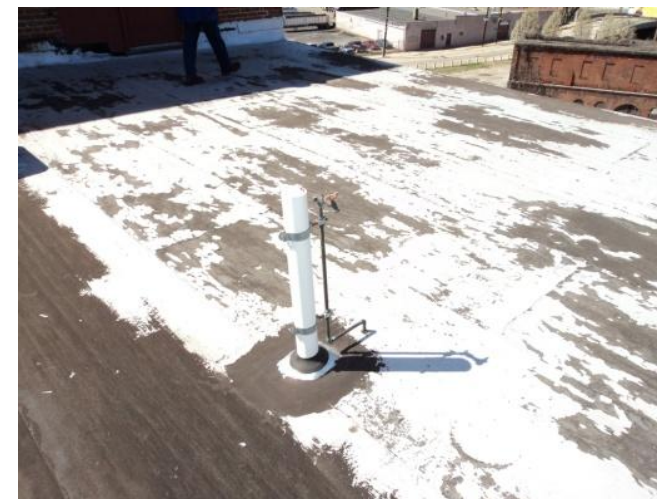
Photo 8: Plumbing Vent Pipe (noted Photo E-3 in Figure 4)

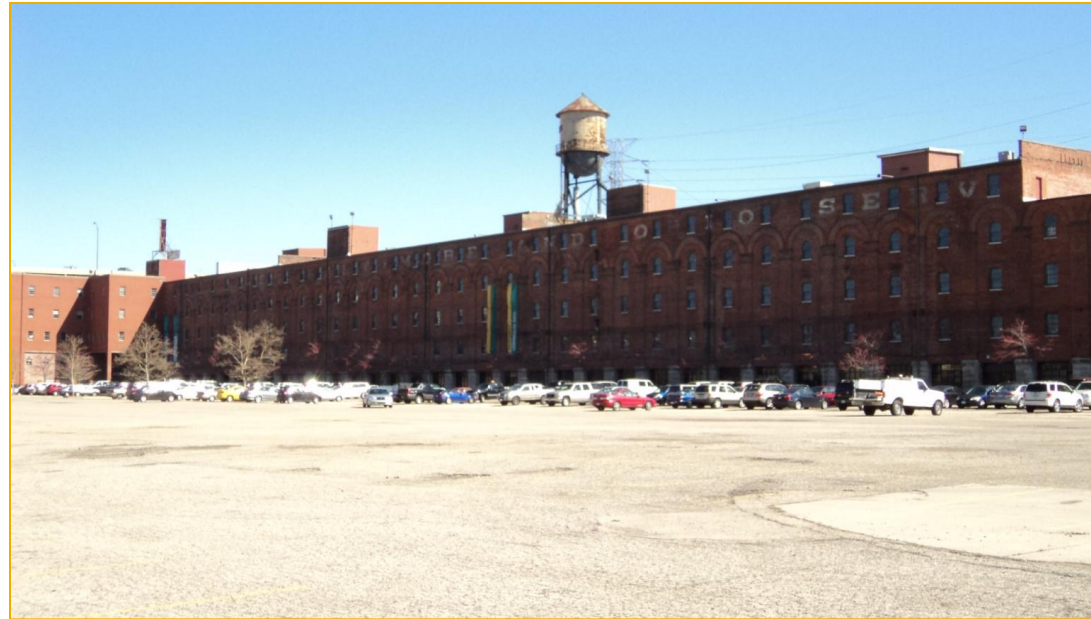
The existing windows of Longworth Hall are original to the building and in need of protection from the environment (See Photos 9 and 10); the addition of storm windows is a recommended measure of protection. The exterior masonry shows signs of cracks, voids, crumbling mortar, and areas of deteriorating masonry units. Also present are large holes and washed out mortar (See Photos 11 and 12).

Photo 9: North Side of Longworth Hall – Existing Windows

The storm windows will be triple track storms with sightlines matching the profile of the existing wood frames. The storms will also have a horizontal mullion to match the sight line of the existing wood window sash. All tuck-pointing will use the U.S. Department of the Interior Office of Historic Preservation standards (The Secretary of Interior's Standards for the Treatment of Historic Properties, National Park Service, 1995 [http://www.nps.gov/history/hps/tps/standards_guidelines.htm, accessed June 28, 2011]) to preserve the appearance and to avoid irreparable damage from modern mortar. It is important that new mortar match the original in porosity and compressive strength.

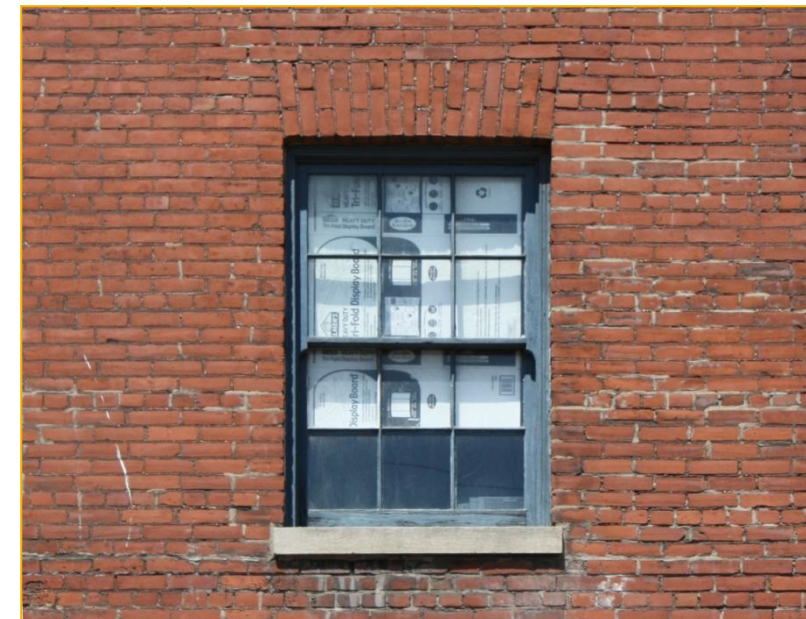
Photo 11: Minor Masonry Damage

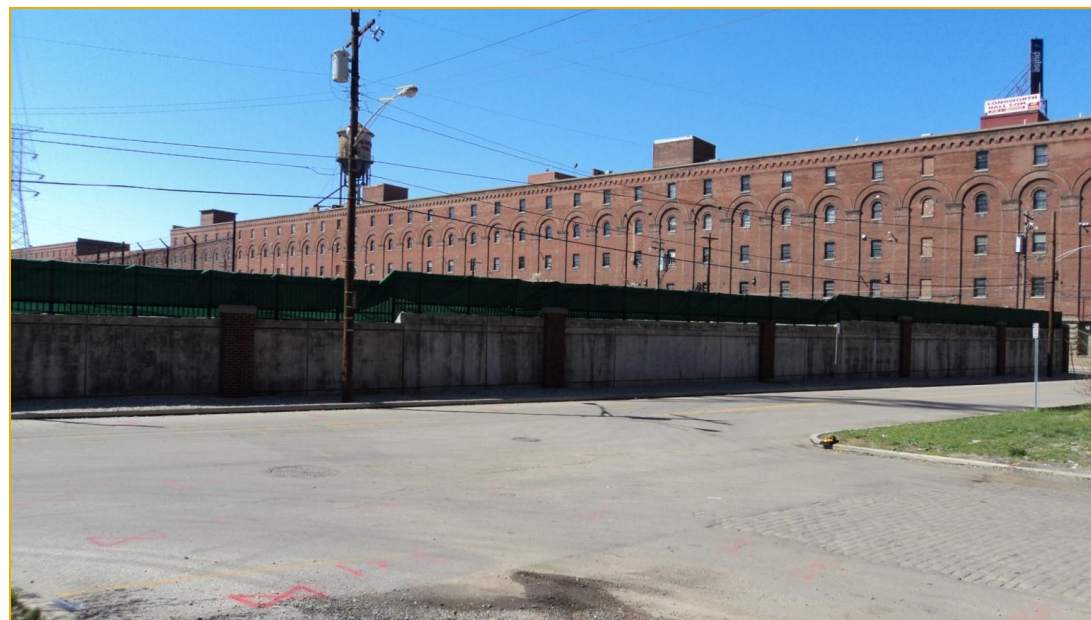
Photo 10: South Side of Longworth Hall - Existing Windows

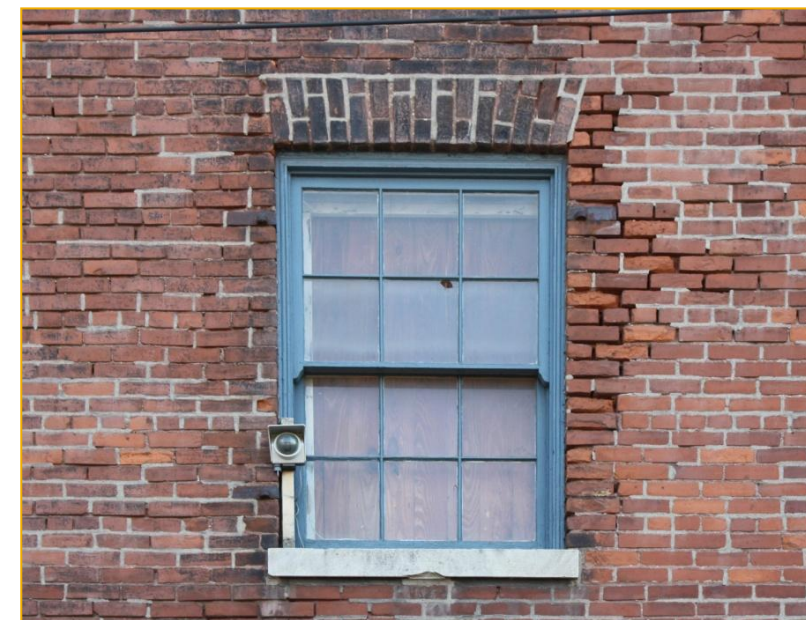
Photo 12: Major Masonry Damage

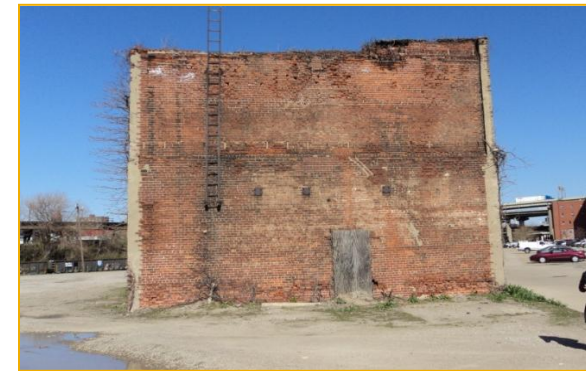
The Boiler House is an existing building adjacent to Longworth hall that was once part of a larger turn of the century roundhouse rail support structure. Over the years the Boiler House has fallen into extreme disrepair and is close to a point of collapse. The building has no roof, floor or associated structural support system. All that remains of the original building are seriously deteriorated exterior brick walls with boarded up windows (See Photos 13 thru 16).

Photo 13: Boiler House: West Elevation

The exterior walls will be braced with an internal structural steel column and beam system. The interior and exterior side of the existing brick masonry walls will be repaired and tuckpointed. Brick salvaged from the demolition of Longworth Hall Area "A" will be used for brick repair on this building to the greatest extent possible. The existing windows will be bricked in while a large arched opening on the south façade will receive a pair of wood doors (See Figure 7). The refurbished walls will receive a limestone cap. The existing floor will be removed and replaced with a concrete slab on grade. The building is currently not serviced by utilities.

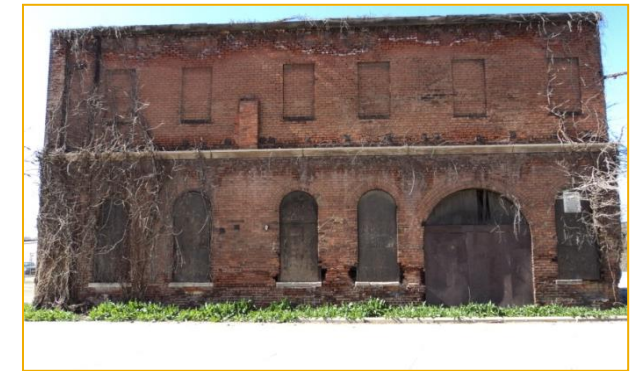
Photo 15: Boiler House: South Elevation

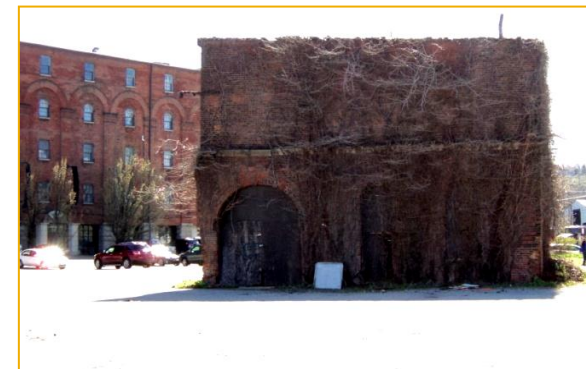
Photo 14: Boiler House: East Elevation

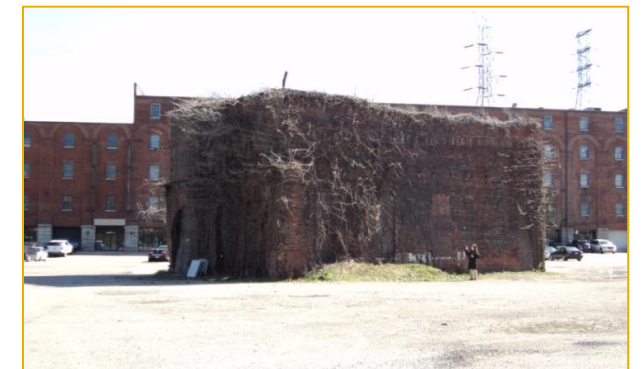
Photo 16: Boiler House: North Elevation

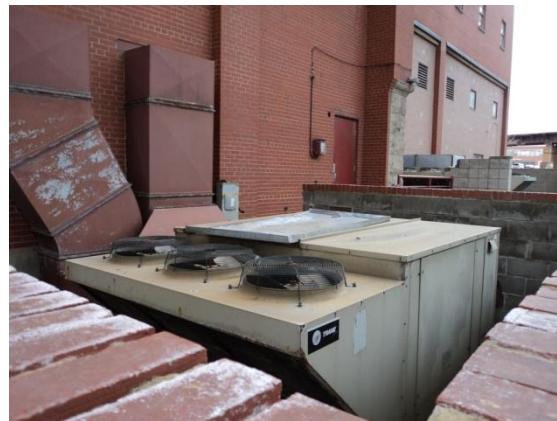
Photo 19: Grade mounted RTU

Impact Analysis – HVAC components on the roof and floors three, four and five will be removed. Grade mounted equipment (Photo 19) and units located on floors one and two can remain. Ductwork, controls, flues, gas piping and other utilities/accessories to the units serving the remaining floors will be modified. New ventilation ducts with gooseneck terminations at the roof will be provided for the modified elevators. The abandoned brick chimney will be removed below the new roof level.

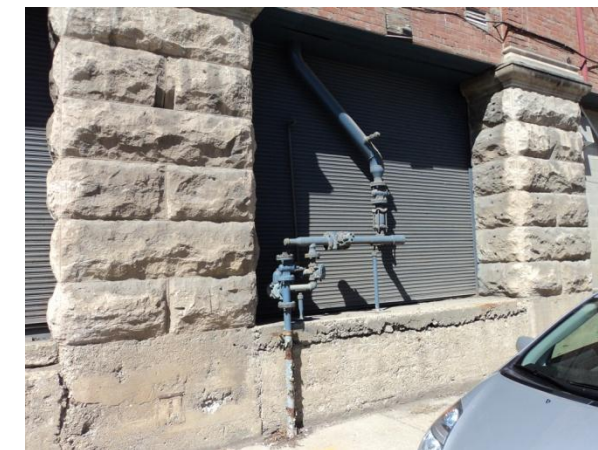
Photo 20: Area B incoming gas pipe

Impact Analysis – Plumbing components on the roof and floors three, four and five will be removed. Water, waste and vent pipes serving fixtures on remaining floors will be modified. The gas piping and other utilities/accessories to hot water heaters and plumbing equipment serving remaining floors will be modified. The new roof for Areas "A", "B", and "N" will need gutters to be provided for storm water drainage. The gas piping originating east of column line 57 feeding Area "B" and partial Area "C" HVAC equipment west of column line 57 will be re-routed inside the facility for floors three, four, five and roof.

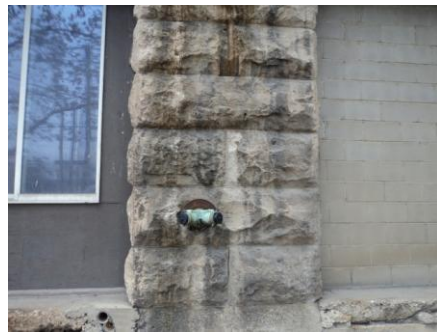
Photo 21: Fire Siamese Connection

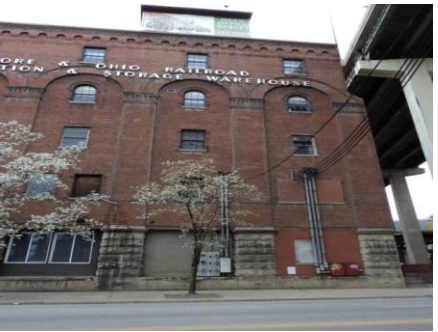
Photo 22: Area A Incoming Power

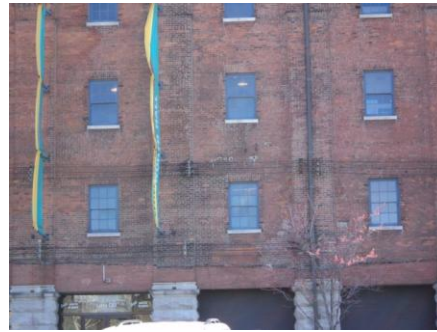
Photo 23: Elevator. Power Lines (top)

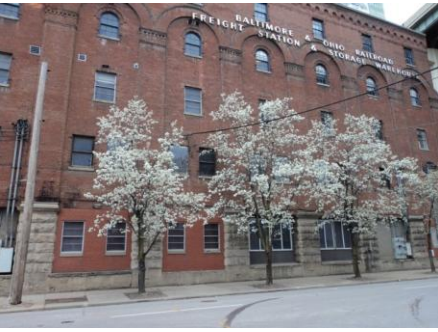
Photo 24: Incoming Communication Lines

Impact Analysis – The telecommunications on floors three, four and five will be removed. The communications lines from the utility poles to the south elevation of the facility will be modified. The communication lines serving Longworth Hall west of column line 57 will be re-routed inside the facility for floors three, four and five. There are two fiber optic lines currently routed below the third floor and can remain as is.

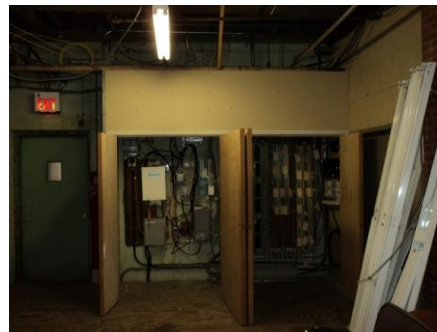
Photo 25: Main Communications Closet
