# **PHASE I PROPERTY ASSESSMENT**

FOR THE:  
**HAM 75 BRENT SPENCE BRIDGE PROPERTY  
AKA DUKE ENERGY SITE  
646 & 655 MEHRING WAY  
CINCINNATI, OHIO 45201**

PREPARED FOR:  
**OHIO DEPARTMENT OF TRANSPORTATION  
1980 WEST BROAD STREET  
COLUMBUS, OHIO 43223**

**FEBRUARY 2017**

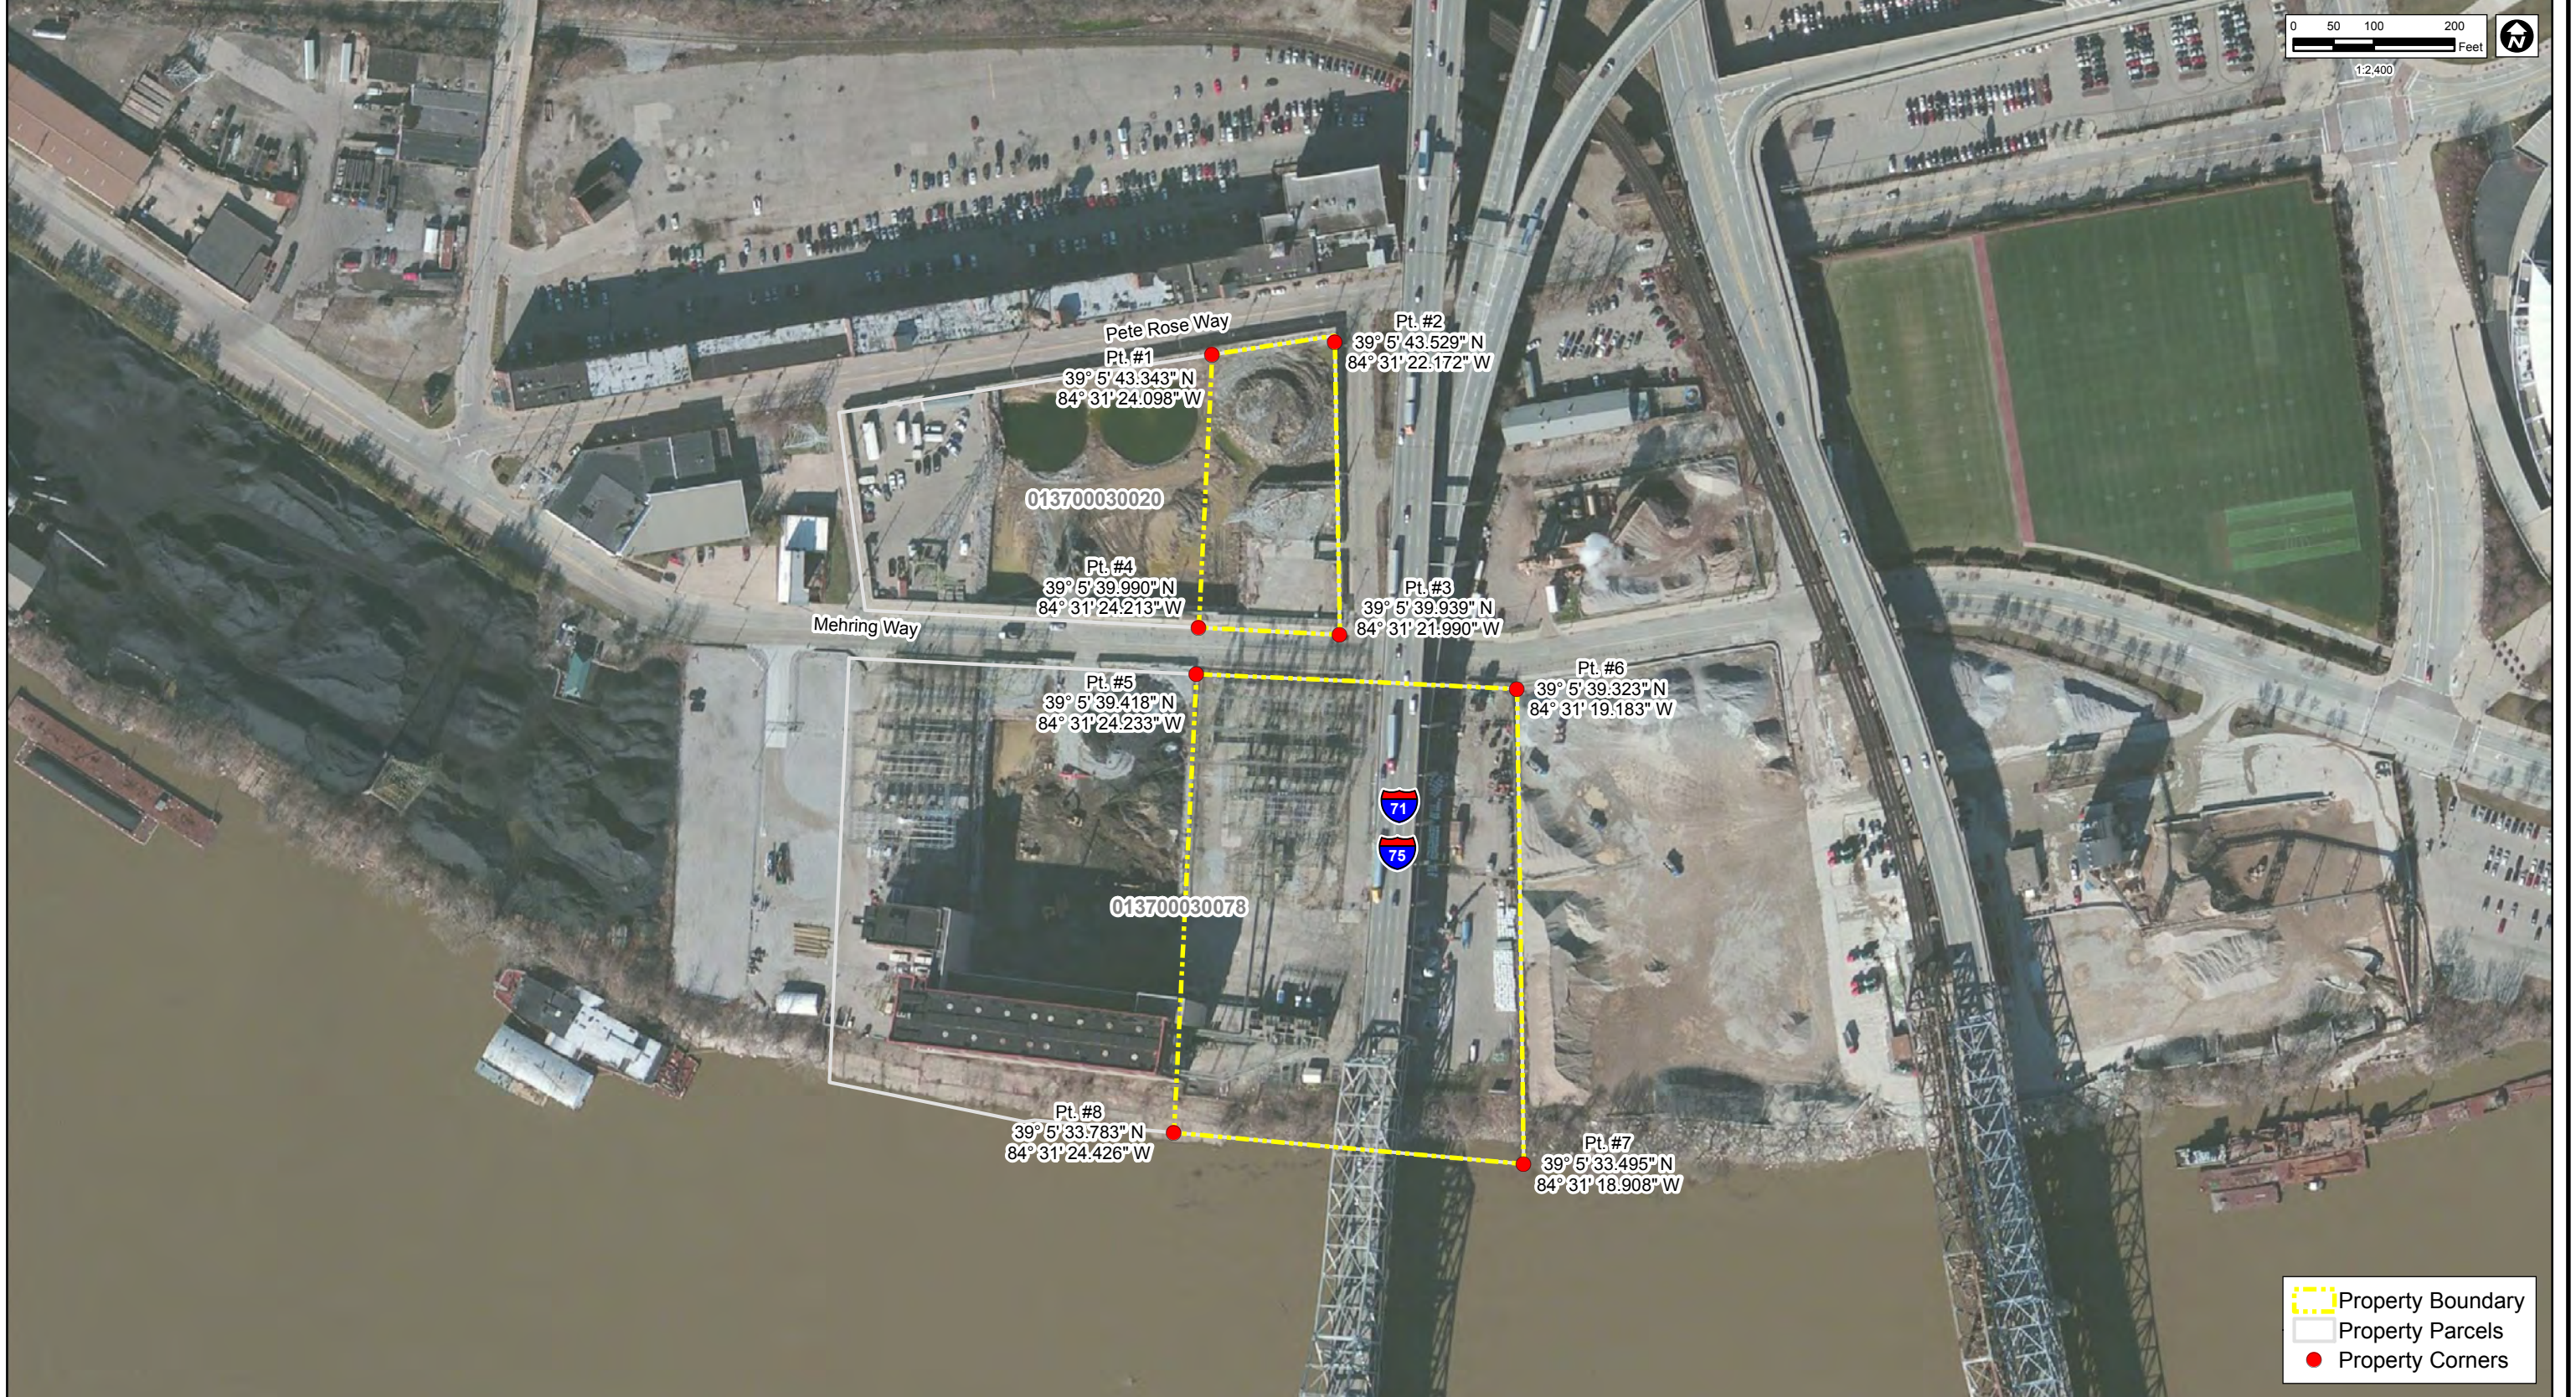
**1**

- Property Boundary
- Property Parcels
- Property Corners

**Notes:**  
The aerial photo was acquired through the ESRI Imagery web service. Aerial photography dated 2015.

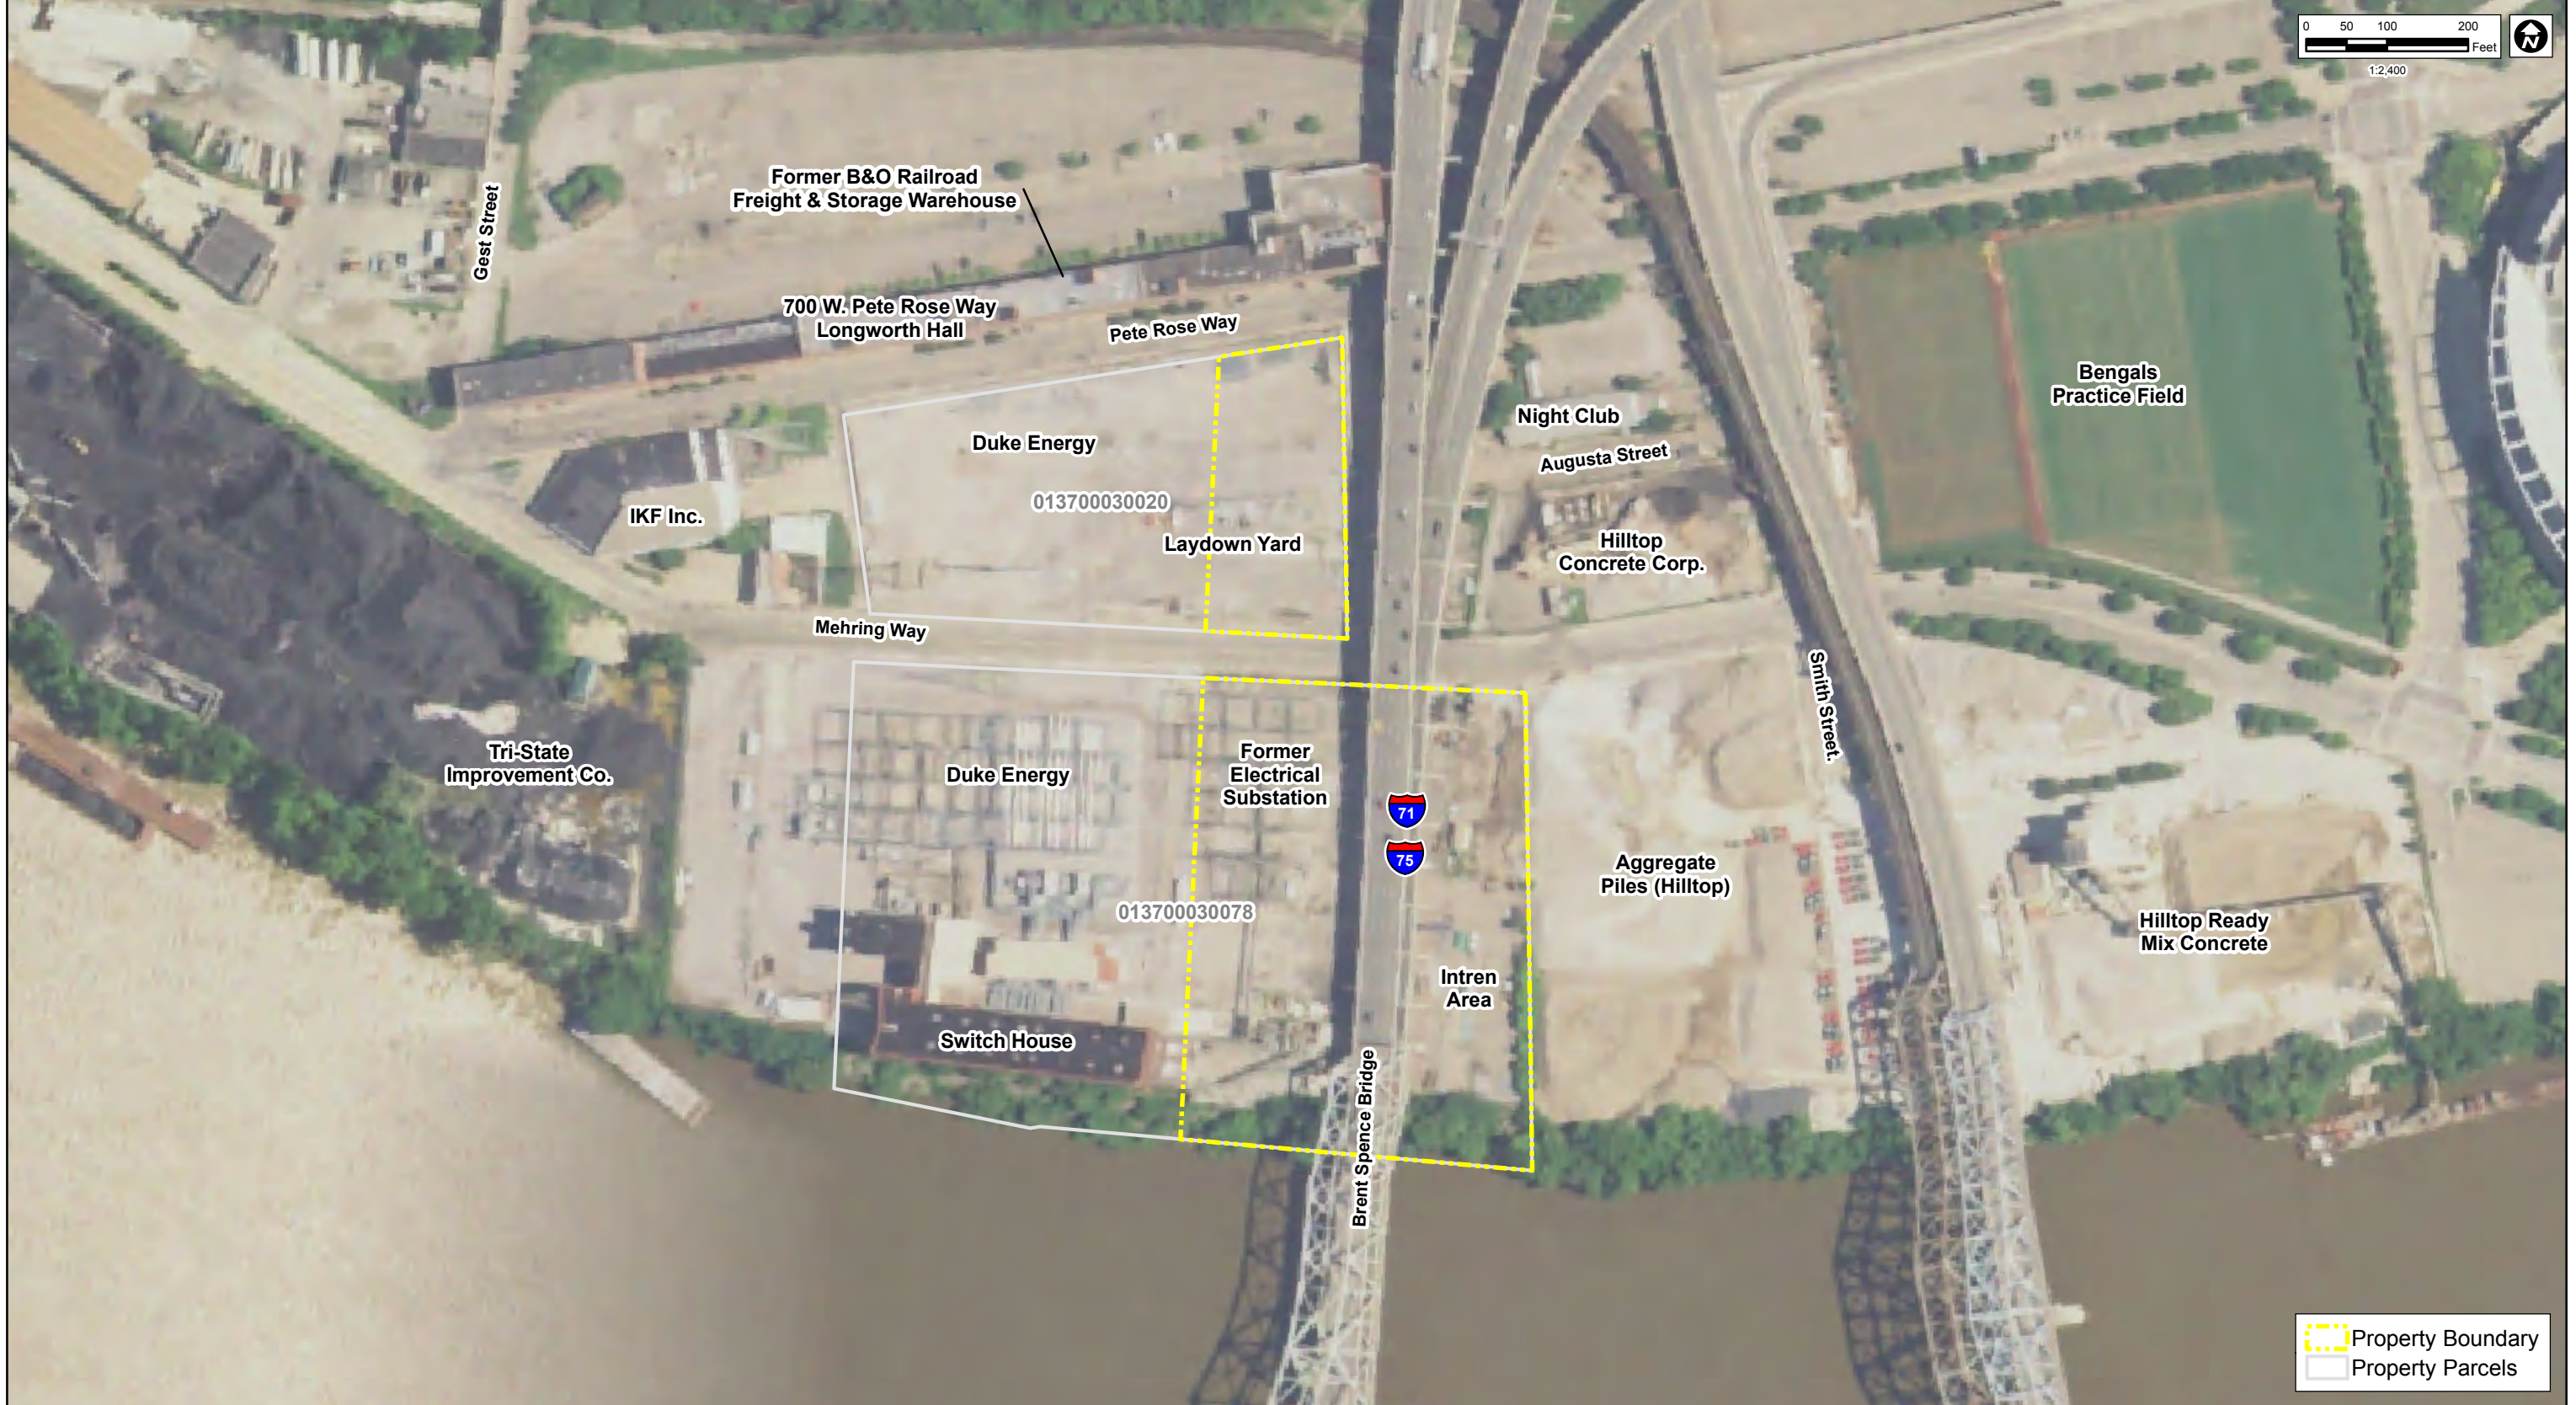
Figure  
**3**

Phase I Property Assessment  
HAM75 - Brent Spence Bridge Property  
**Property Plan Showing  
Property and Surrounding Area**  
Portion of 646 and 655 Mehring Way  
City of Cincinnati, Hamilton County, Ohio
