Brent Spence Bridge Replacement/Rehabilitation Project

Ecological Survey Report

KYTC Project Item No. 6-17

February 2010

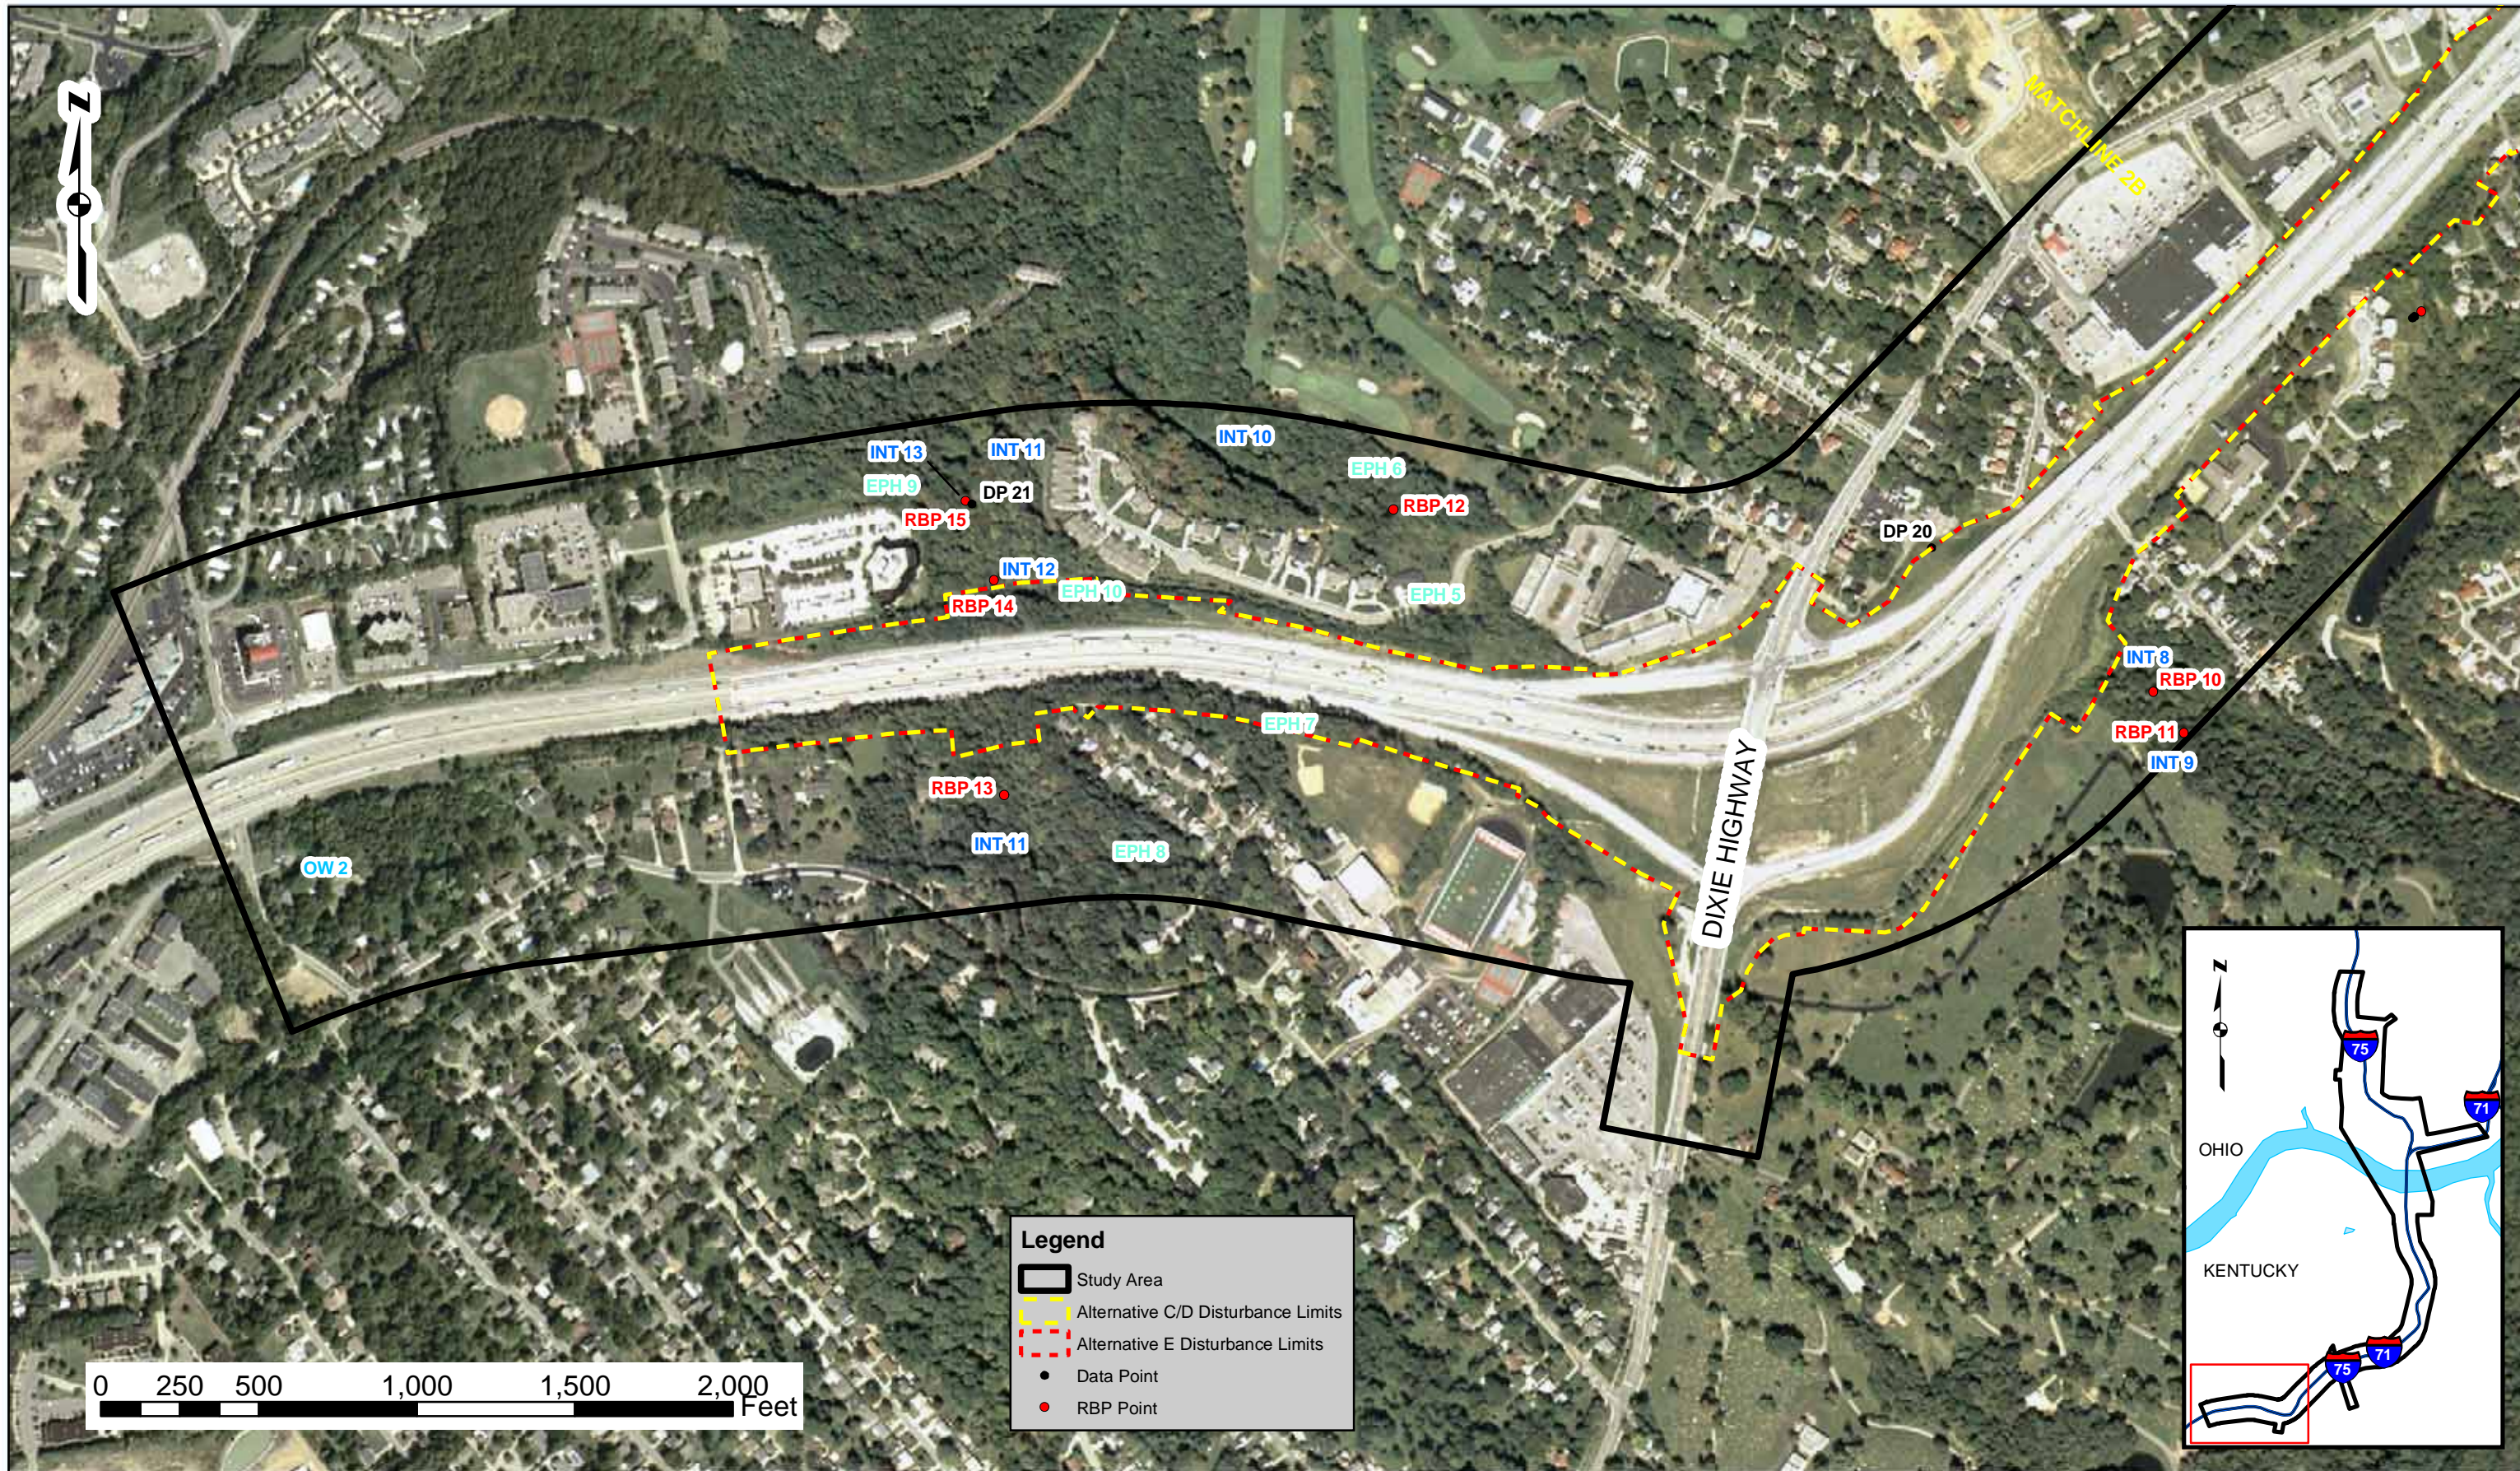
**ALTERNATIVES WITH STUDY AREA MAP (AERIAL PHOTOGRAPH)
BRENT SPENCE BRIDGE
REPLACEMENT/REHABILITATION PROJECT
LEVEL ONE ECOLOGICAL SURVEY REPORT**

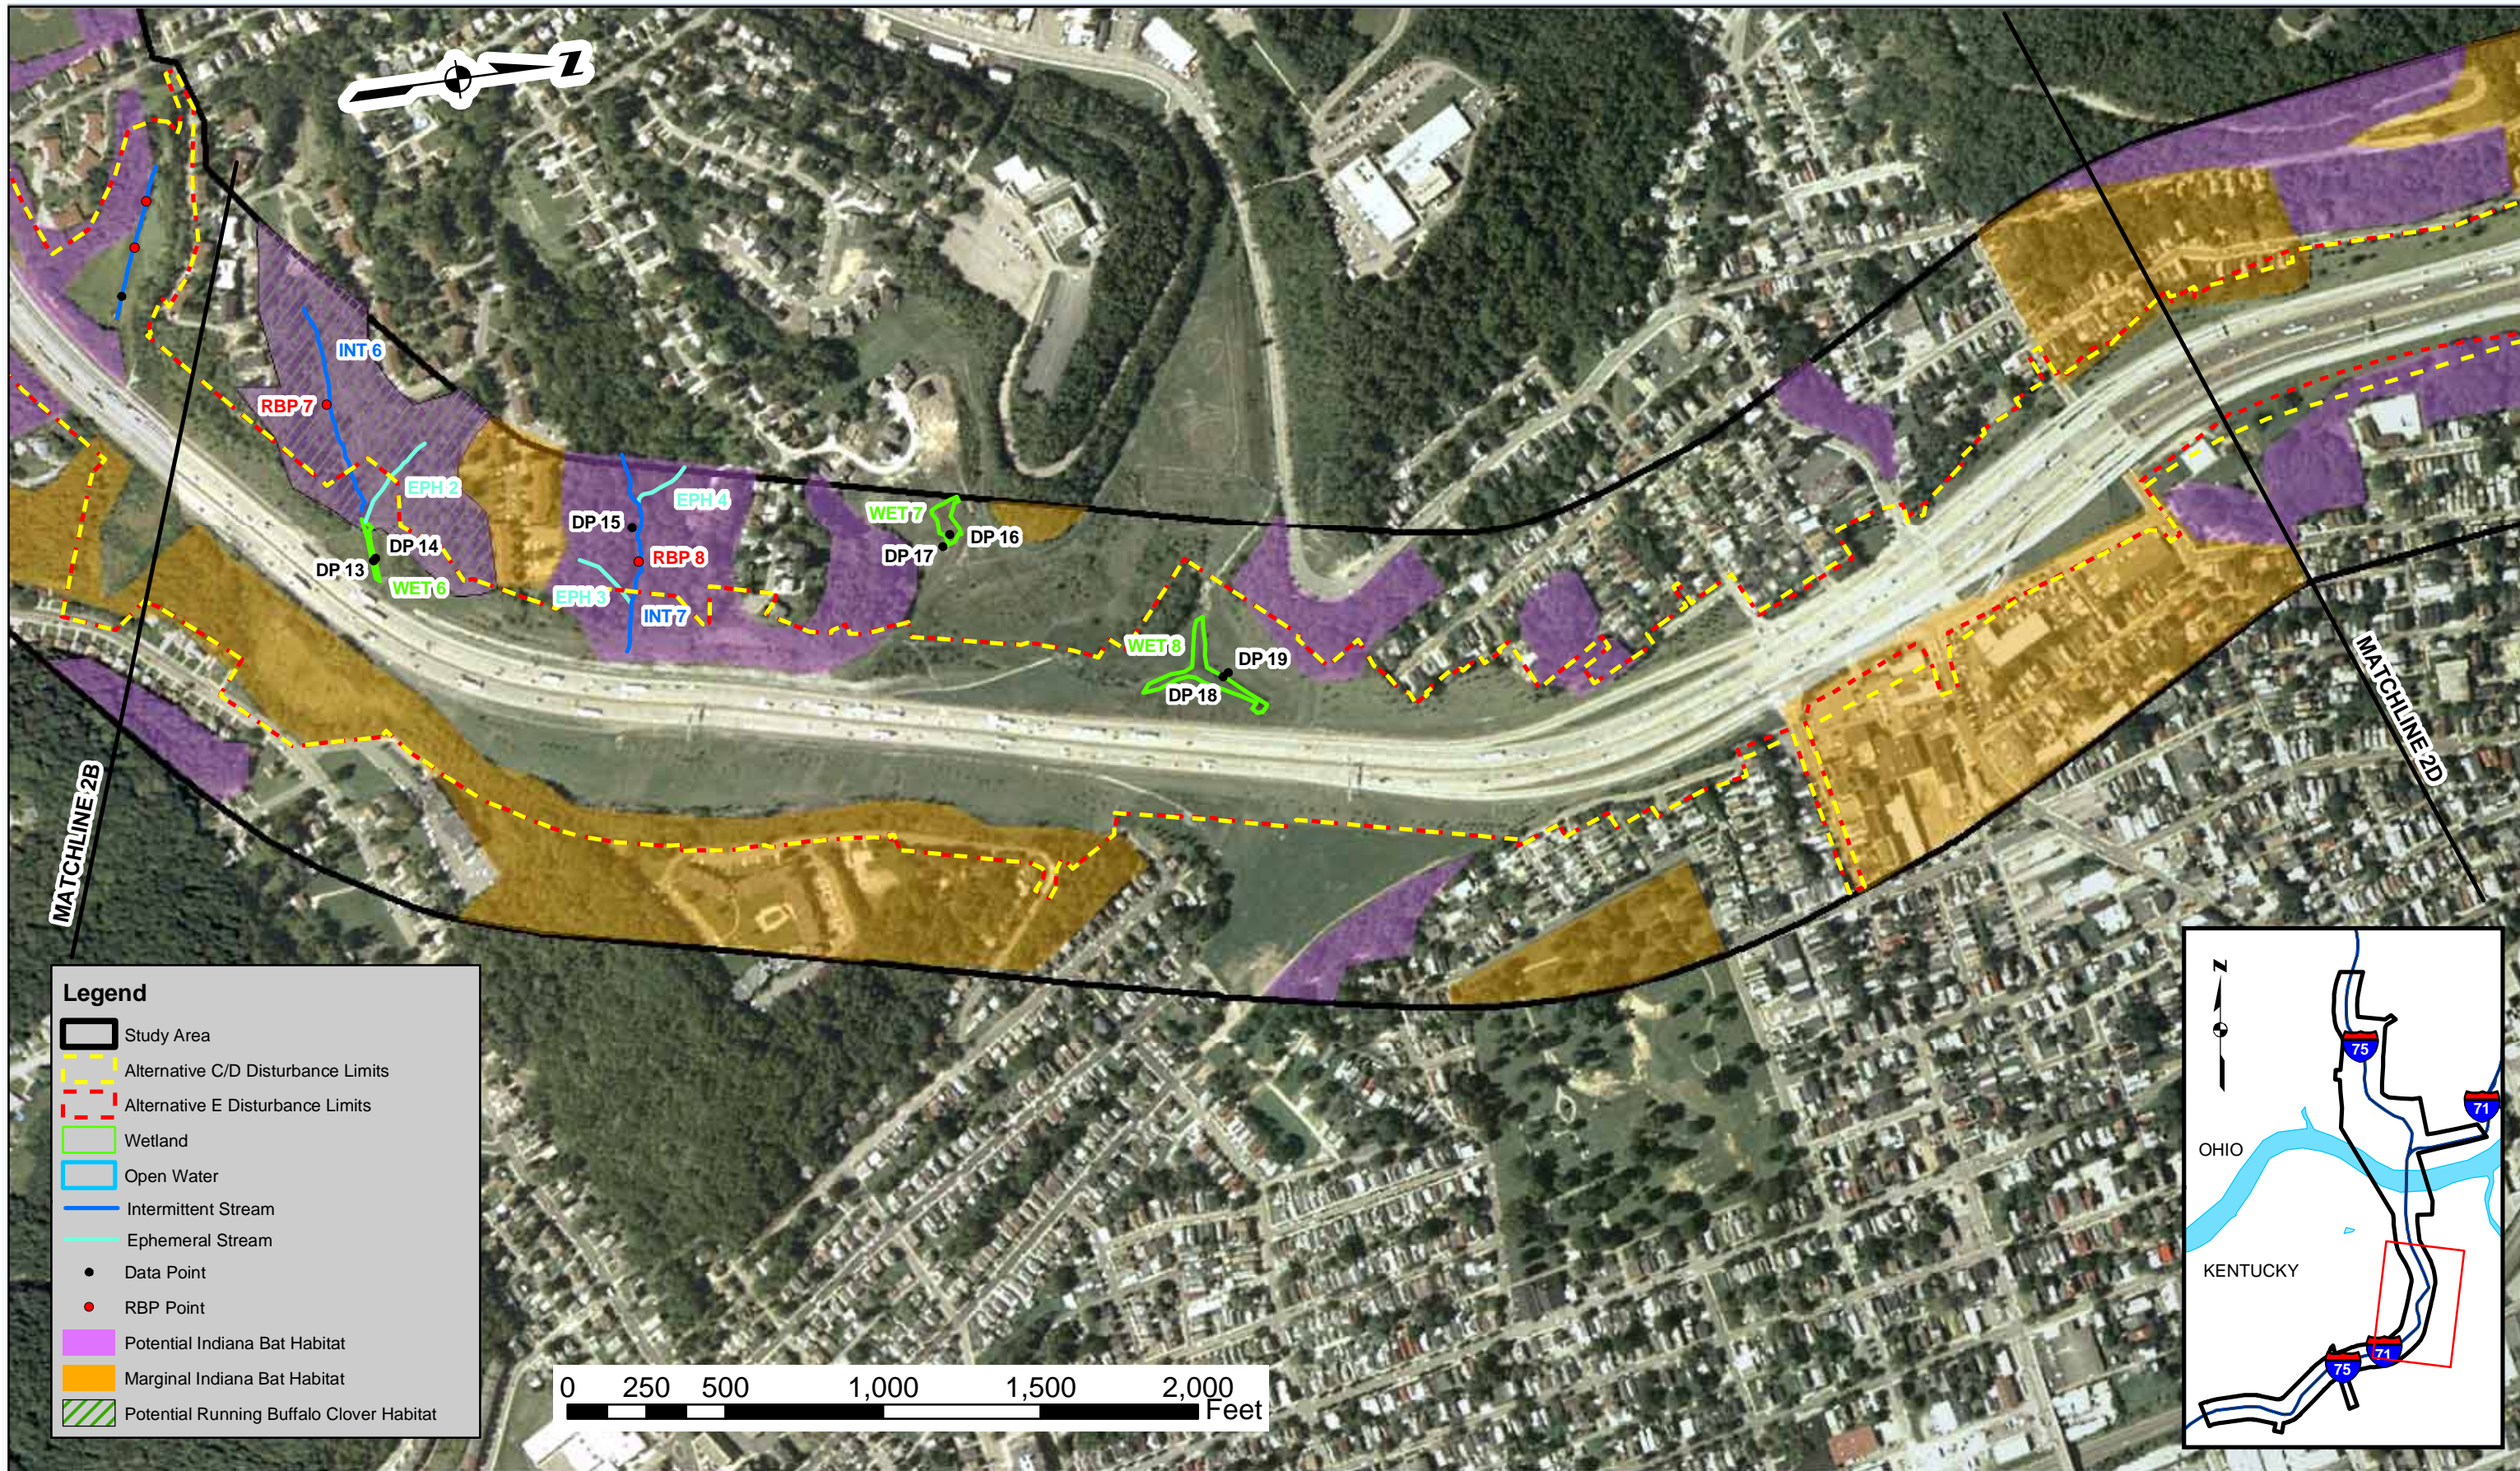
**ALTERNATIVES WITH STUDY AREA MAP (AERIAL PHOTOGRAPH)
BRENT SPENCE BRIDGE
REPLACEMENT/REHABILITATION PROJECT
LEVEL ONE ECOLOGICAL SURVEY REPORT**

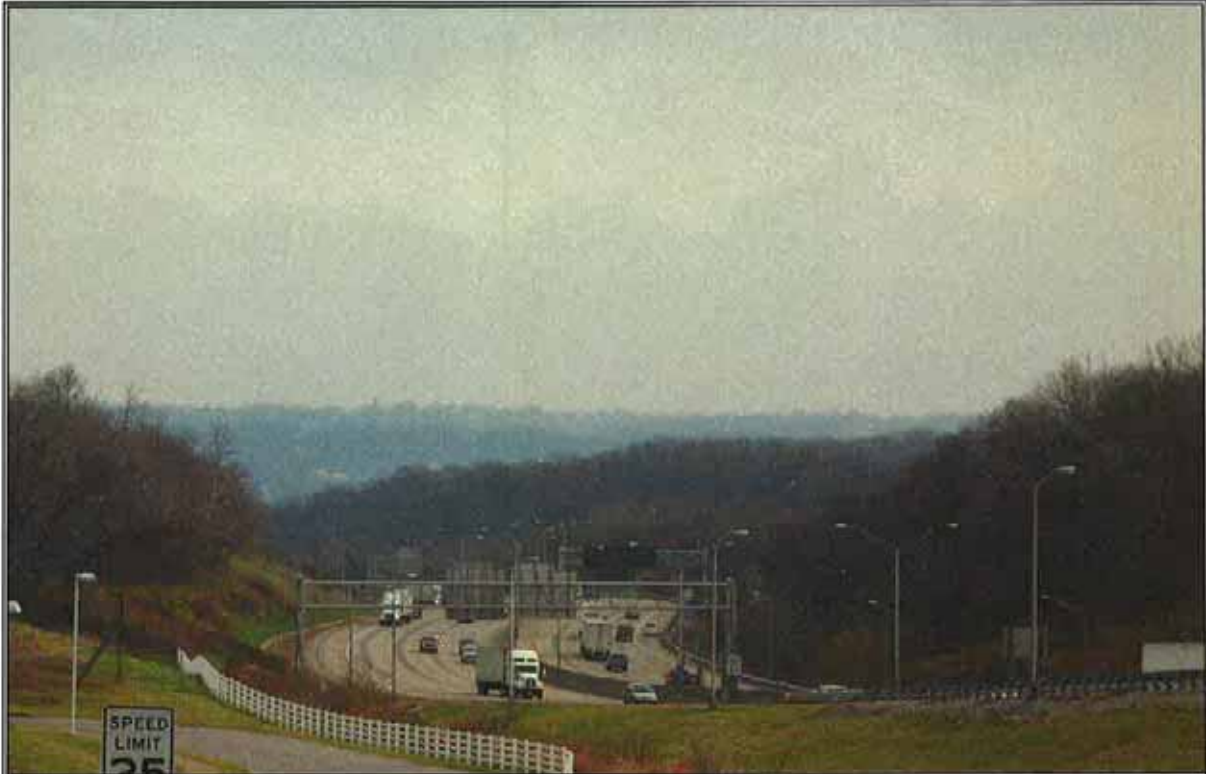
Photograph 1: General view of I-75/I-71 study area from near the Kyles Lane overpass looking northeast. Brent Spence Bridge Replacement and Rehabilitation Project. November 29, 2006.

The overall project corridor is located along a 7.8-mile segment of I-75 within the Commonwealth of Kentucky (state line mile 186.7) and the State of Ohio (state line mile 2.7) (Exhibit 1; Photograph 1). The southern limit of the project is 5,000 feet south of the midpoint of the Dixie Highway Interchange on I-71/I-75 in Fort Wright, south of Covington,

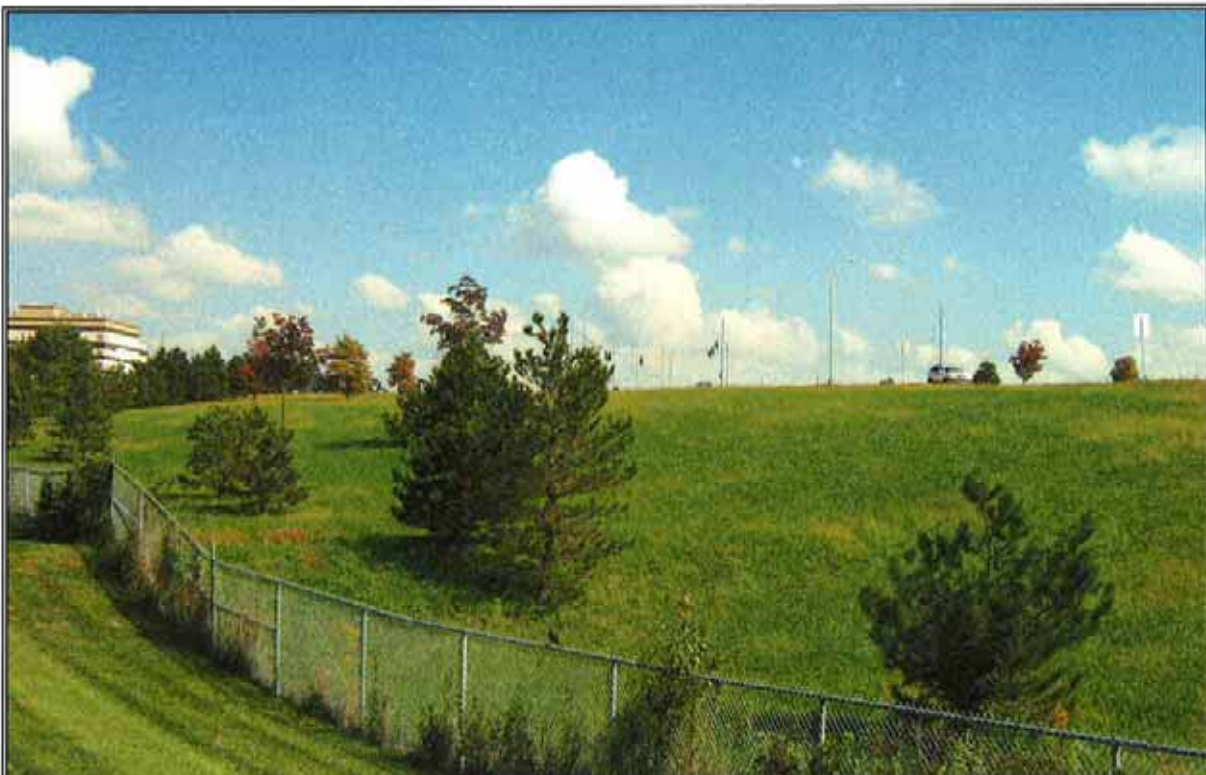
Photograph 2: Typical maintained grass area located within the project corridor. Brent Spence Bridge Replacement and Rehabilitation Project. October 9, 2006.

The United States Geologic Survey (USGS) topographic quadrangle (Covington, KY) maps the study area as gently to severely sloping down to the Ohio River (Exhibit 1). Recent aerial photographs indicate that a majority of the study area consists of residential, commercial, and institutional development along the existing I-75/I-71 corridor (Photographs 2 and 3). Few undisturbed natural areas remain within the study area.

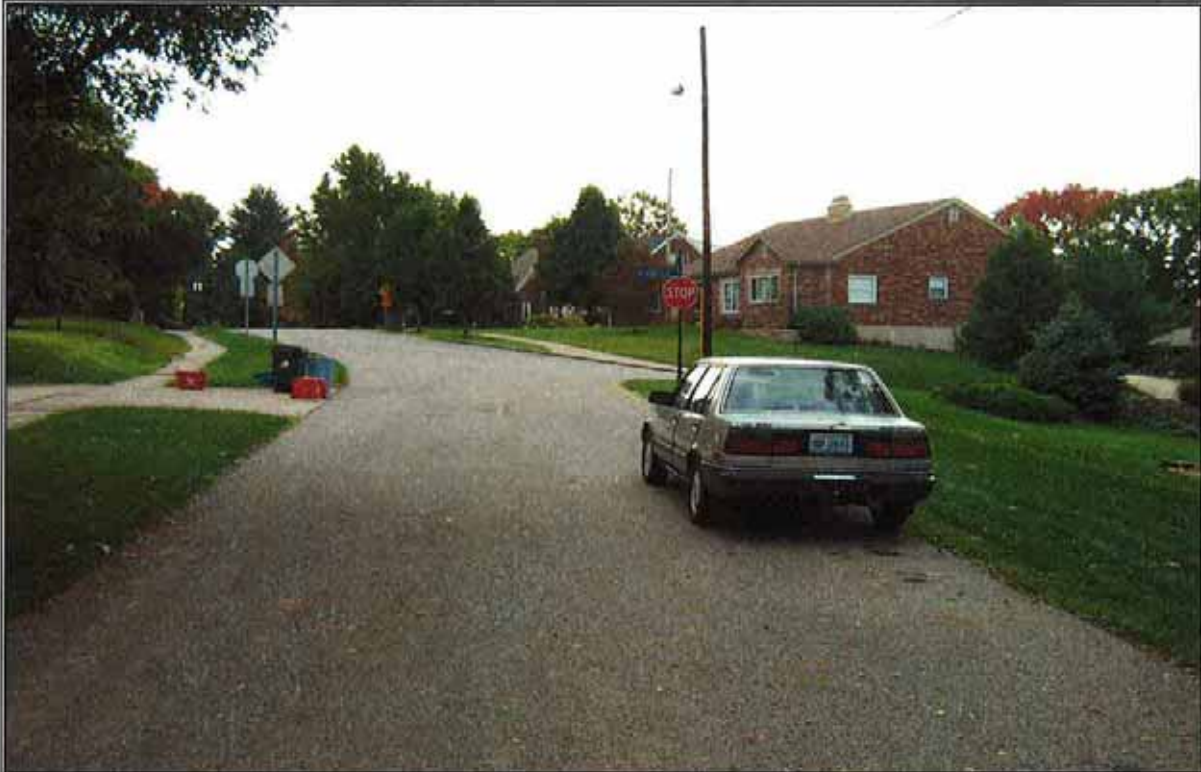
Photograph 3: Typical single-family residential development within project corridor. Brent Spence Bridge Replacement and Rehabilitation Project. October 10, 2006.

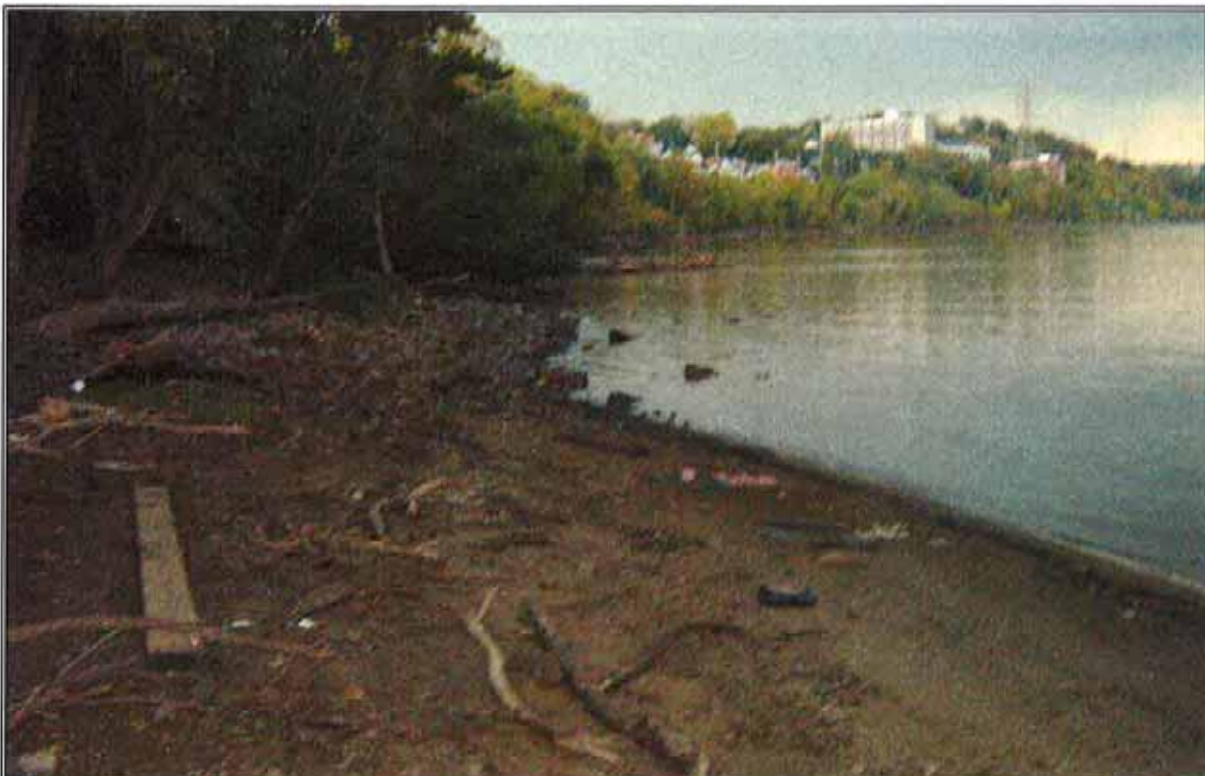
Photograph 4: Kentucky bank of Ohio River beneath existing Brent Spence Bridge (looking downstream). Brent Spence Bridge Replacement and Rehabilitation Project. October 11, 2006.

The Ohio River is approximately 1,300 feet wide at the existing Brent Spence Bridge location (Photographs 4 and 5). The normal pool elevation of the Ohio River in the area of the bridge is about 455 feet above msl and the ordinary high water mark is approximately 468.5 feet above msl.

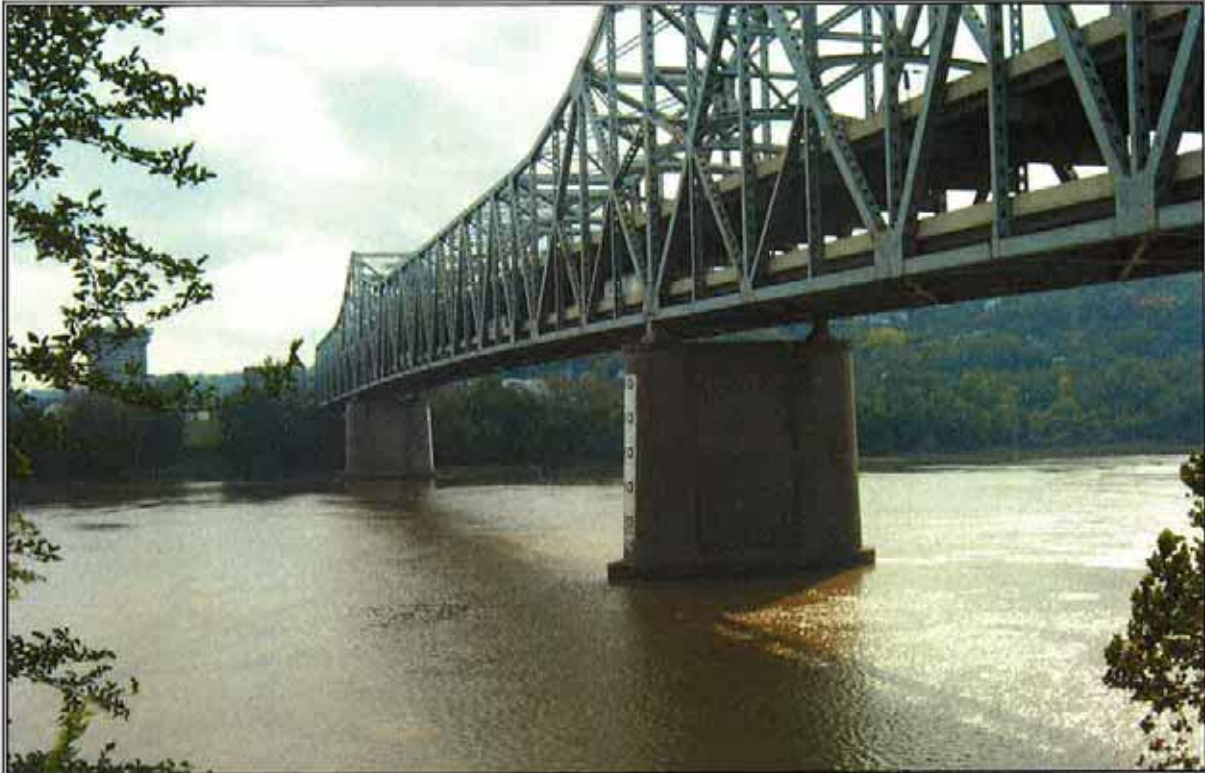
Photograph 5: Ohio River and existing Brent Spence Bridge (view from Ohio). Brent Spence Bridge Replacement and Rehabilitation Project. October 11, 2006.

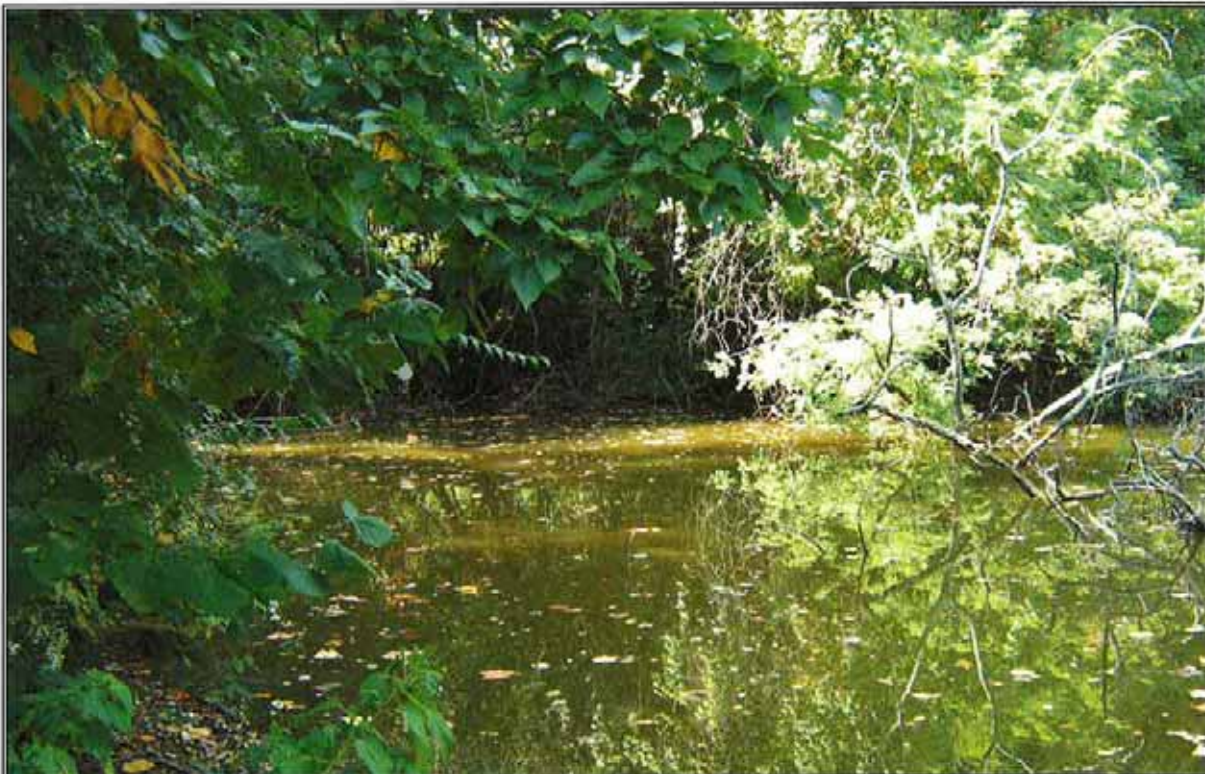
Photograph 6: Open Water Pond 1. Brent Spence Bridge Replacement and Rehabilitation Project. October 9, 2006.

During the field assessment, physical characteristics were collected for 13 intermittent and 10 ephemeral streams (Table 3; Exhibit 2A-2D; Exhibit 3A-3D). A total of 9,525 linear feet of intermittent stream and 2,180 linear feet of ephemeral stream were delineated within the study area. USEPA's *Rapid Bioassessment Protocols for Use in Wadeable Streams and Rivers* (RBP) (1999) Habitat Assessment Form for each intermittent stream is presented in Appendix IV. Two open water ponds were also identified within the study area (Table 4; Exhibit 2A-2D; Exhibit 3A-3D). Each intermittent and ephemeral stream and the open water pond are discussed in more detail below (Photographs 6 through 23).

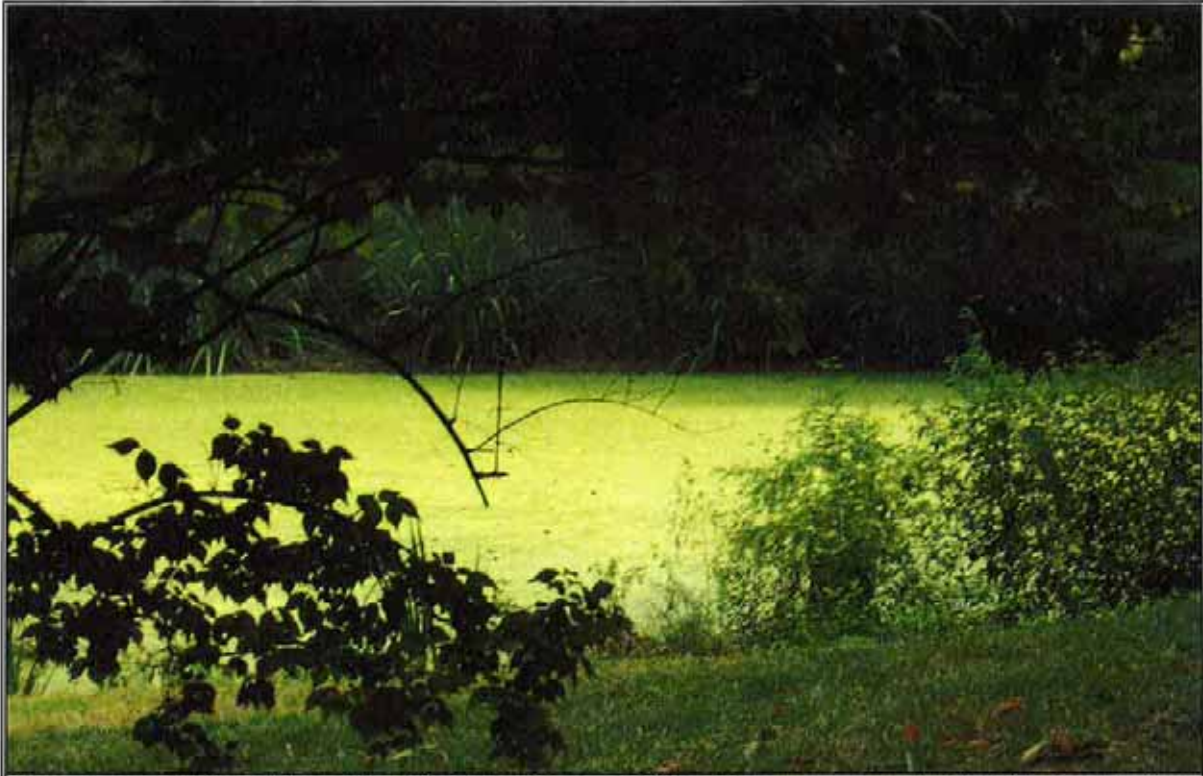
Photograph 7: Open Water Pond 2. Brent Spence Bridge Replacement and Rehabilitation Project. September 3, 2009.

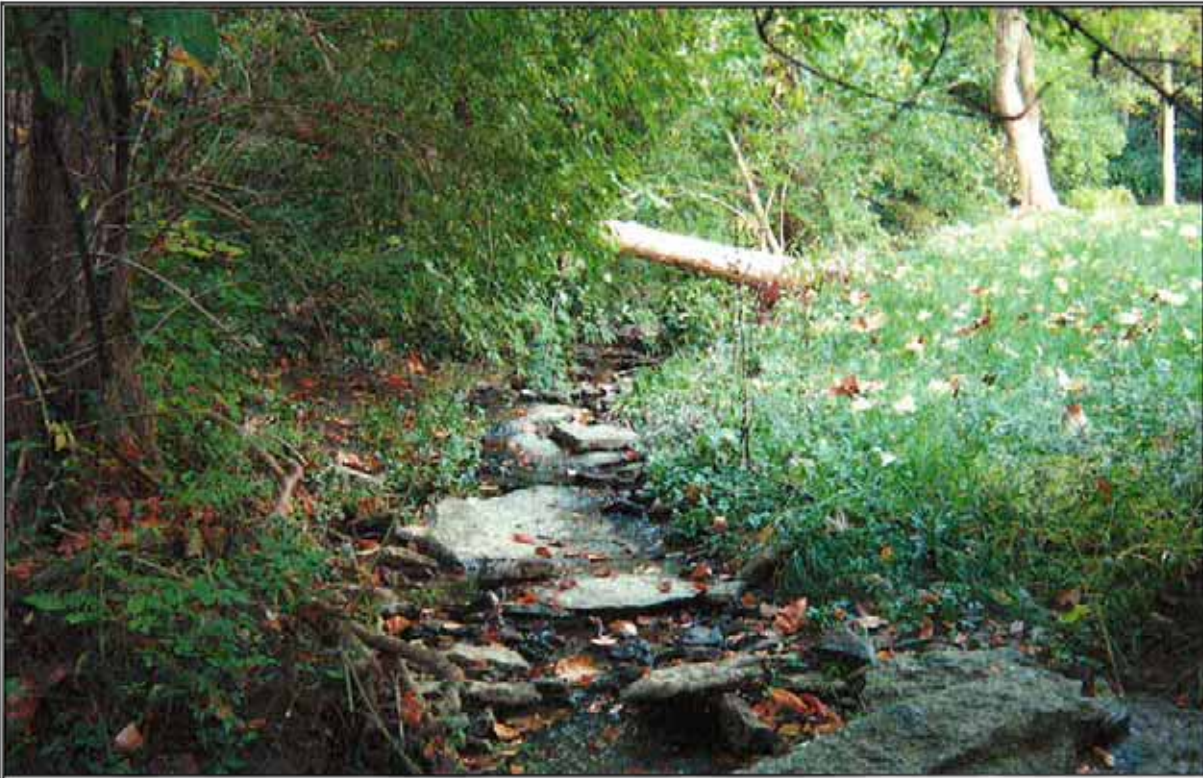
Photograph 8: Intermittent Stream 1 (looking upstream from Intermittent Stream 2 confluence). Brent Spence Bridge Replacement and Rehabilitation Project. October 9, 2006.

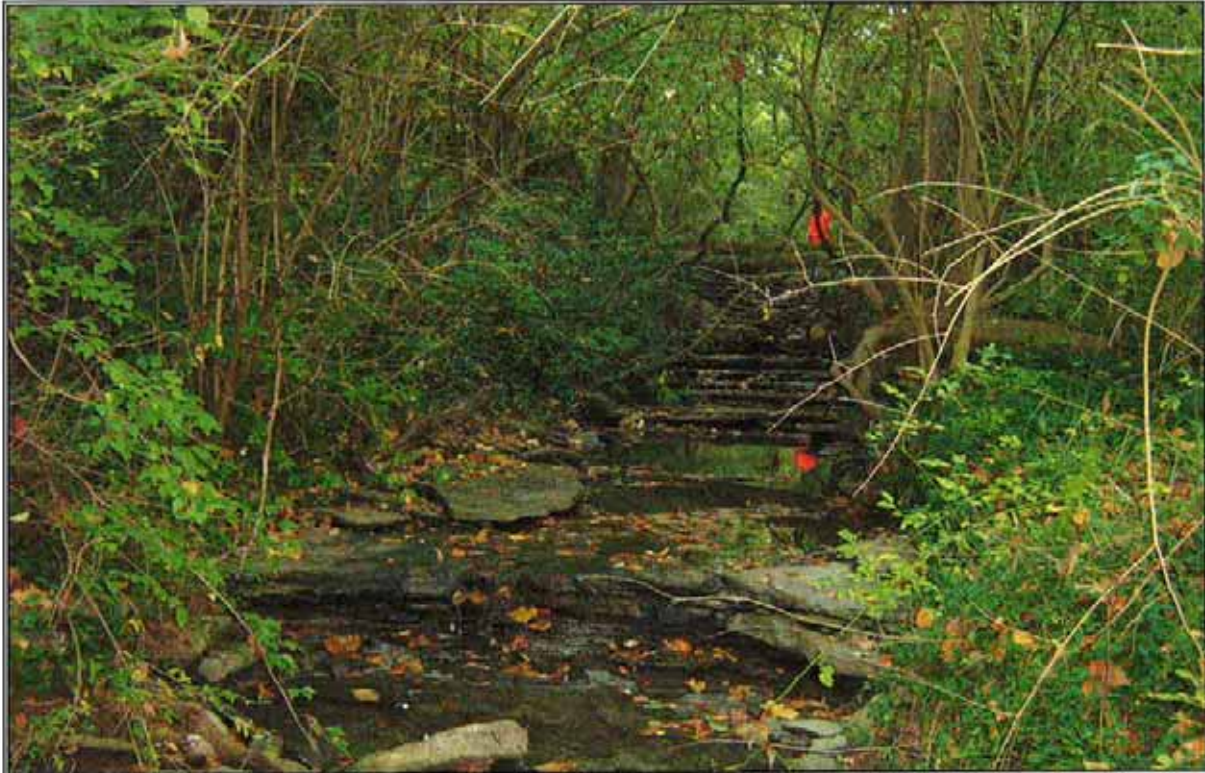
Photograph 9: Intermittent Stream 2 (looking upstream from Intermittent Stream 1 confluence). Brent Spence Bridge Replacement and Rehabilitation Project. October 9, 2006.

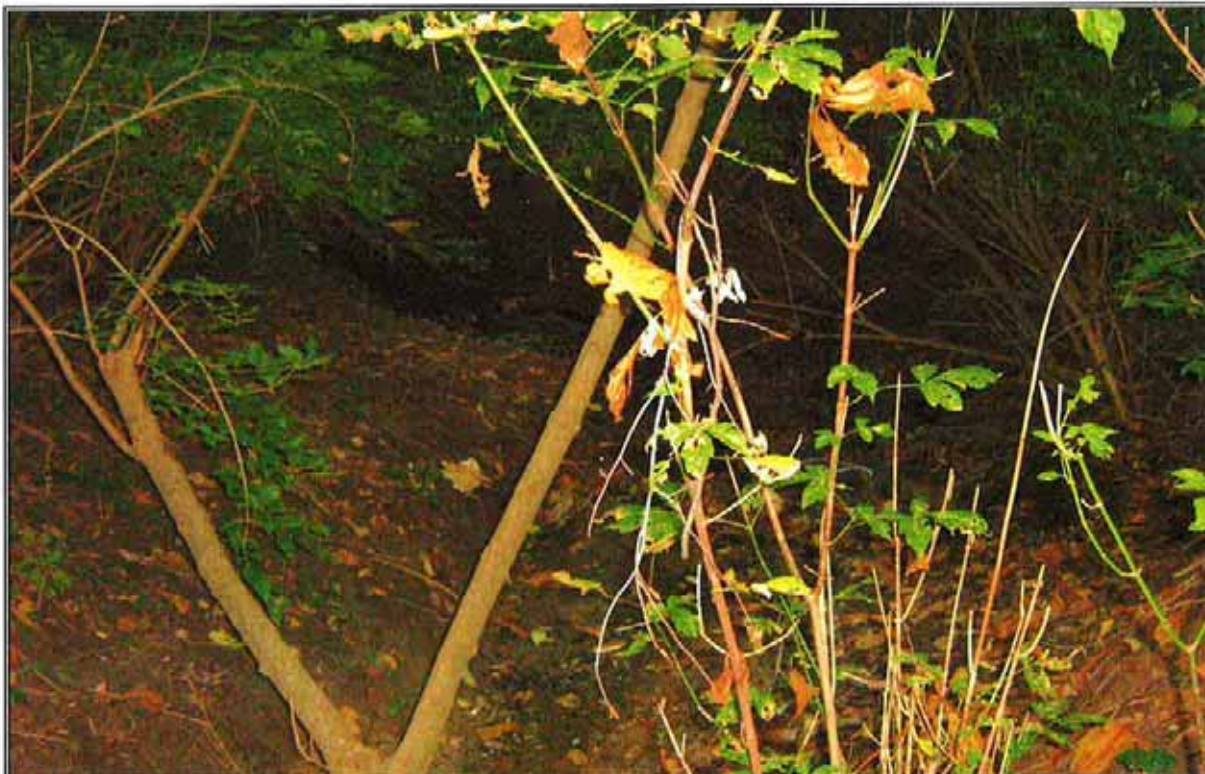
Photograph 10: Intermittent Stream 3 (looking upstream). Brent Spence Bridge Replacement and Rehabilitation Project. October 9, 2006.

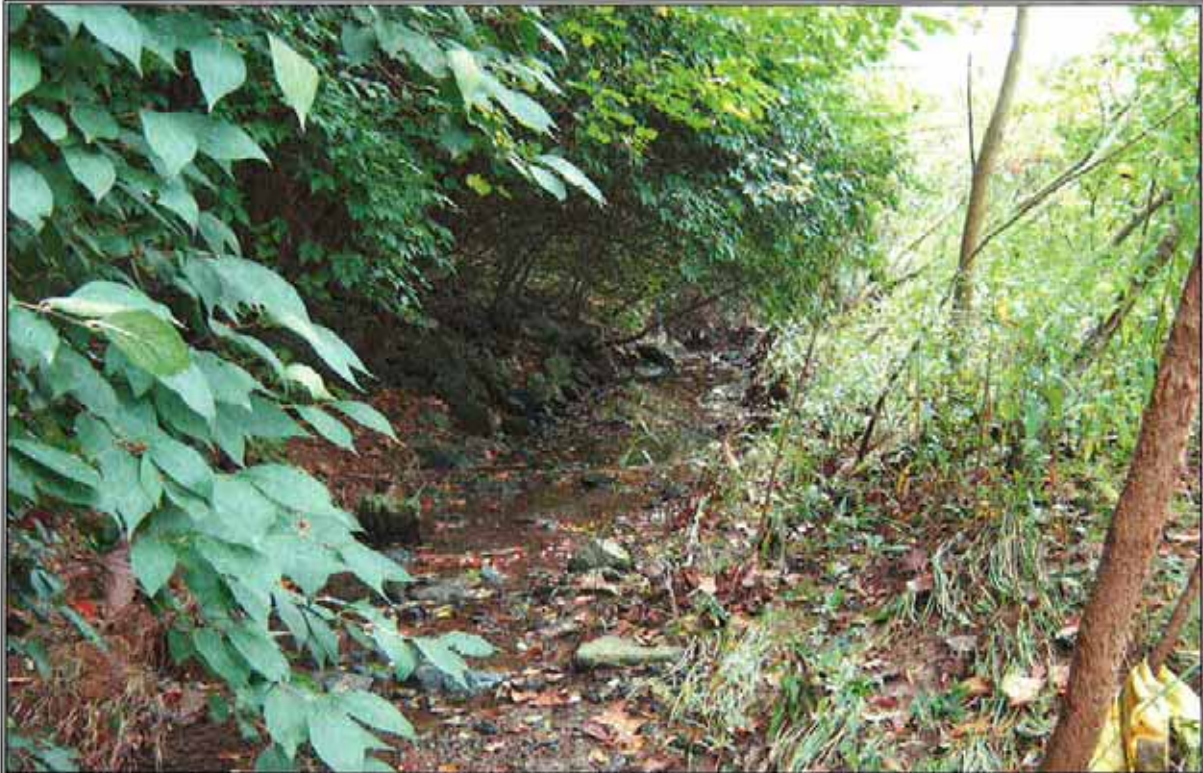
Photograph 11: Upper portion of Intermittent Stream 4 (looking upstream) with interstate right of frame. This area is to be impacted by road widening. Brent Spence Bridge Replacement and Rehabilitation Project. October 10, 2006.

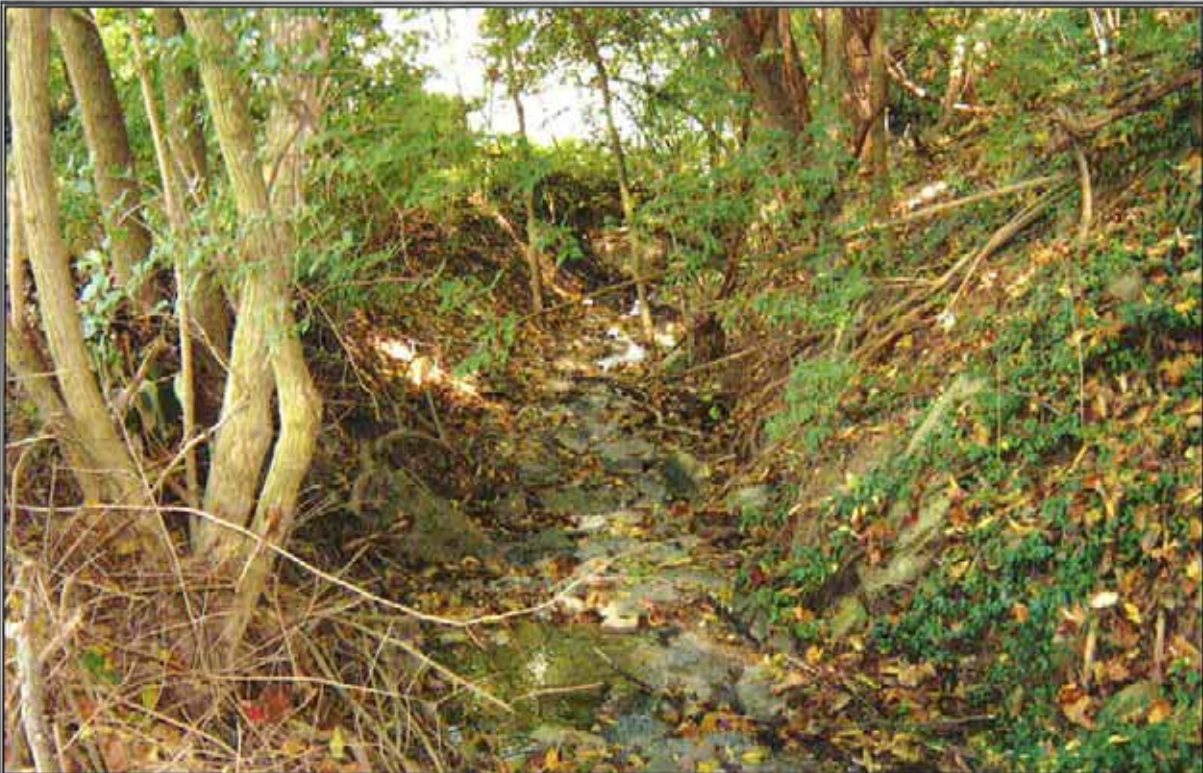
Photograph 12: Lower portion of Intermittent Stream 4 (looking downstream). Brent Spence Bridge Replacement and Rehabilitation Project. October 12, 2006.

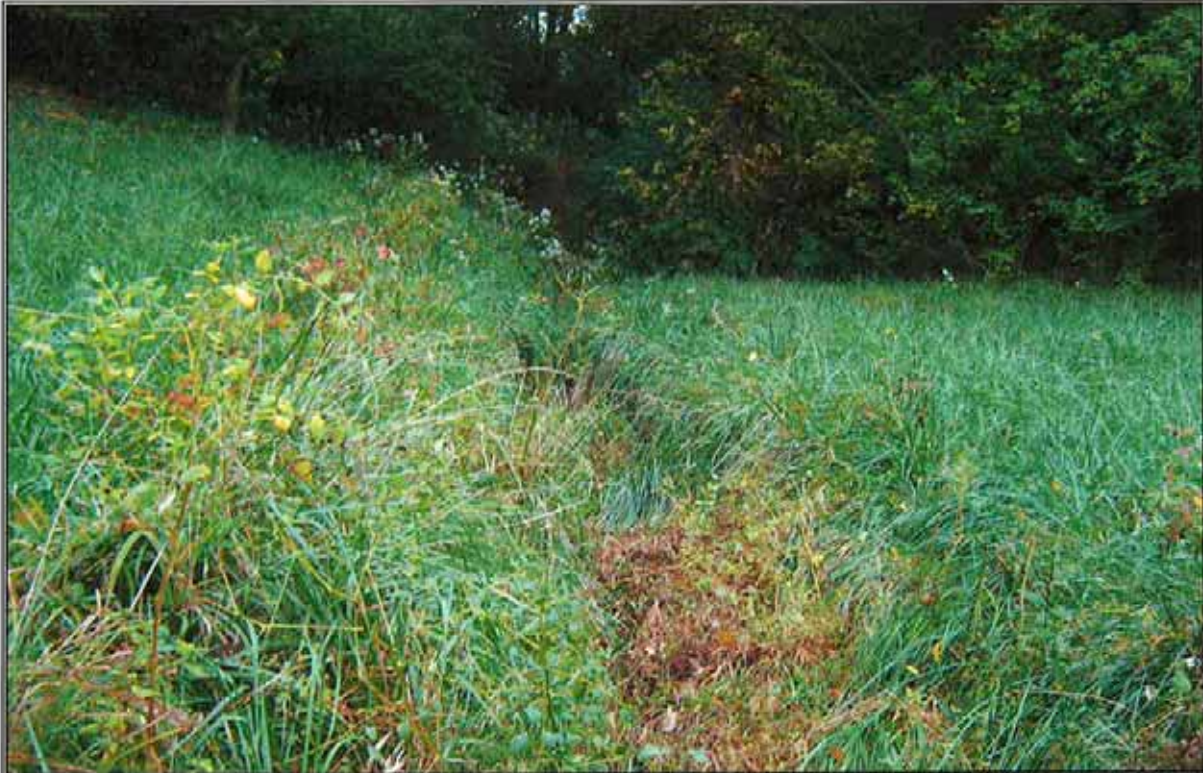
Photograph 13: Intermittent Stream 5 (looking upstream). Note that the stream is located in the woods and a maintained grass area. Brent Spence Bridge Replacement and Rehabilitation Project. October 11, 2006.

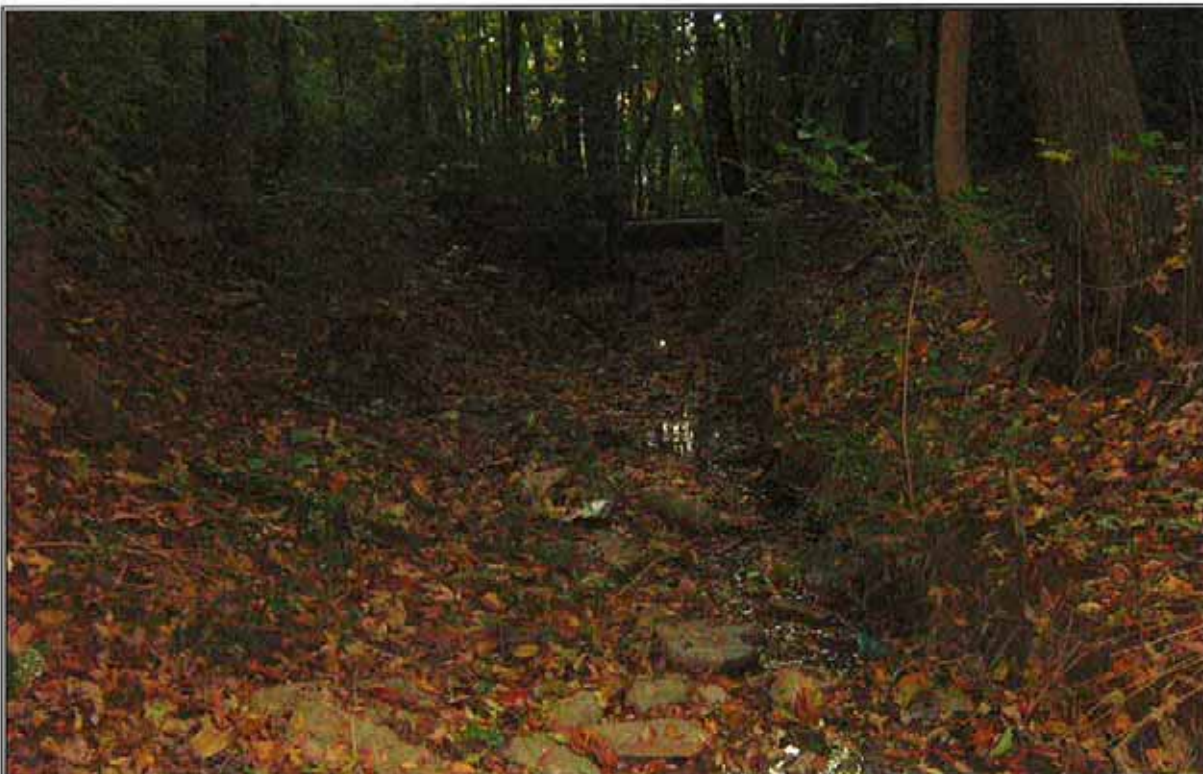
Photograph 14: Intermittent Stream 6 (looking upstream). Brent Spence Bridge Replacement and Rehabilitation Project. October 12, 2006.

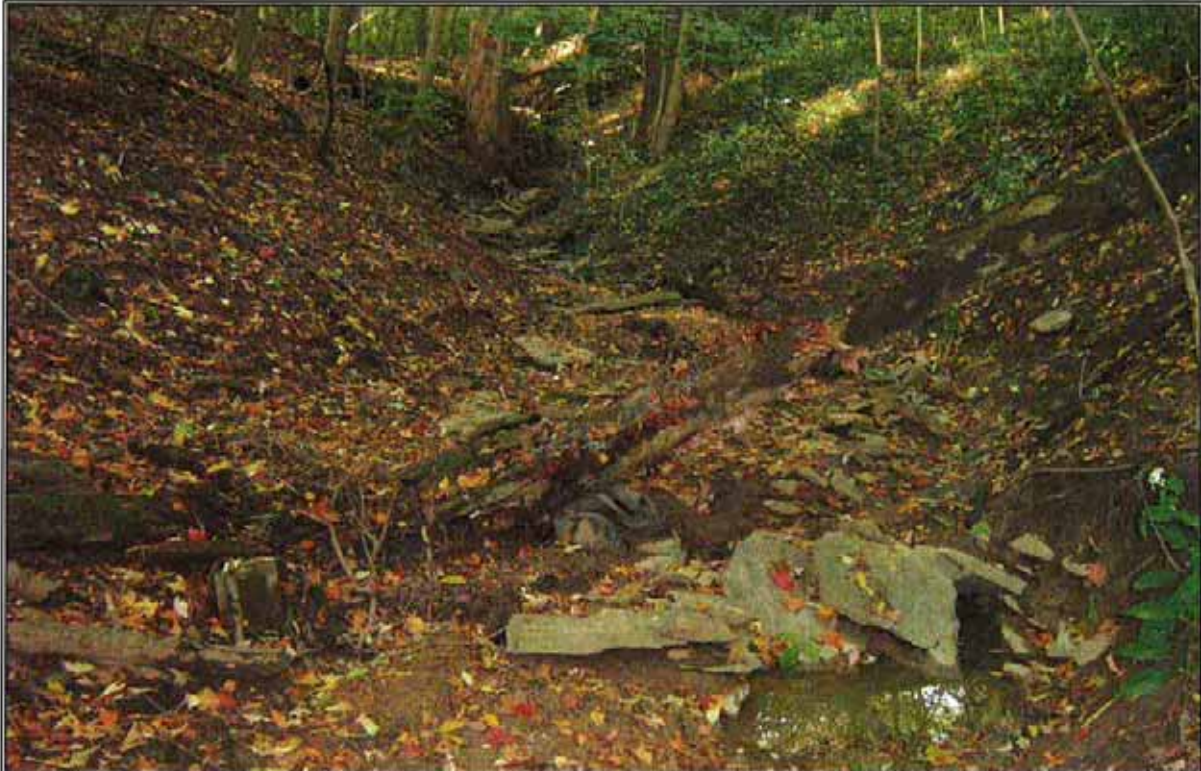
Photograph 15: Intermittent Stream 7 (looking upstream). Brent Spence Bridge Replacement and Rehabilitation Project. October 12, 2006.
