Brent Spence Bridge Replacement/Rehabilitation Project

Ecological Survey Report

KYTC Project Item No. 6-17

February 2010

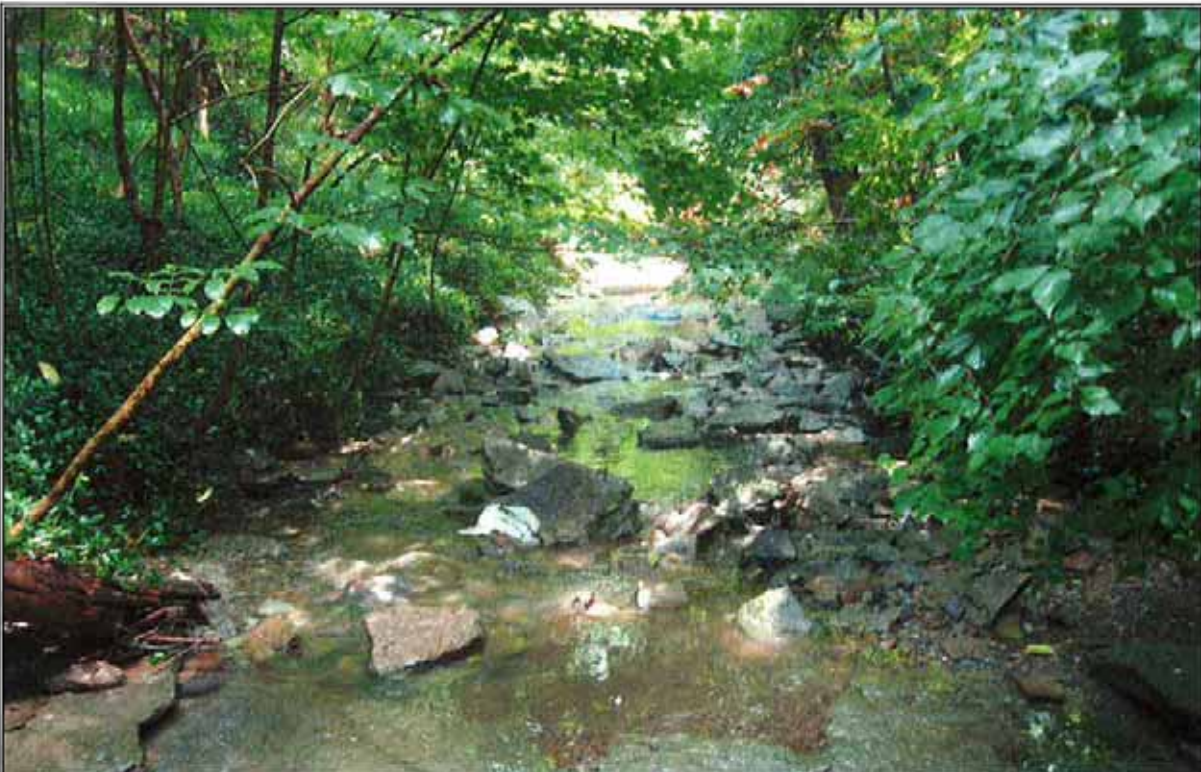
Photograph 16: Intermittent Stream 8 (looking downstream). Brent Spence Bridge Replacement and Rehabilitation Project. July 30, 2009.

During the field assessment, physical characteristics were collected for 13 intermittent and 10 ephemeral streams (Table 3; Exhibit 2A-2D; Exhibit 3A-3D). A total of 9,525 linear feet of intermittent stream and 2,180 linear feet of ephemeral stream were delineated within the study area. USEPA's *Rapid Bioassessment Protocols for Use in Wadeable Streams and Rivers* (RBP) (1999) Habitat Assessment Form for each intermittent stream is presented in Appendix IV. Two open water ponds were also identified within the study area (Table 4; Exhibit 2A-2D; Exhibit 3A-3D). Each intermittent and ephemeral stream and the open water pond are discussed in more detail below (Photographs 6 through 23).

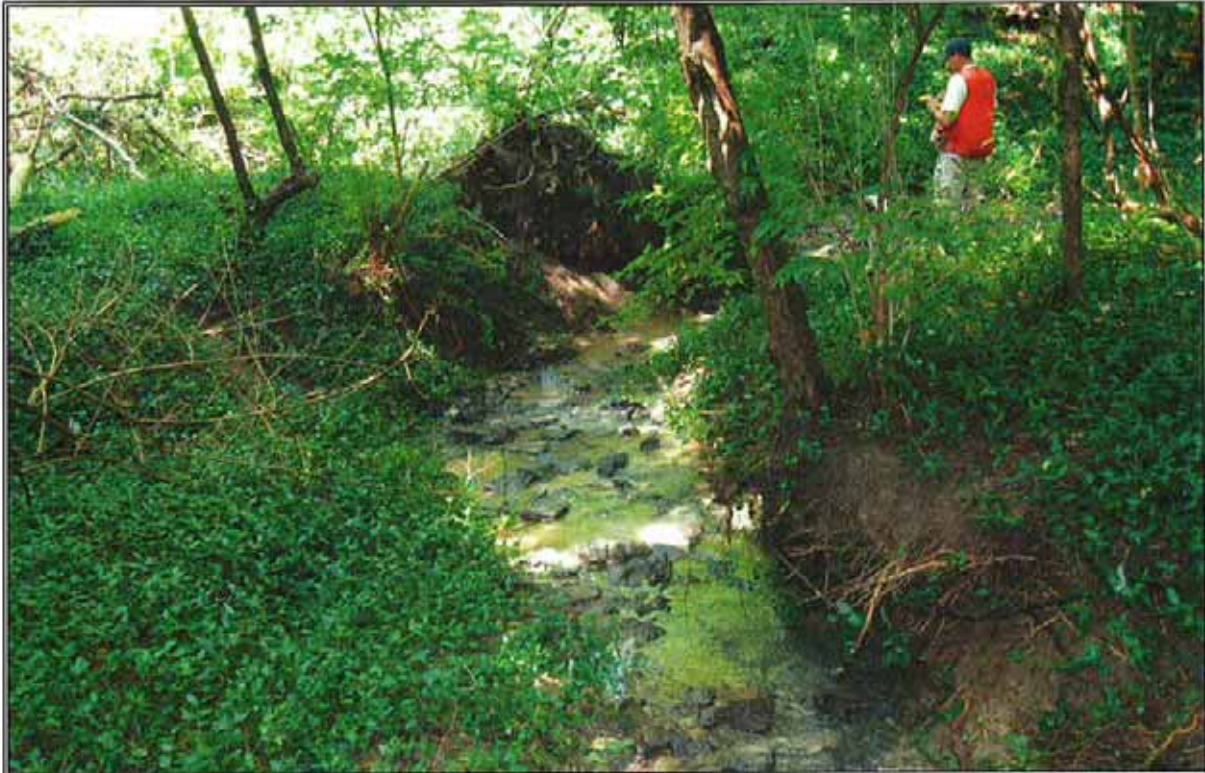
Photograph 17: Intermittent Stream 9 (looking downstream toward Intermittent Stream 8). Brent Spence Bridge Replacement and Rehabilitation Project. July 30, 2009.

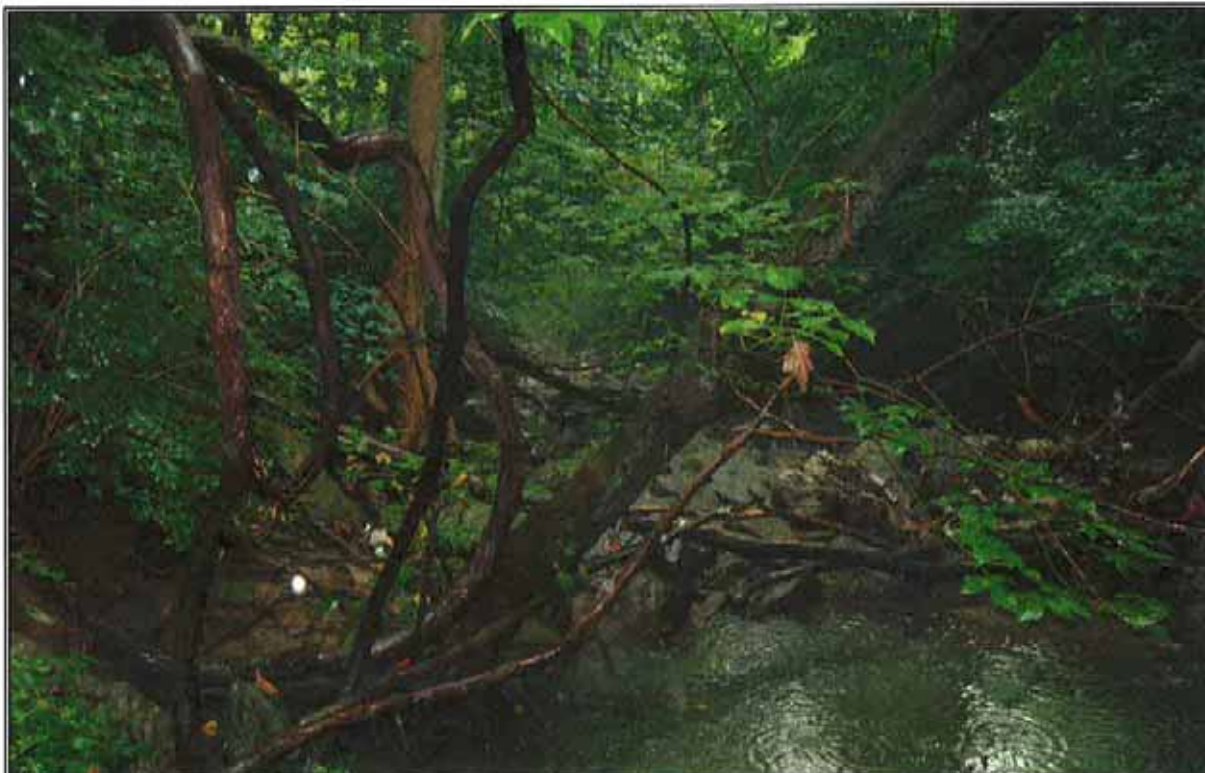
Photograph 18: Intermittent Stream 10 (looking downstream from culvert). Brent Spence Bridge Replacement and Rehabilitation Project. July 30, 2009.

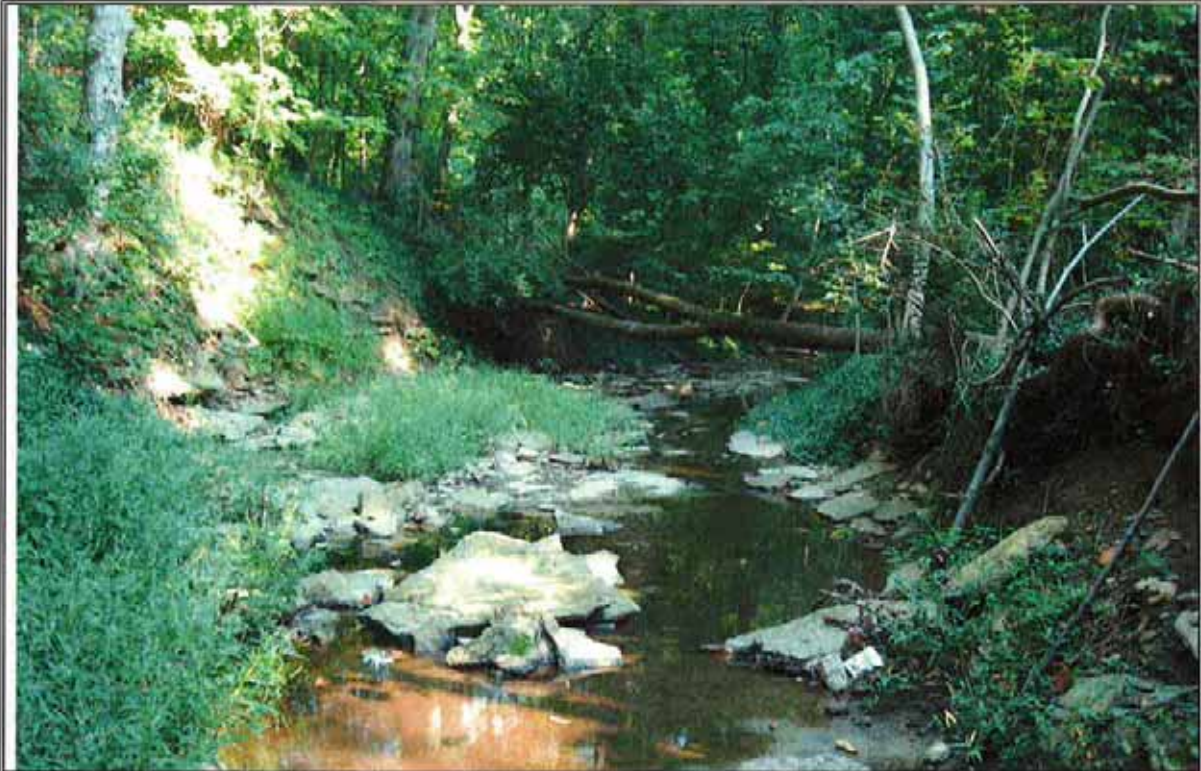
Photograph 19: Intermittent Stream 11 (looking downstream). Brent Spence Bridge Replacement and Rehabilitation Project. August 26, 2009.

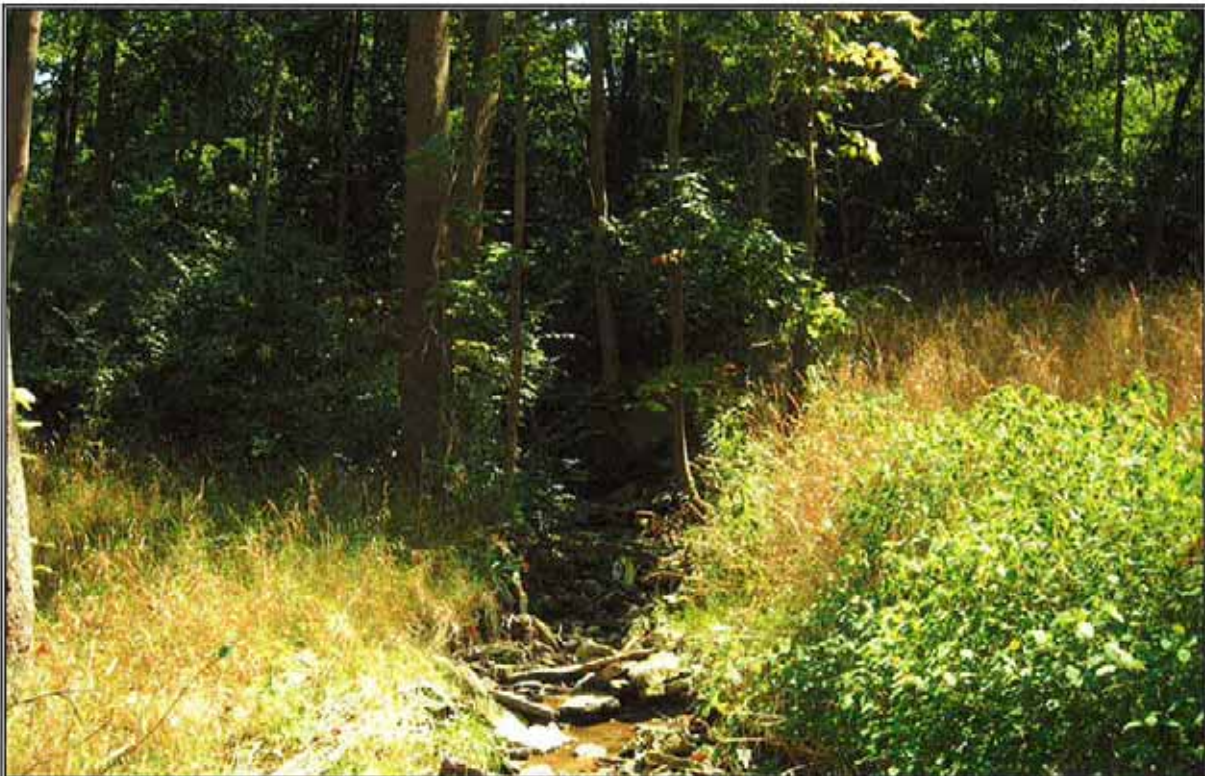
Photograph 20: Intermittent Stream 12 (looking upstream toward I-71/I-75). Brent Spence Bridge Replacement and Rehabilitation Project. September 3, 2009.

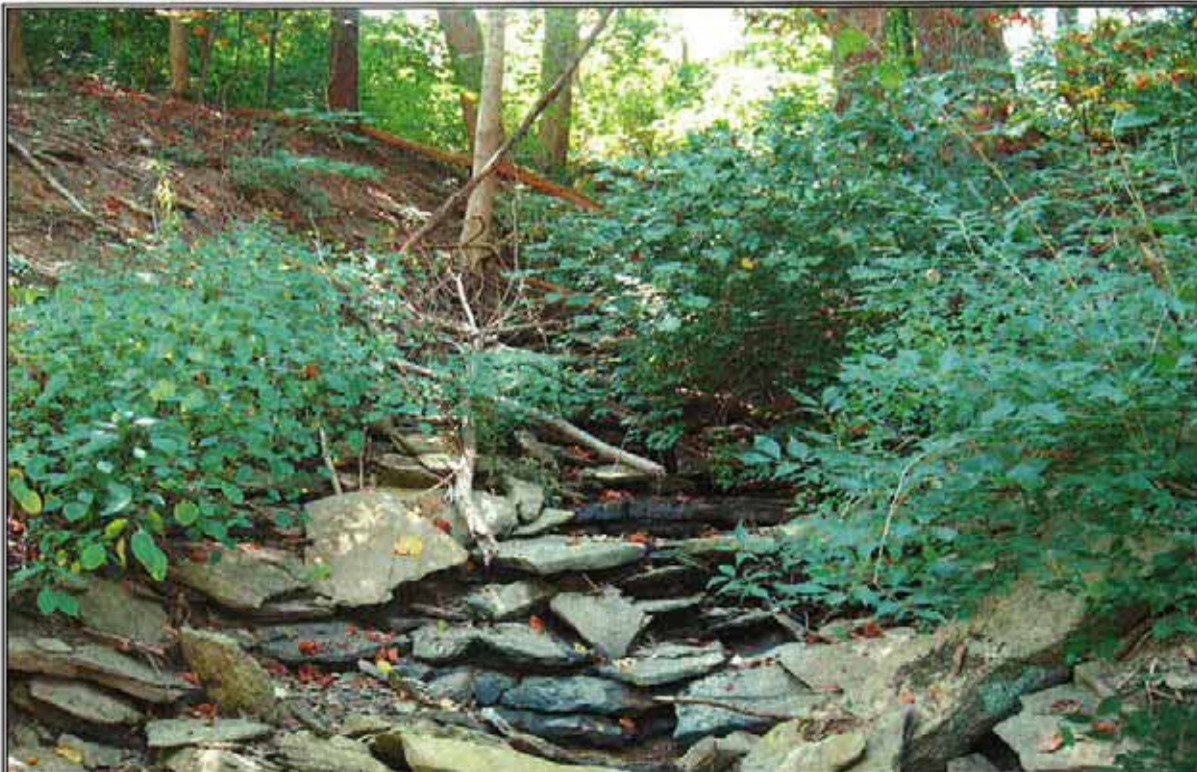
Photograph 21: Intermittent Stream 13 (looking upstream). Brent Spence Bridge Replacement and Rehabilitation Project. September 3, 2009.

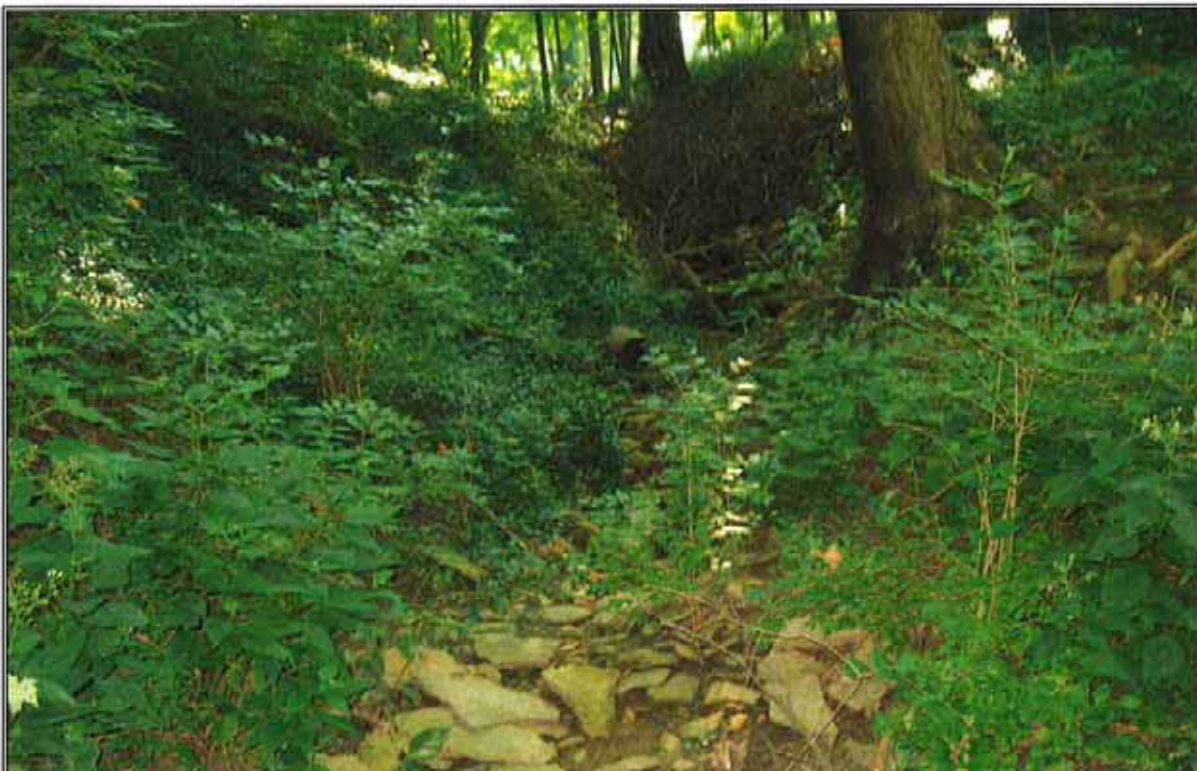
Photograph 22: Typical ephemeral stream within the project corridor. Brent Spence Bridge Replacement and Rehabilitation Project. August 26, 2009.

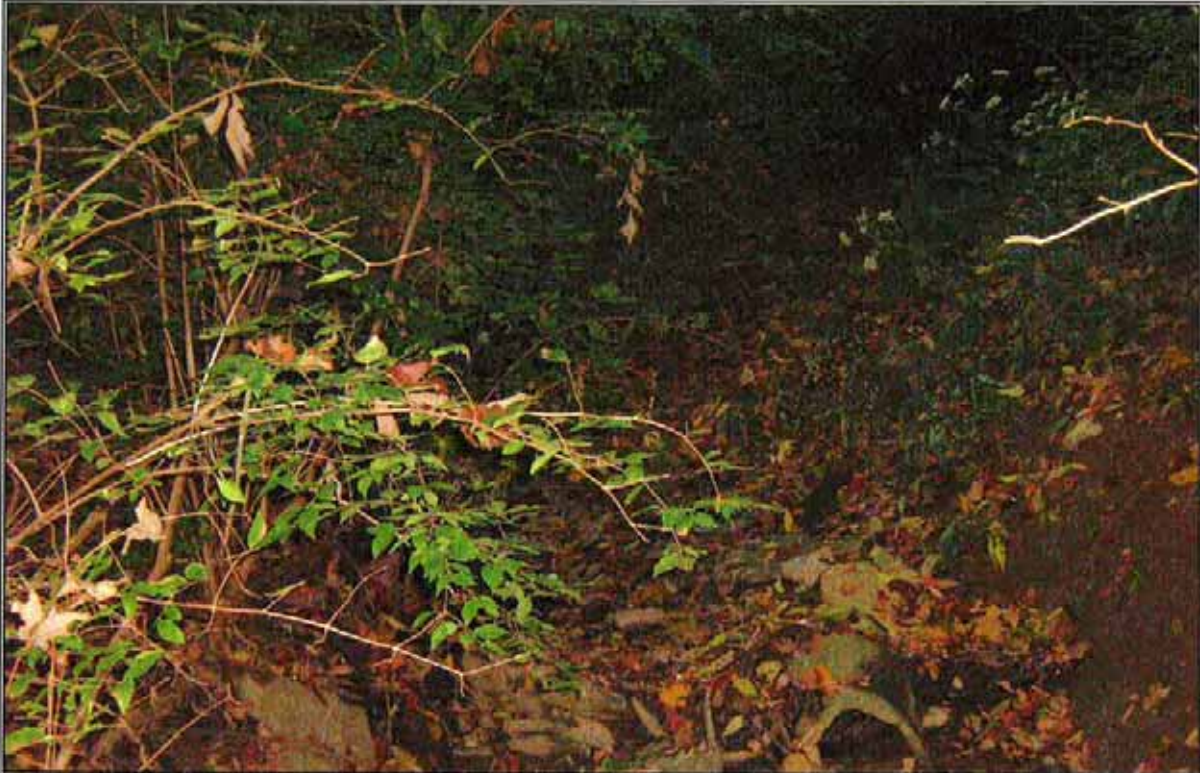
Photograph 23: Typical ephemeral stream within the project corridor. Brent Spence Bridge Replacement and Rehabilitation Project. October 12, 2006.

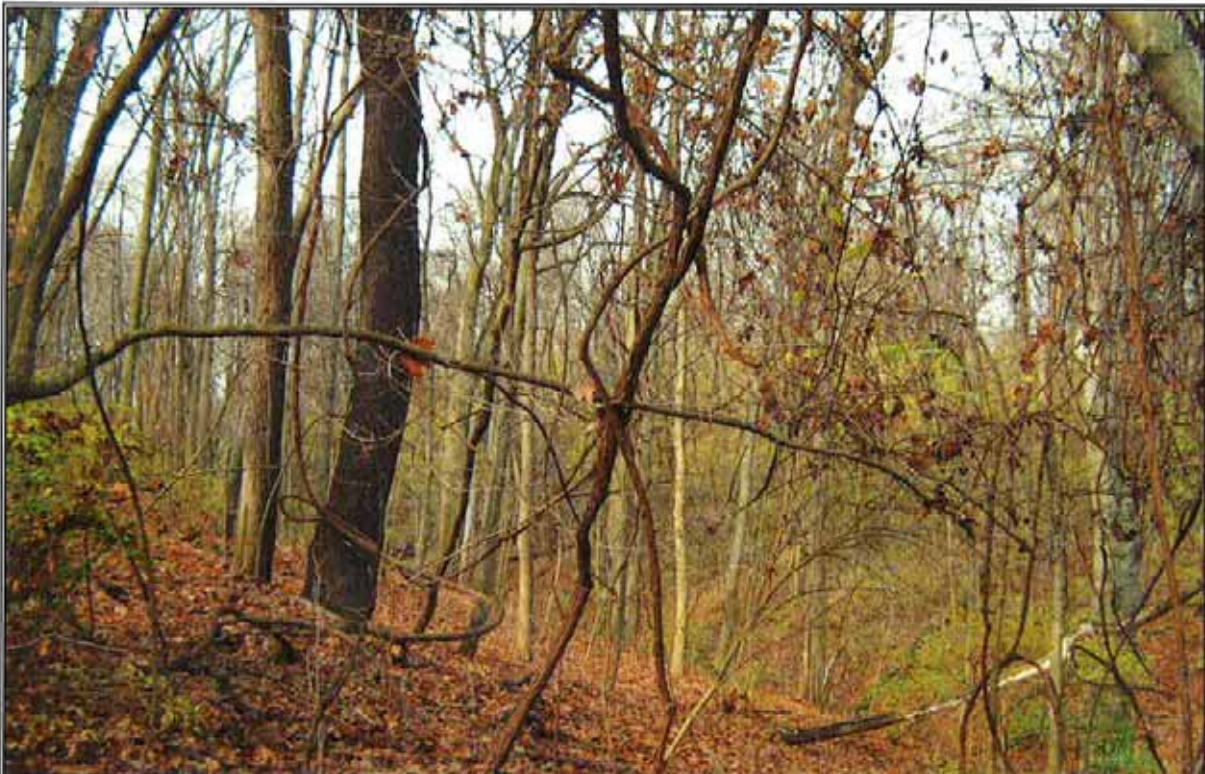
Photograph 24: Typical mixed age woods vegetation within the survey area. Brent Spence Bridge Replacement and Rehabilitation Project. November 29, 2006.

Mixed-age woods: Mixed-age woods within the corridor total approximately 138 acres (13.4 percent) and consist primarily of trees with diameters-at-breast height (dbh) greater than 10 inches (Table 7; Exhibit 6A-6D; Photograph 24). These areas have a closed canopy and distinct understory vegetation. Based on the surrounding urban landscape, the mixed-age woods habitat has been primarily marginalized to undevelopable land along hillsides. Dominant tree species in the mixed-age woods include: hackberry, hickory (*Carya sp.*), sugar maple, silver maple (*Acer saccharinum*), black cherry (*Prunus serotina*), white oak, chestnut oak (*Quercus prinus*), chinkapin oak (*Quercus muehlenbergii*). Dominant understory species include bush honeysuckle and wintercreeper. Other understory species include grape (*Vitis sp.*), poison ivy

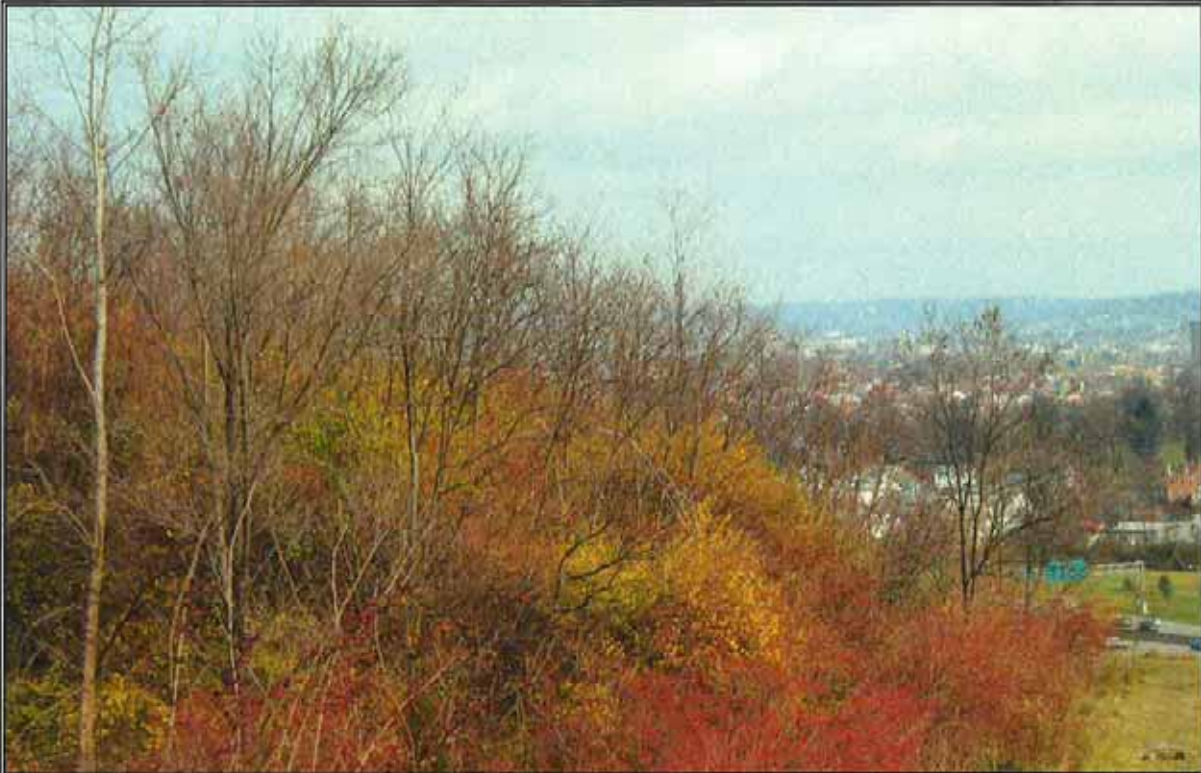
Photograph 25: Typical young woods vegetation within the survey area. Brent Spence Bridge Replacement and Rehabilitation Project. November 29, 2006.

Young Woods: Young woods within the corridor total approximately 23 acres (2.2 percent) and consist of smaller diameter trees with a dbh of less than 10 inches (Table 7; Photograph 25). These areas either lack a closed canopy or possess a partially closed canopy. Tree species in this habitat are similar to those in the mixed-age woods habitat. Understory vegetation is less defined and consists primarily of bush honeysuckle, multiflora rose, black raspberry (*Rubus occidentalis*), and Japanese honeysuckle (*Lonicera japonica*). Mammal, herpetofaunal, and avian species likely occurring within the young woods habitat are similar to those within the mixed-age woods habitat.

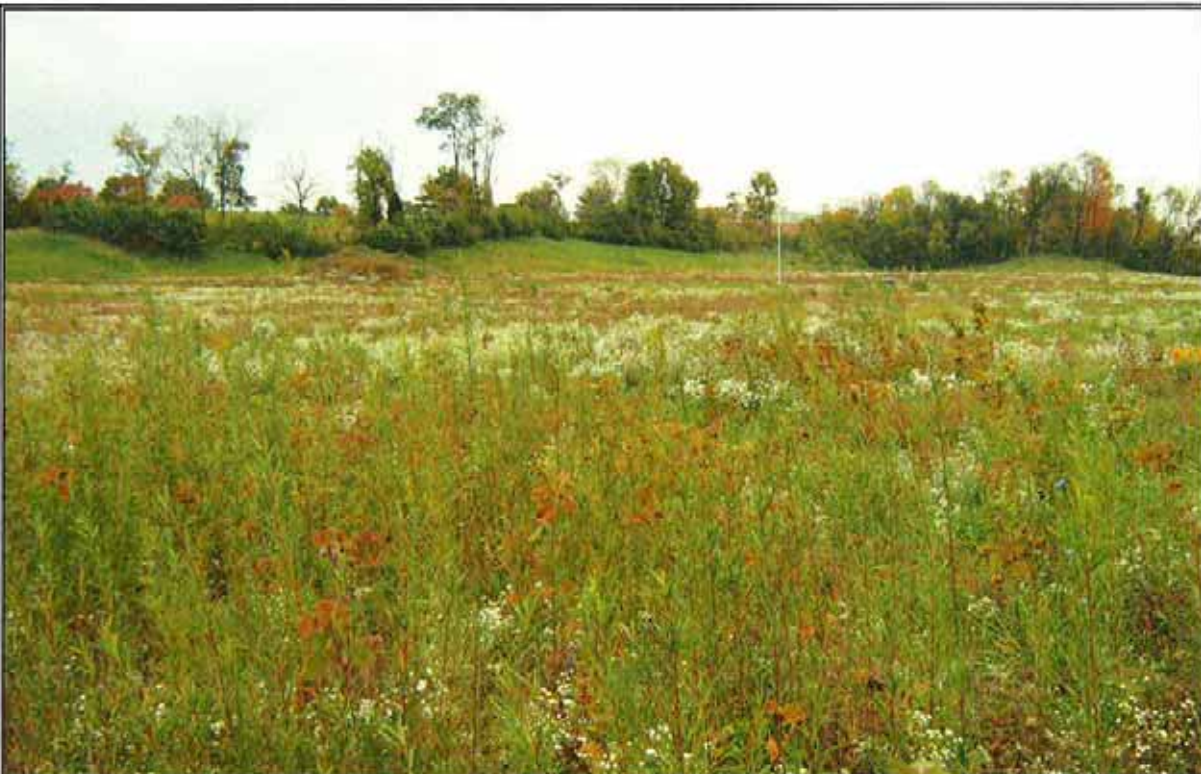
Photograph 26: Typical old field habitat within the survey area. Brent Spence Bridge Replacement and Rehabilitation Project. October 11, 2006.

Old Field: Old field habitat within the corridor totals approximately 40 acres (3.9 percent) and is dominated by herbaceous plants and small-diameter trees and shrubs (Table 7; Exhibit 6A-6D; Photograph 26). Old field species identified within the corridor include box elder (*Acer negundo*), red maple (*Acer rubrum*), eastern cottonwood (*Populus deltoides*), winged sumac (*Rhus copallinum*), black locust (*Robinia pseudoacacia*), tall fescue (*Festuca arundinacea*), red clover (*Trifolium pratense*), alsike clover (*Trifolium hybridum*), annual ragweed (*Ambrosia artemisiifolia*), bull thistle (*Cirsium vulgare*), Canada thistle (*Cirsium arvense*), and Queen Anne's Lace (*Daucus carota*).

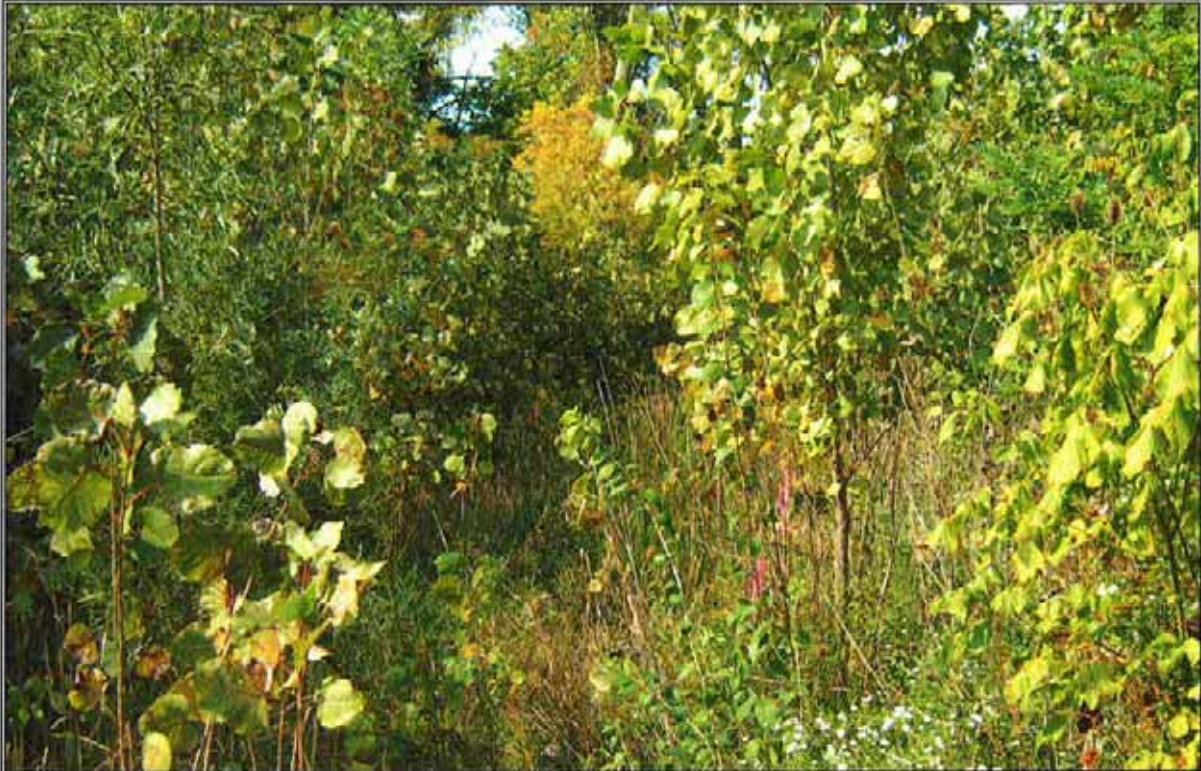
Photograph 27: Wetland 1 consisting of emergent and young sapling vegetation. Brent Spence Bridge Replacement and Rehabilitation Project. October 9, 2006.

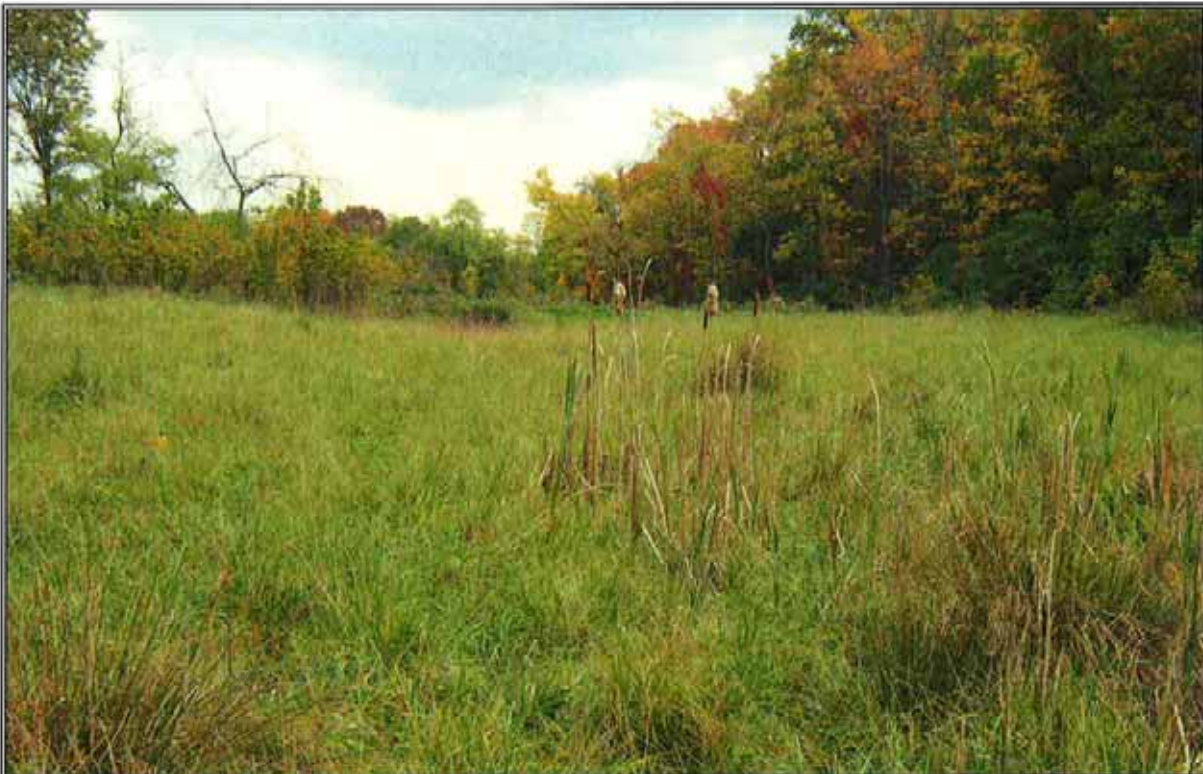
Photograph 28: Wetland 2 consisting of emergent vegetation. Brent Spence Bridge Replacement and Rehabilitation Project. October 10, 2006.

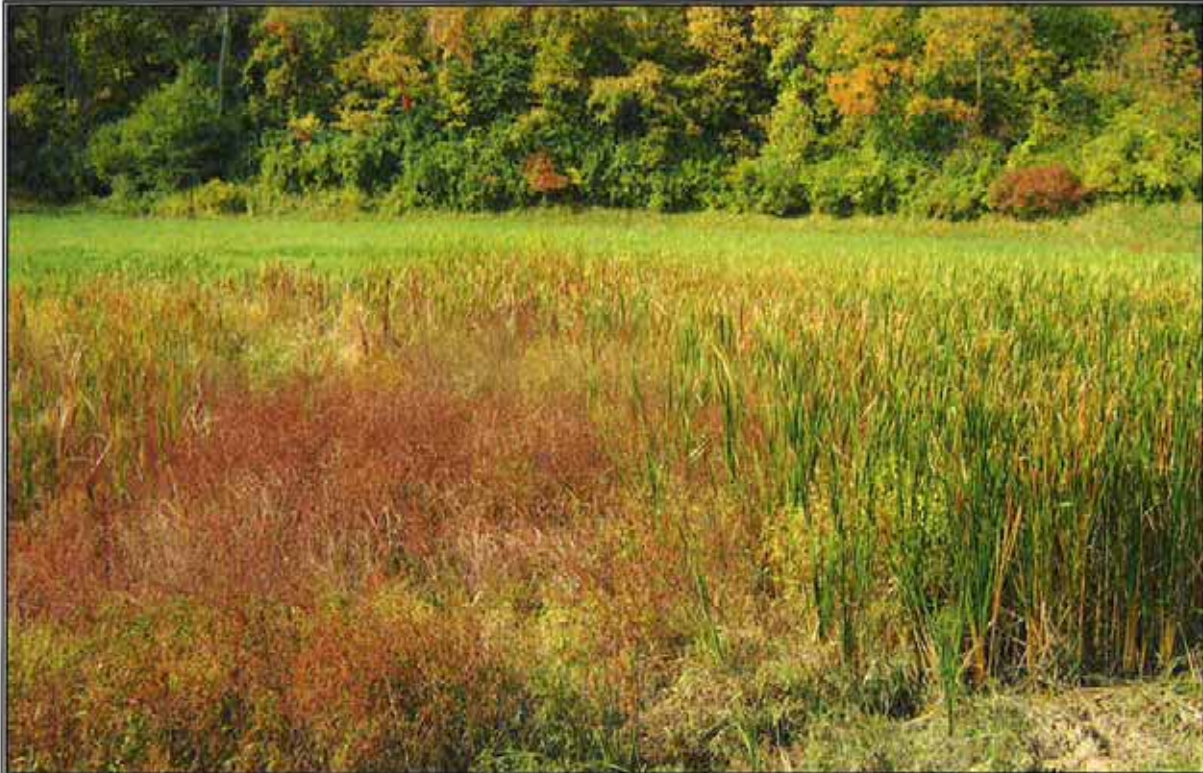
Photograph 29: Wetland 3 consisting of emergent vegetation within a detention basin along Intermittent Stream 4. Brent Spence Bridge Replacement and Rehabilitation Project. October 10, 2006.

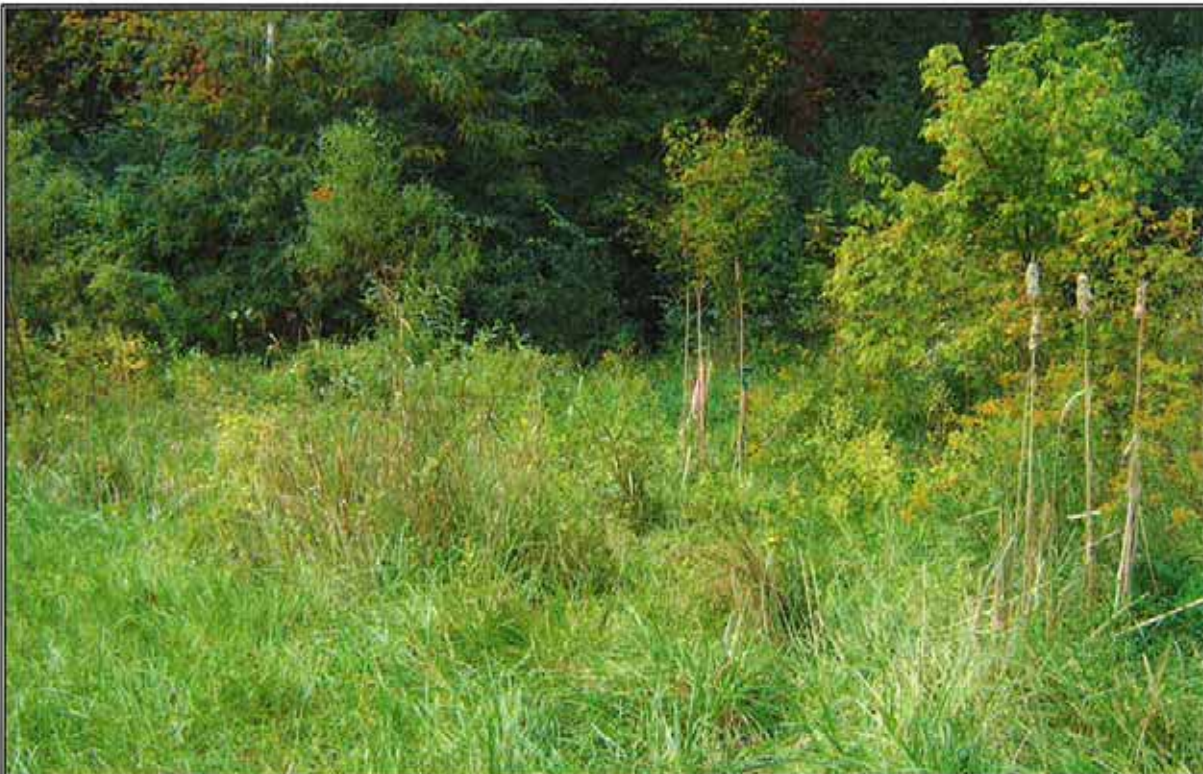
Photograph 30: Wetland 4 consisting of emergent vegetation along Intermittent Stream 4. Brent Spence Bridge Replacement and Rehabilitation Project. October 10, 2006.

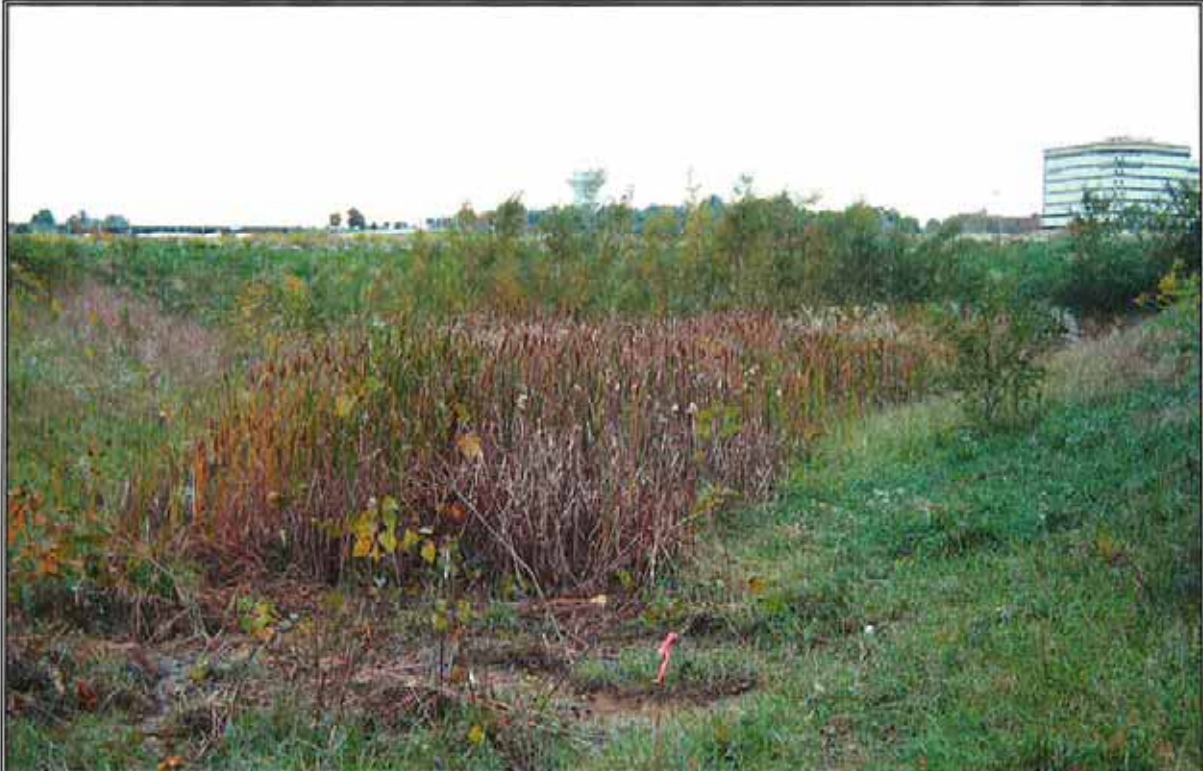
Photograph 31: Wetland 5 consisting of emergent vegetation within a detention basin. Brent Spence Bridge Replacement and Rehabilitation Project. October 11, 2006.

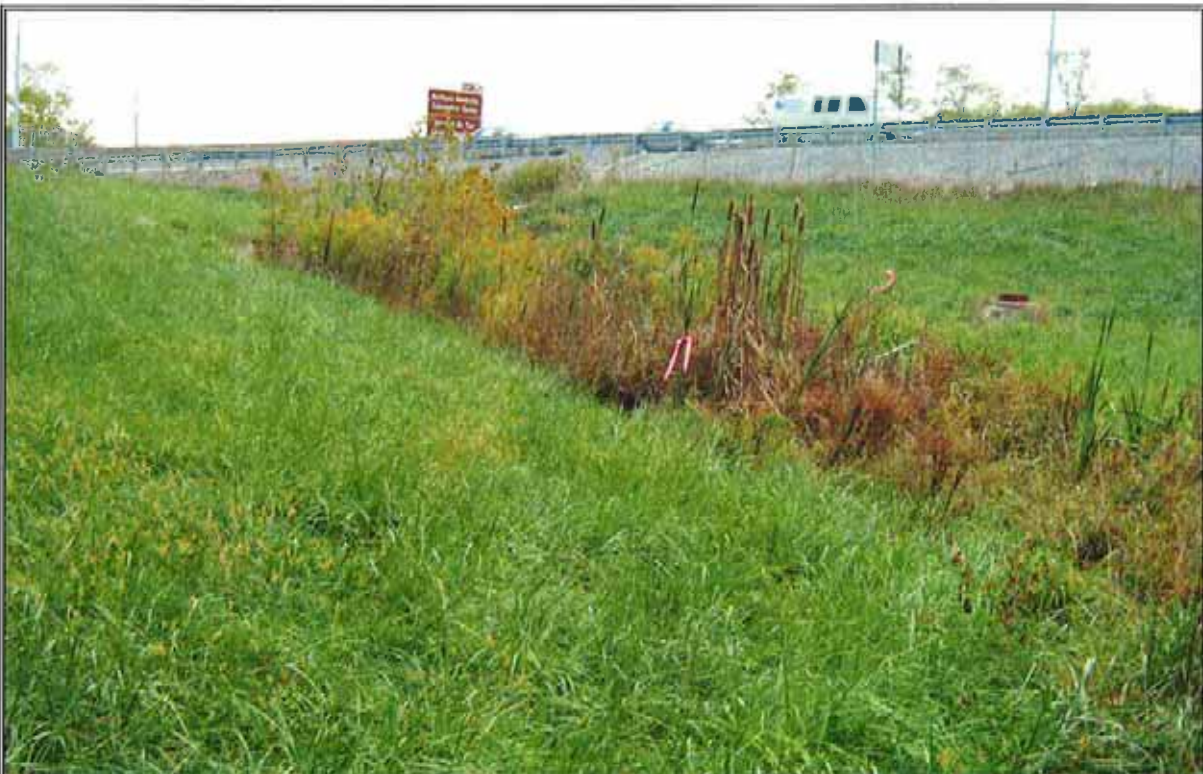
Photograph 32: Wetland 6 consisting of emergent vegetation within a detention basin below Intermittent Stream 6 and along I-75/I-71. Brent Spence Bridge Replacement and Rehabilitation Project. October 12, 2006.

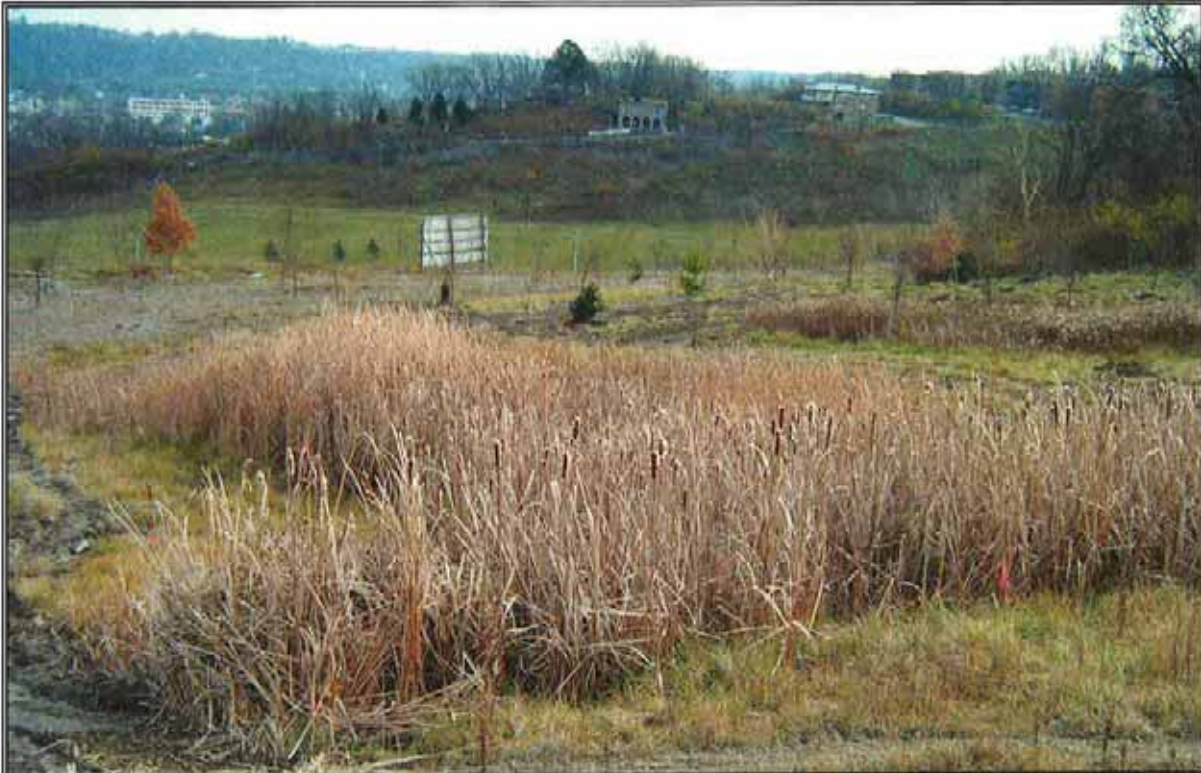
Photograph 33: Wetland 7 consisting of emergent vegetation along a hillside slope. Brent Spence Bridge Replacement and Rehabilitation Project. November 29, 2006.

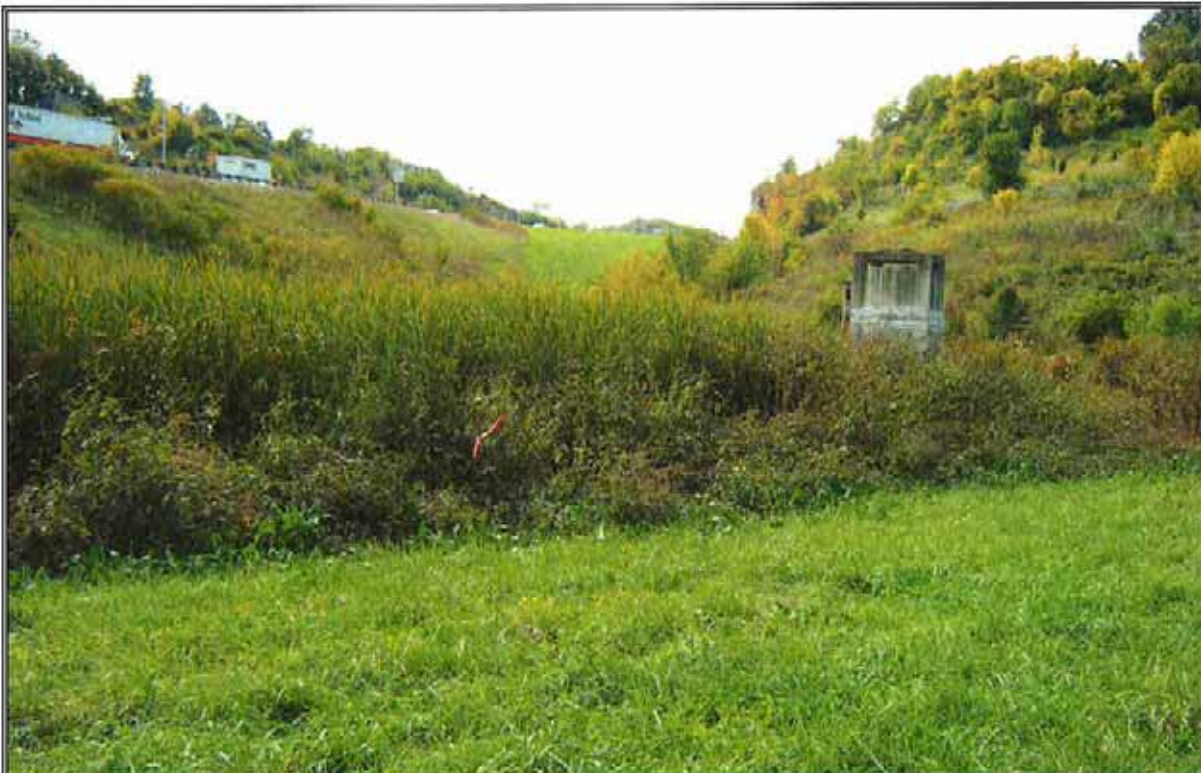
Photograph 34: Wetland 8 consisting of emergent vegetation along I-75/I-71. Note detention structure typically found in the wetland basins. Brent Spence Bridge Replacement and Rehabilitation Project. October 12, 2006.

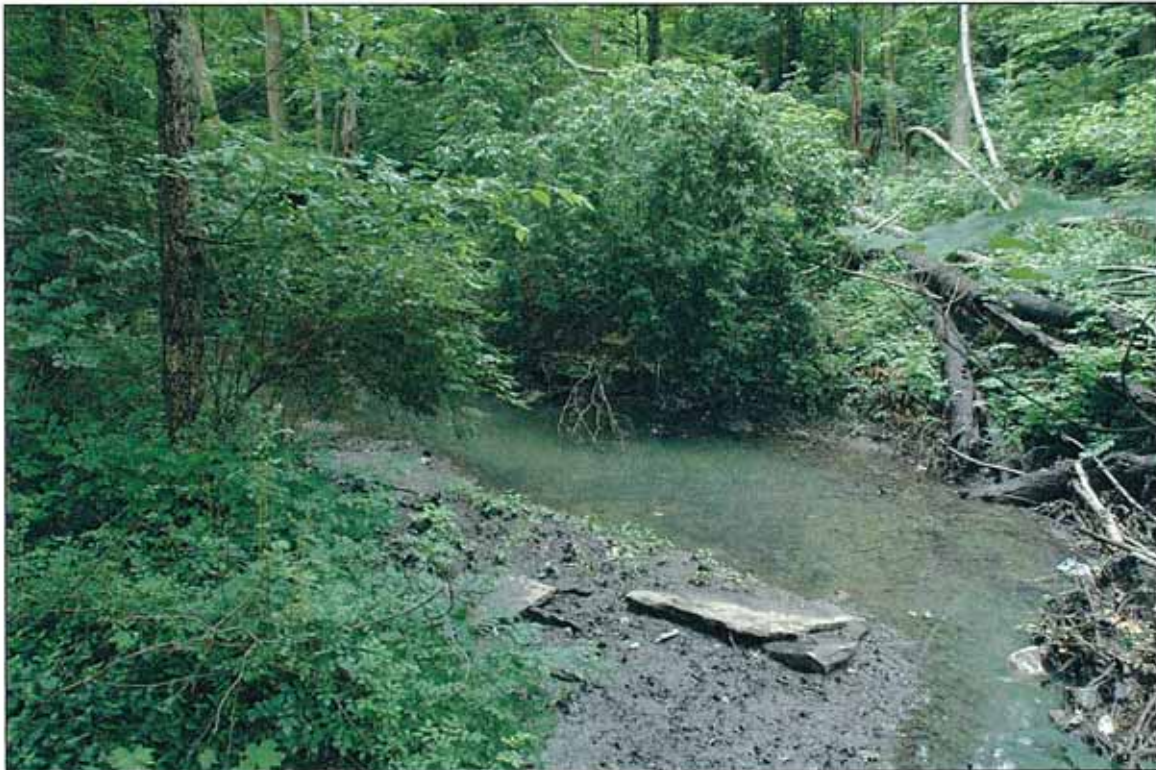
Disturbed mudflat near intermittent creek.

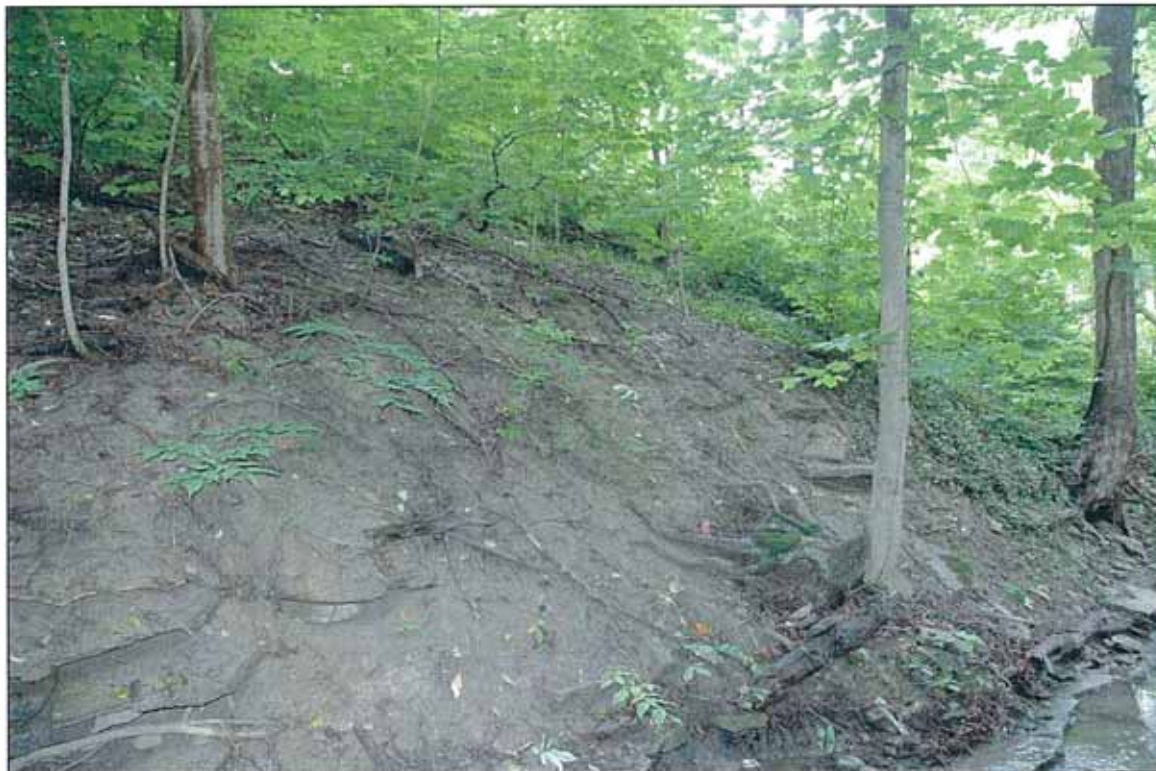
Disturbed forested riparian strip.

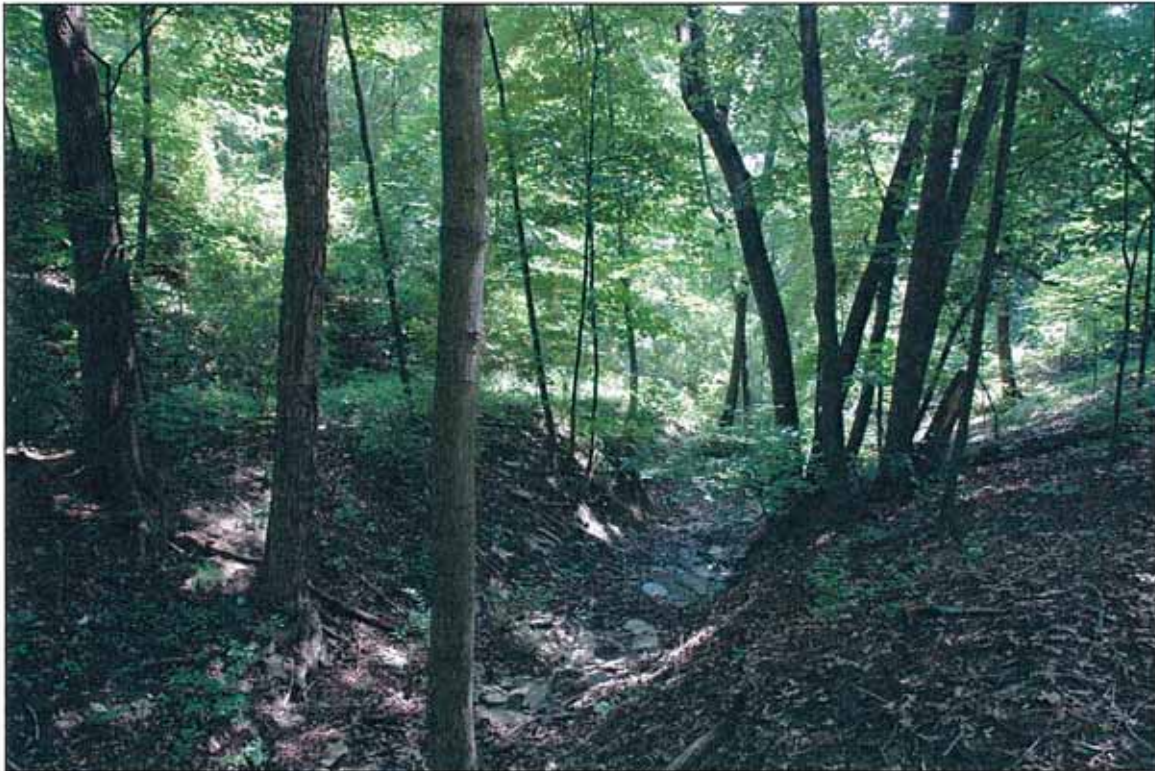
Unnamed intermittent drainage.
