Brent Spence Bridge Replacement/Rehabilitation Project

Phase I History/Architecture Survey Addendum Report for the Western Hills Viaduct Interchange Hamilton County, Ohio

ODOT PID No. 75119
HAM-71/75-0.00/0.22
KYTC Project Item No. 6-17
November 2010

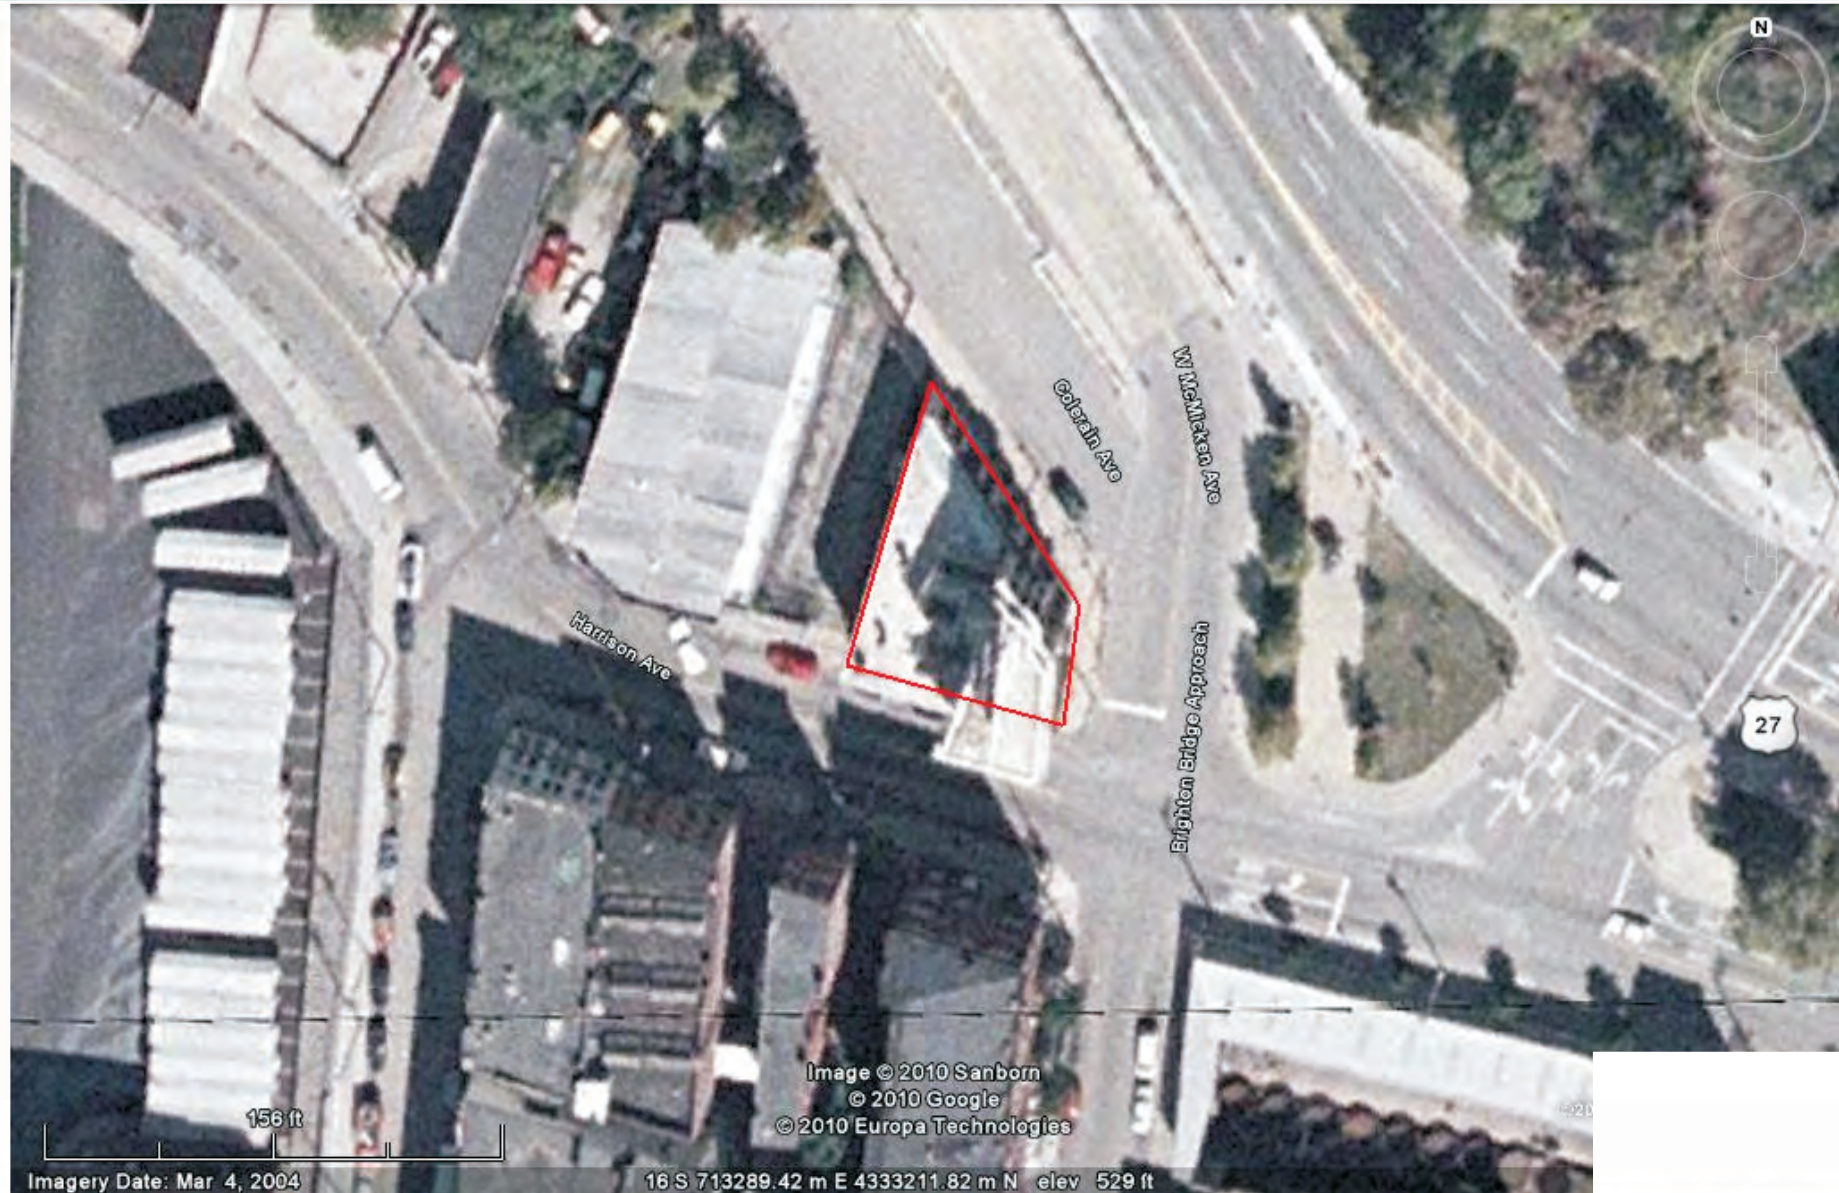
Recommended Boundaries of HAM-0484-06,
located at 650 West McMicken Avenue.

This 1878, two-and-one-half story, Italianate duplex has a stone foundation, brick walls, window openings with original two-over-two sash, and a flat roof (Plate B49). The front façade features two original Italianate doors, one for each section of the double-house, segmentally arched windows with carved stone lintels, and an elaborate cornice with some damage to the panels and frieze windows. The building has a historic period rear addition. The building is not considered part of the proposed West McMicken Avenue Historic District because of several unsympathetic infill buildings located between this building and the district boundary to the north. The resource is an ornate, stylish, and well-preserved example of the Italianate style applied to a party-wall duplex and has a strong presence on the streetscape. While the Italianate style is well represented in the city, this building is distinguished for its wealth of robust ornamentation, high degree of integrity and relatively uncommon building type. Its high level of finish is atypical for investment properties of the period. The building retains all aspects of integrity, and is recommended eligible for listing in the NRHP under Criterion C. The building does not appear to be associated with any significant events or persons, and therefore does not meet NRHP Criteria A or B. Recommended boundaries include the parcel boundaries of the property (Exhibit 4).

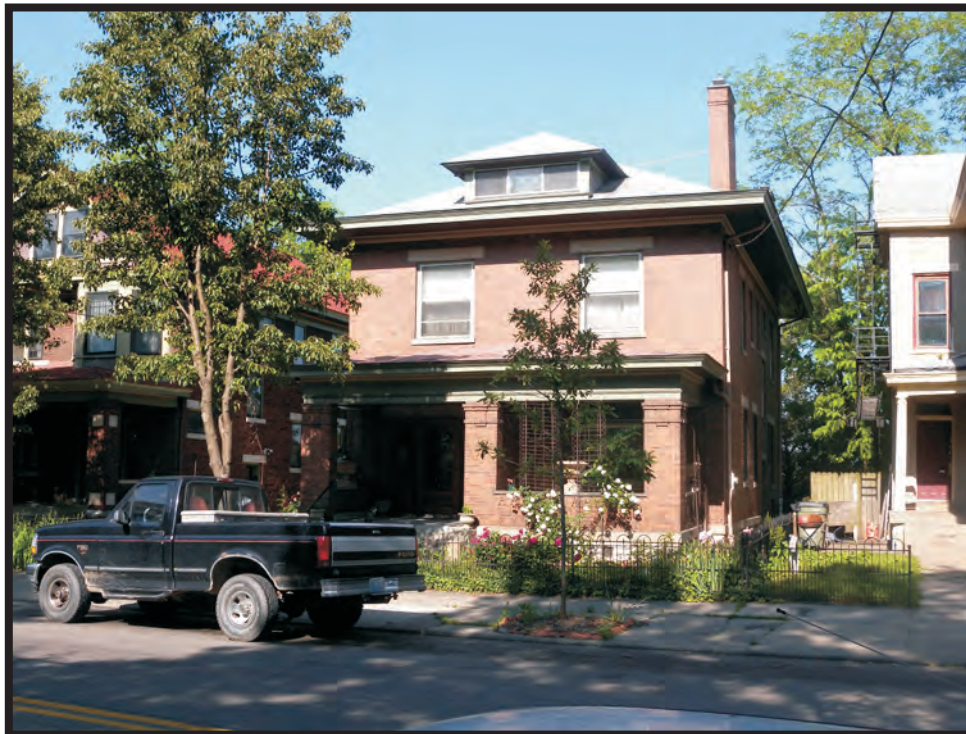
Plate B16. Building at 2405 West McMicken Avenue, facing southwest.

- 2405 West McMicken Avenue (Plate B16). This 1909, two-and-one-half-story, American Foursquare building has a stone foundation, brick walls, window openings with original and replacement sash, and a hipped roof covered with asphalt shingles. A hipped-roof dormer is centered on each slope of the roof. The front façade also features a full-façade brick porch. The entryway contains the doorway with sidelights and stone lintel. Window openings contain stone lintels and sills. Also on the property is a contributing detached garage outbuilding. The building retains all aspects of integrity and is recommended as a contributing building in the proposed West McMicken Historic District.

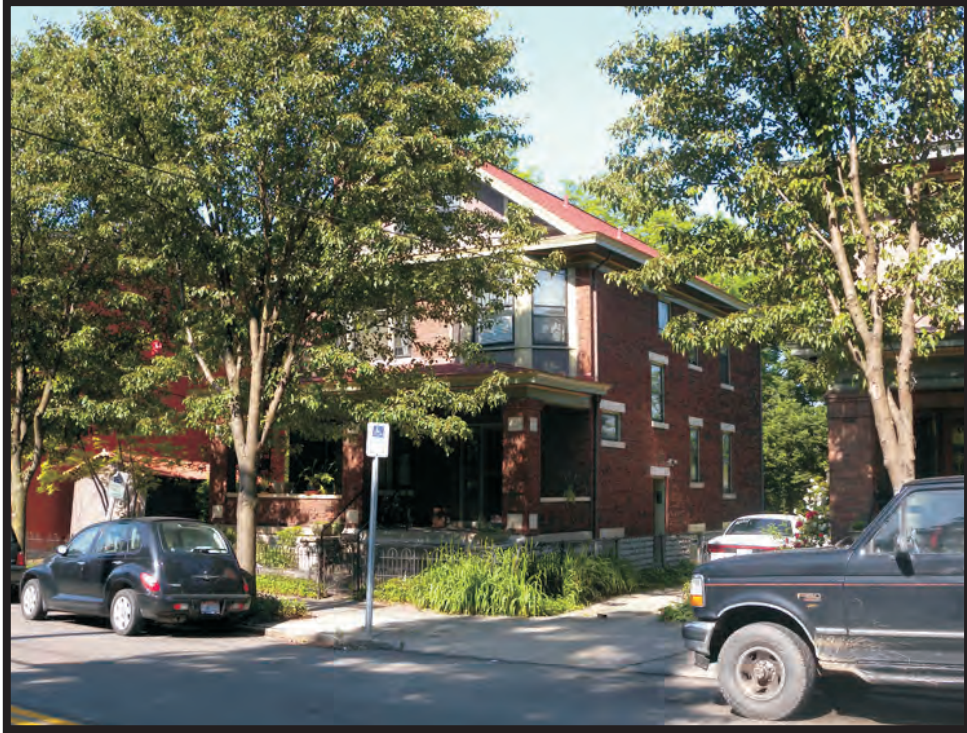
Plate B17. Building at 2403 West McMicken Avenue, facing southwest.

- 2403 West McMicken Avenue (Plate B17). This 1919, two-and-one-half story, American Foursquare building has a stone foundation, brick walls, window openings with replacement sash, and a front-gabled roof covered with asphalt shingles. The first story features a full-façade brick porch and an entryway with sidelights. The second story features a bay window on the front façade. The building retains all aspects of integrity and is recommended as a contributing building in the proposed West McMicken Historic District.

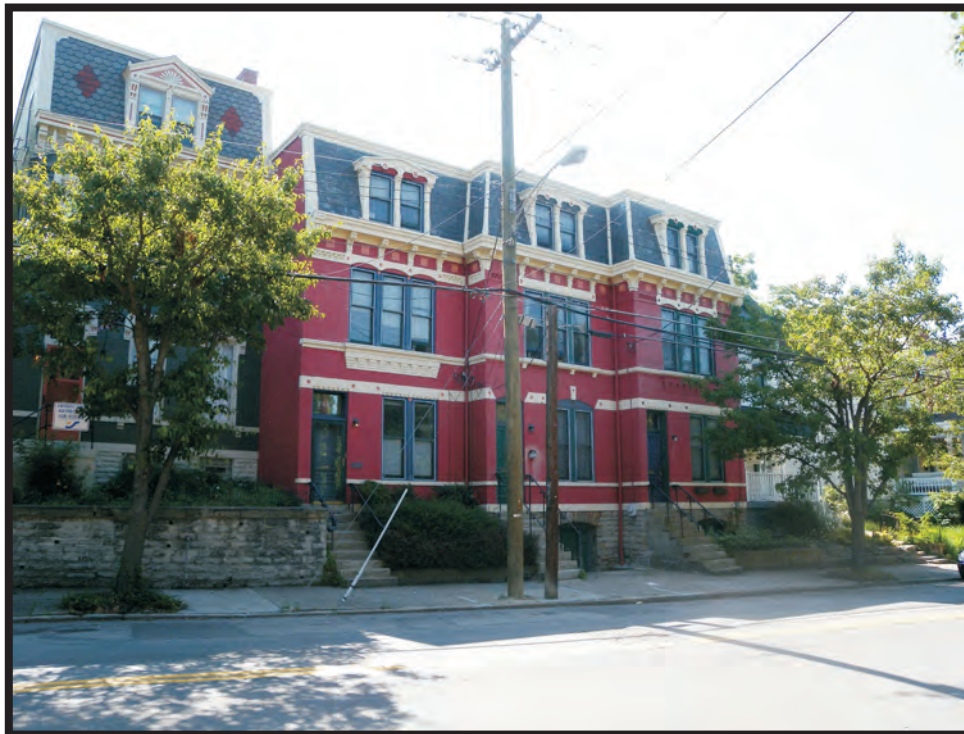
Plate B20. Building at 2358-2362 West McMicken Avenue, facing southeast.

- 2358 West McMicken Avenue (Plate B20). The ca. 1895, two-and-one-half-story, three-unit, Second Empire rowhouse has a stone foundation, brick walls, window openings with original one-over-one sash, and a mansard roof covered with slate and pedimented dormers. The walls contain brick corbelling and terra cotta panels in the cornice line. The building retains all aspects of integrity and is recommended as a contributing building in the proposed West McMicken Avenue Historic District.

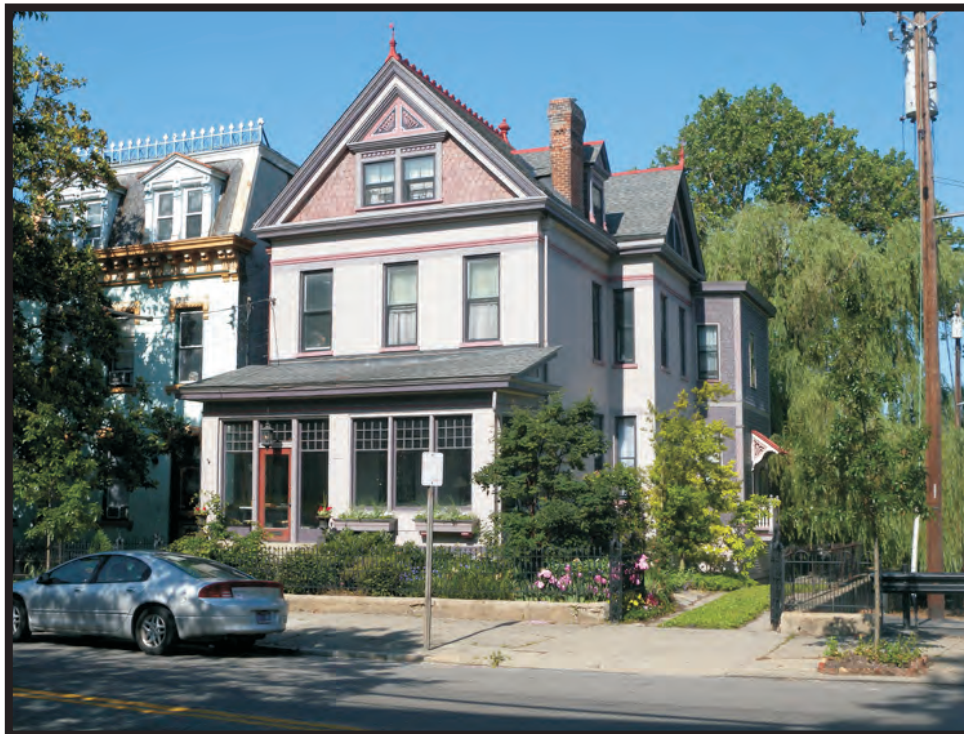
Plate B30. Building at 2343 West McMicken Avenue, facing southwest.

- 2343 West McMicken Avenue (Plate B30). This 1885, two-and-one-half story, Queen Anne residence has a stone foundation, brick walls, window openings with replacement sash, and a front gabled roof covered with asphalt shingles. A historic frame addition is found on the rear of the building and is clad with fishscale shingles. The front façade features an enclosed porch and fishscale shingles in the gable end. The building retains integrity of location, setting, workmanship, association, materials, and feeling, and is recommended as a contributing building in the proposed West McMicken Avenue Historic District.

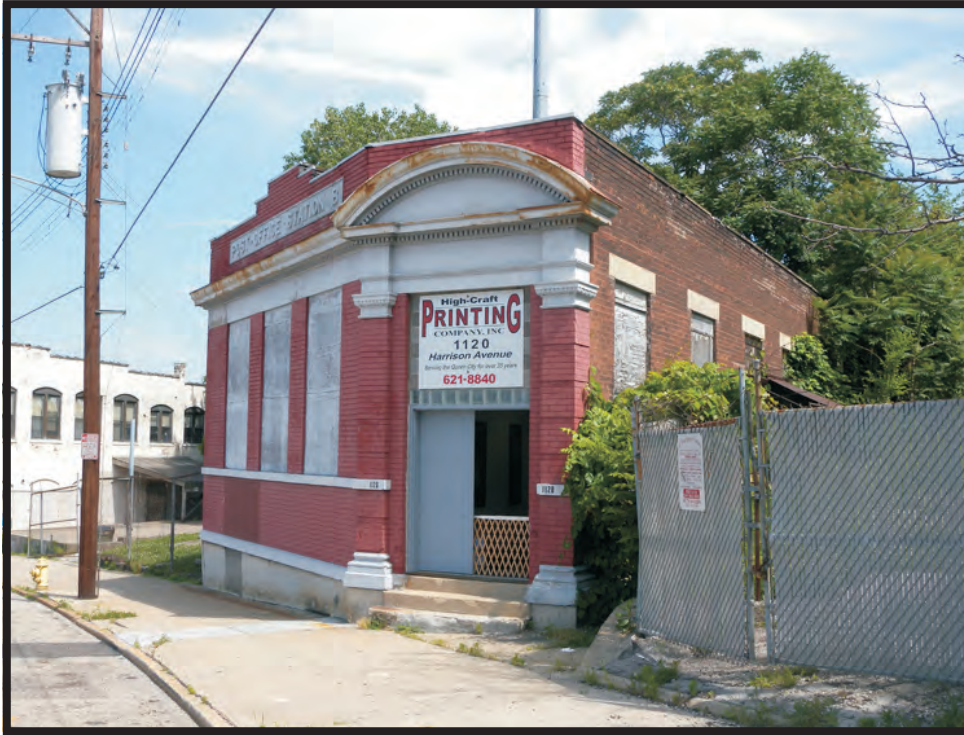
Plate B87. Building at 1120 Harrison Avenue (HAM-7366-28), facing north.

This ca. 1900, one-story, Neo-Classical Revival building located at 1120 Harrison Avenue has an ashlar stone foundation, brick walls, window openings with no sash covered with plywood, and a flat roof (Plate B87). The building served as a U.S. Post Office from ca. 1900–1932. The main entryway is flanked by pilasters and a Neo-Classical pediment with dentil molding. The dentil molding continues along the cornice line. Above the cornice, an engraving reads "Post Office Station B". The building retains

integrity of location, setting, workmanship, association, and feeling. This is one of the few Neo-Classical Revival style buildings located in the area, and is a better example of the style than other nearby buildings, such as the commercial building at 663-665 West McMicken Avenue. The building is an early example of the Neo-Classical Revival, which gained acceptance following the 1893 World's Columbian Exposition in Chicago and the 1901 Pan-American Exhibition in San Francisco. This resource is recommended eligible for inclusion in the NRHP under Criteria C. The OHI states that the post office should be evaluated in context with other similarly constructed neighborhood postal facilities to determine eligibility status under Criterion A (Mitchell 2002). While the building is recommended eligible under Criterion C, more research may indicate the building is also eligible under Criterion A. The building does not appear to be associated with any significant persons, and therefore does not meet NRHP Criterion B. Recommended boundaries include the footprint of the building (Exhibit 6).
