Brent Spence Bridge Replacement/Rehabilitation Project

Phase I History/Architecture Survey Hamilton County, Ohio

ODOT PID No. 75119
HAM-71/75-0.00/0.22
KYTC Project Item No. 6-17

June 2007

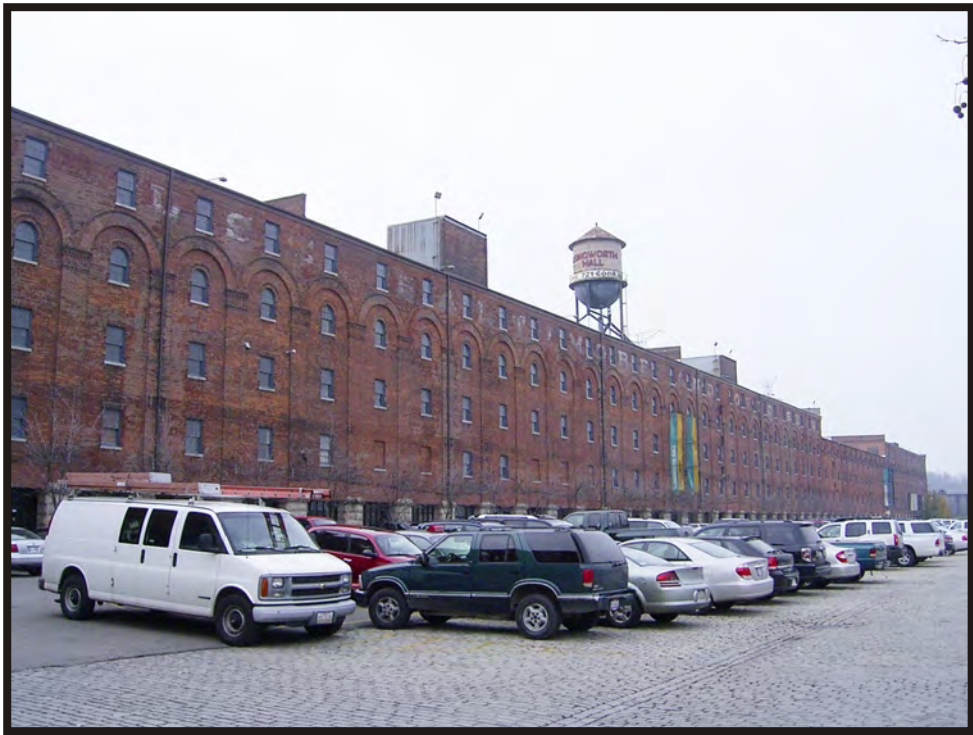
Plate B10. View of Longworth Hall (HAM-1656-43), facing southwest.

Located within the project APE at 700 Pete Rose Way, Resource HAM-1656-43 (Baltimore & Ohio Railroad Freight Station and Storage Warehouse also known as Longworth Hall) is a large, five-story, common bond brick railroad freight storage building exhibiting details associated with the Romanesque style (Plates B10-B15). It is distinguished by its great length of 1,160 feet. Located just west of the central business district, in an area containing numerous mixed industrial uses, the building has a concrete foundation and a flat roof and possesses a high degree of integrity despite several changes to its exterior. The front façade has three bays with an arcade treatment. The first floor has rock-faced ashlar piers supporting columns rising to the fourth floor, from which decorative semi-circular arches adorn the façades. The warehouse was designed by M.A. Long and built in 1904 in order to consolidate several smaller obsolete warehouses. The B & O Railroad had placed an emphasis on Cincinnati as a major shipping center and transfer point, and the warehouse contributed to the functioning of the railroad until competition from trucks reduced its effectiveness and profitability. Originally 1,277 feet long, the east end of the warehouse was reduced by 150 feet in 1961 to allow for the supporting piers of elevated IR-71/75. A five-story 30,000 square foot brick addition was then built onto the northeast corner. A fire in the original building destroyed part of the fifth floor which was never rebuilt. The warehouse is an important surviving example of an industry that is losing its older distinctive buildings. A two-story brick building associated with the boiler room and scales is also associated with this resource, and is documented as part of Longworth Hall in Appendix A. The Baltimore & Ohio Railroad Freight Station and Storage Warehouse was listed on the NRHP in 1986.

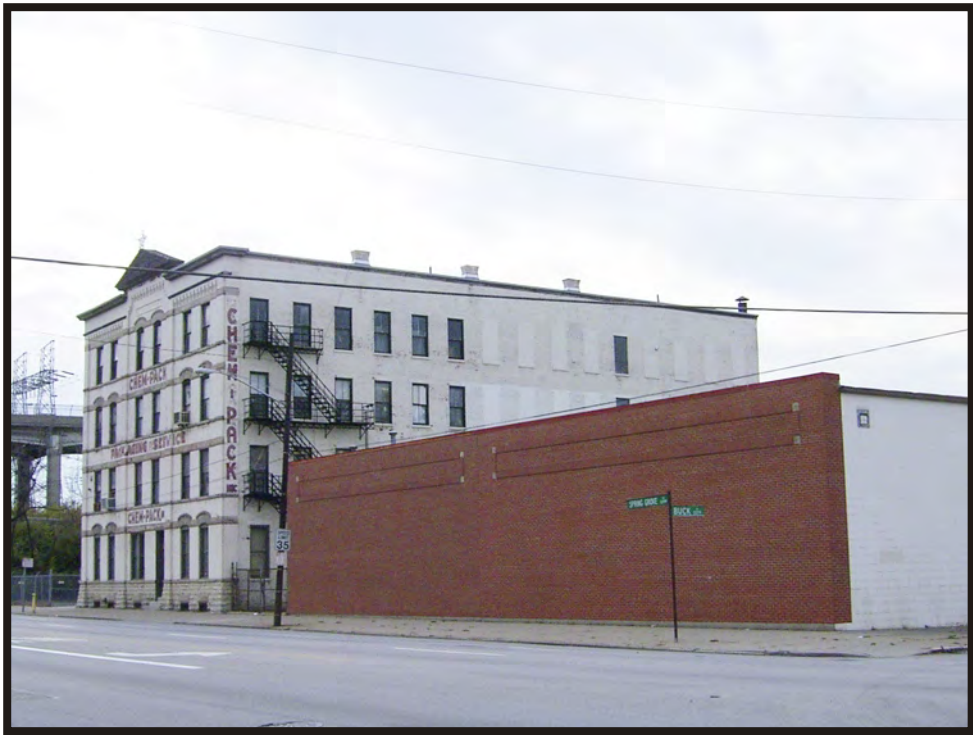
Plate B30. View of Chem-Pack (HAM-1709-40), facing southwest.

Located just outside the project APE at 2261 Spring Grove Avenue, Resource HAM-1709-40 (Chem-Pack, Inc.) is a ca. 1890 industrial building with Victorian elements (Plate B30). The building has a rock-faced ashlar foundation and walls clad in brick. The roof is flat and window openings on the primary façade are one-over-one, double-hung sash with brick, arched pediments. The side façade windows have plain lintels and lug sills. The building sits next to a busy street and is just north of the Western Hills Viaduct. The Hamilton County Auditor's website lists year of construction for this building as 1891; however, the building does not appear on the 1891 Sanborn Map. The building first appears on the 1904 Sanborn as The Eureka Soap Company, "Manufacturers of Toilet Soap & Perfumes" with an address of 2261-2275 Spring Grove Avenue. The building is listed as a four-story building connecting to an iron-clad, one-story warehouse. The Sanborn map shows an office located on the first-floor of the northeast corner of the building, and the building had an open elevator.

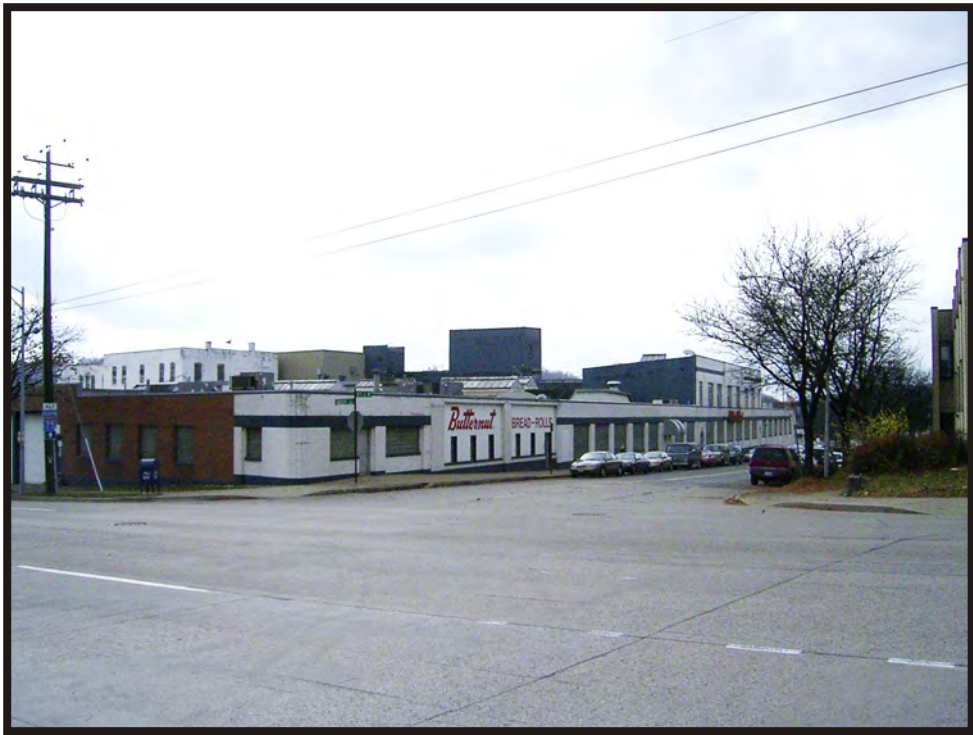
Plate B46. View of Butternut Bread (HAM-2029-43), facing southwest.

Located within the project APE at 748 West Fourth Street, Resource HAM-2029-43 (Police Patrol Station #4) is a ca. 1890 Romanesque Revival police station that is currently the location of a Butternut Bread facility (Plates B46-B48). Architect Samuel Hannaford designed this and several other police and fire stations throughout the city. The rectangular plan, two-story building has an ashlar foundation, walls clad in brick, and a flat roof. This long police station has a narrow façade distinguished by four arcaded windows on the second floor. A large portal once opened on the first floor, but it has been filled in. Ashlar lintels, brick corbelling, nameplates, and the words "Police Patrol Station #4" also enhance the façade. Before the automotive age, this station housed horse patrol units. The building is located in a commercial-warehouse environment. Most windows on the western façade have been bricked in and there is a very large addition covering the entire east side. The building is now incorporated within a parking lot of tractor trailers for the previously unrecorded bakery complex which currently operates on the site. Police Patrol Station #4 was recommended not eligible for the NRHP by Historic Preservation Associates in 2002 due to the loss of original building integrity and its diminished location context. This recommendation remains appropriate today.

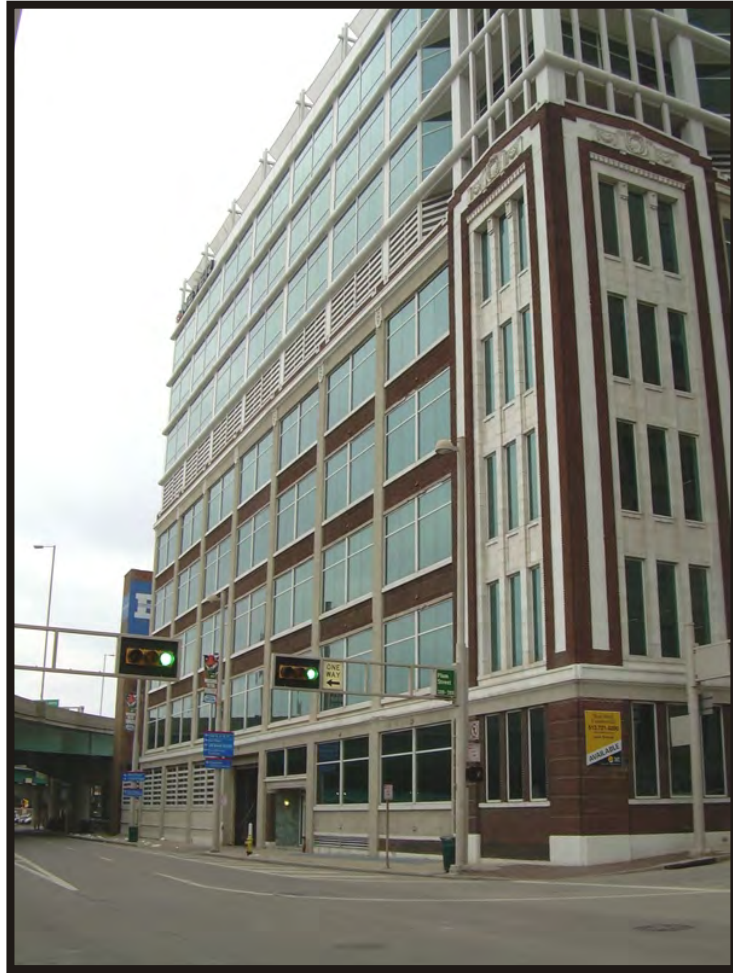
Plate B102. View of Resources HAM-0080-44 and HAM-5540-44 at 220 and 218 West 3rd Street, facing northwest.

Located within the project APE at 220 West Third Street, the Goering and Goering building is a three-story brick building with a stucco exterior, stone foundation, and cast iron pilasters flanking a modified storefront (Plate B102). The window openings have been modified and contain replacement sash. This property was surveyed in 1993 and recommended not eligible for listing in the NRHP by ODOT (with concurrence from OHPO) in a letter dated July 16, 1993.

Located within the project APE at 218 West Third Street, this one-story commercial building has a concrete foundation, walls clad in brick, and a flat roof (Plate B102). The main façade exhibits an asymmetrical façade highlighted by a soldier course interior cornice, rectangular panel, and stepped parapet with corbelled brick courses. Original fenestration has been blocked up and a drive in dock door has been enlarged. This property was surveyed in 1993 and recommended not eligible for listing in the NRHP by ODOT (with concurrence from OHPO) in a letter dated July 16, 1993.
