Brent Spence Bridge Replacement/Rehabilitation Project

Red Flag Summary

PID No. 75119

HAM-71/75-0.00/0.22

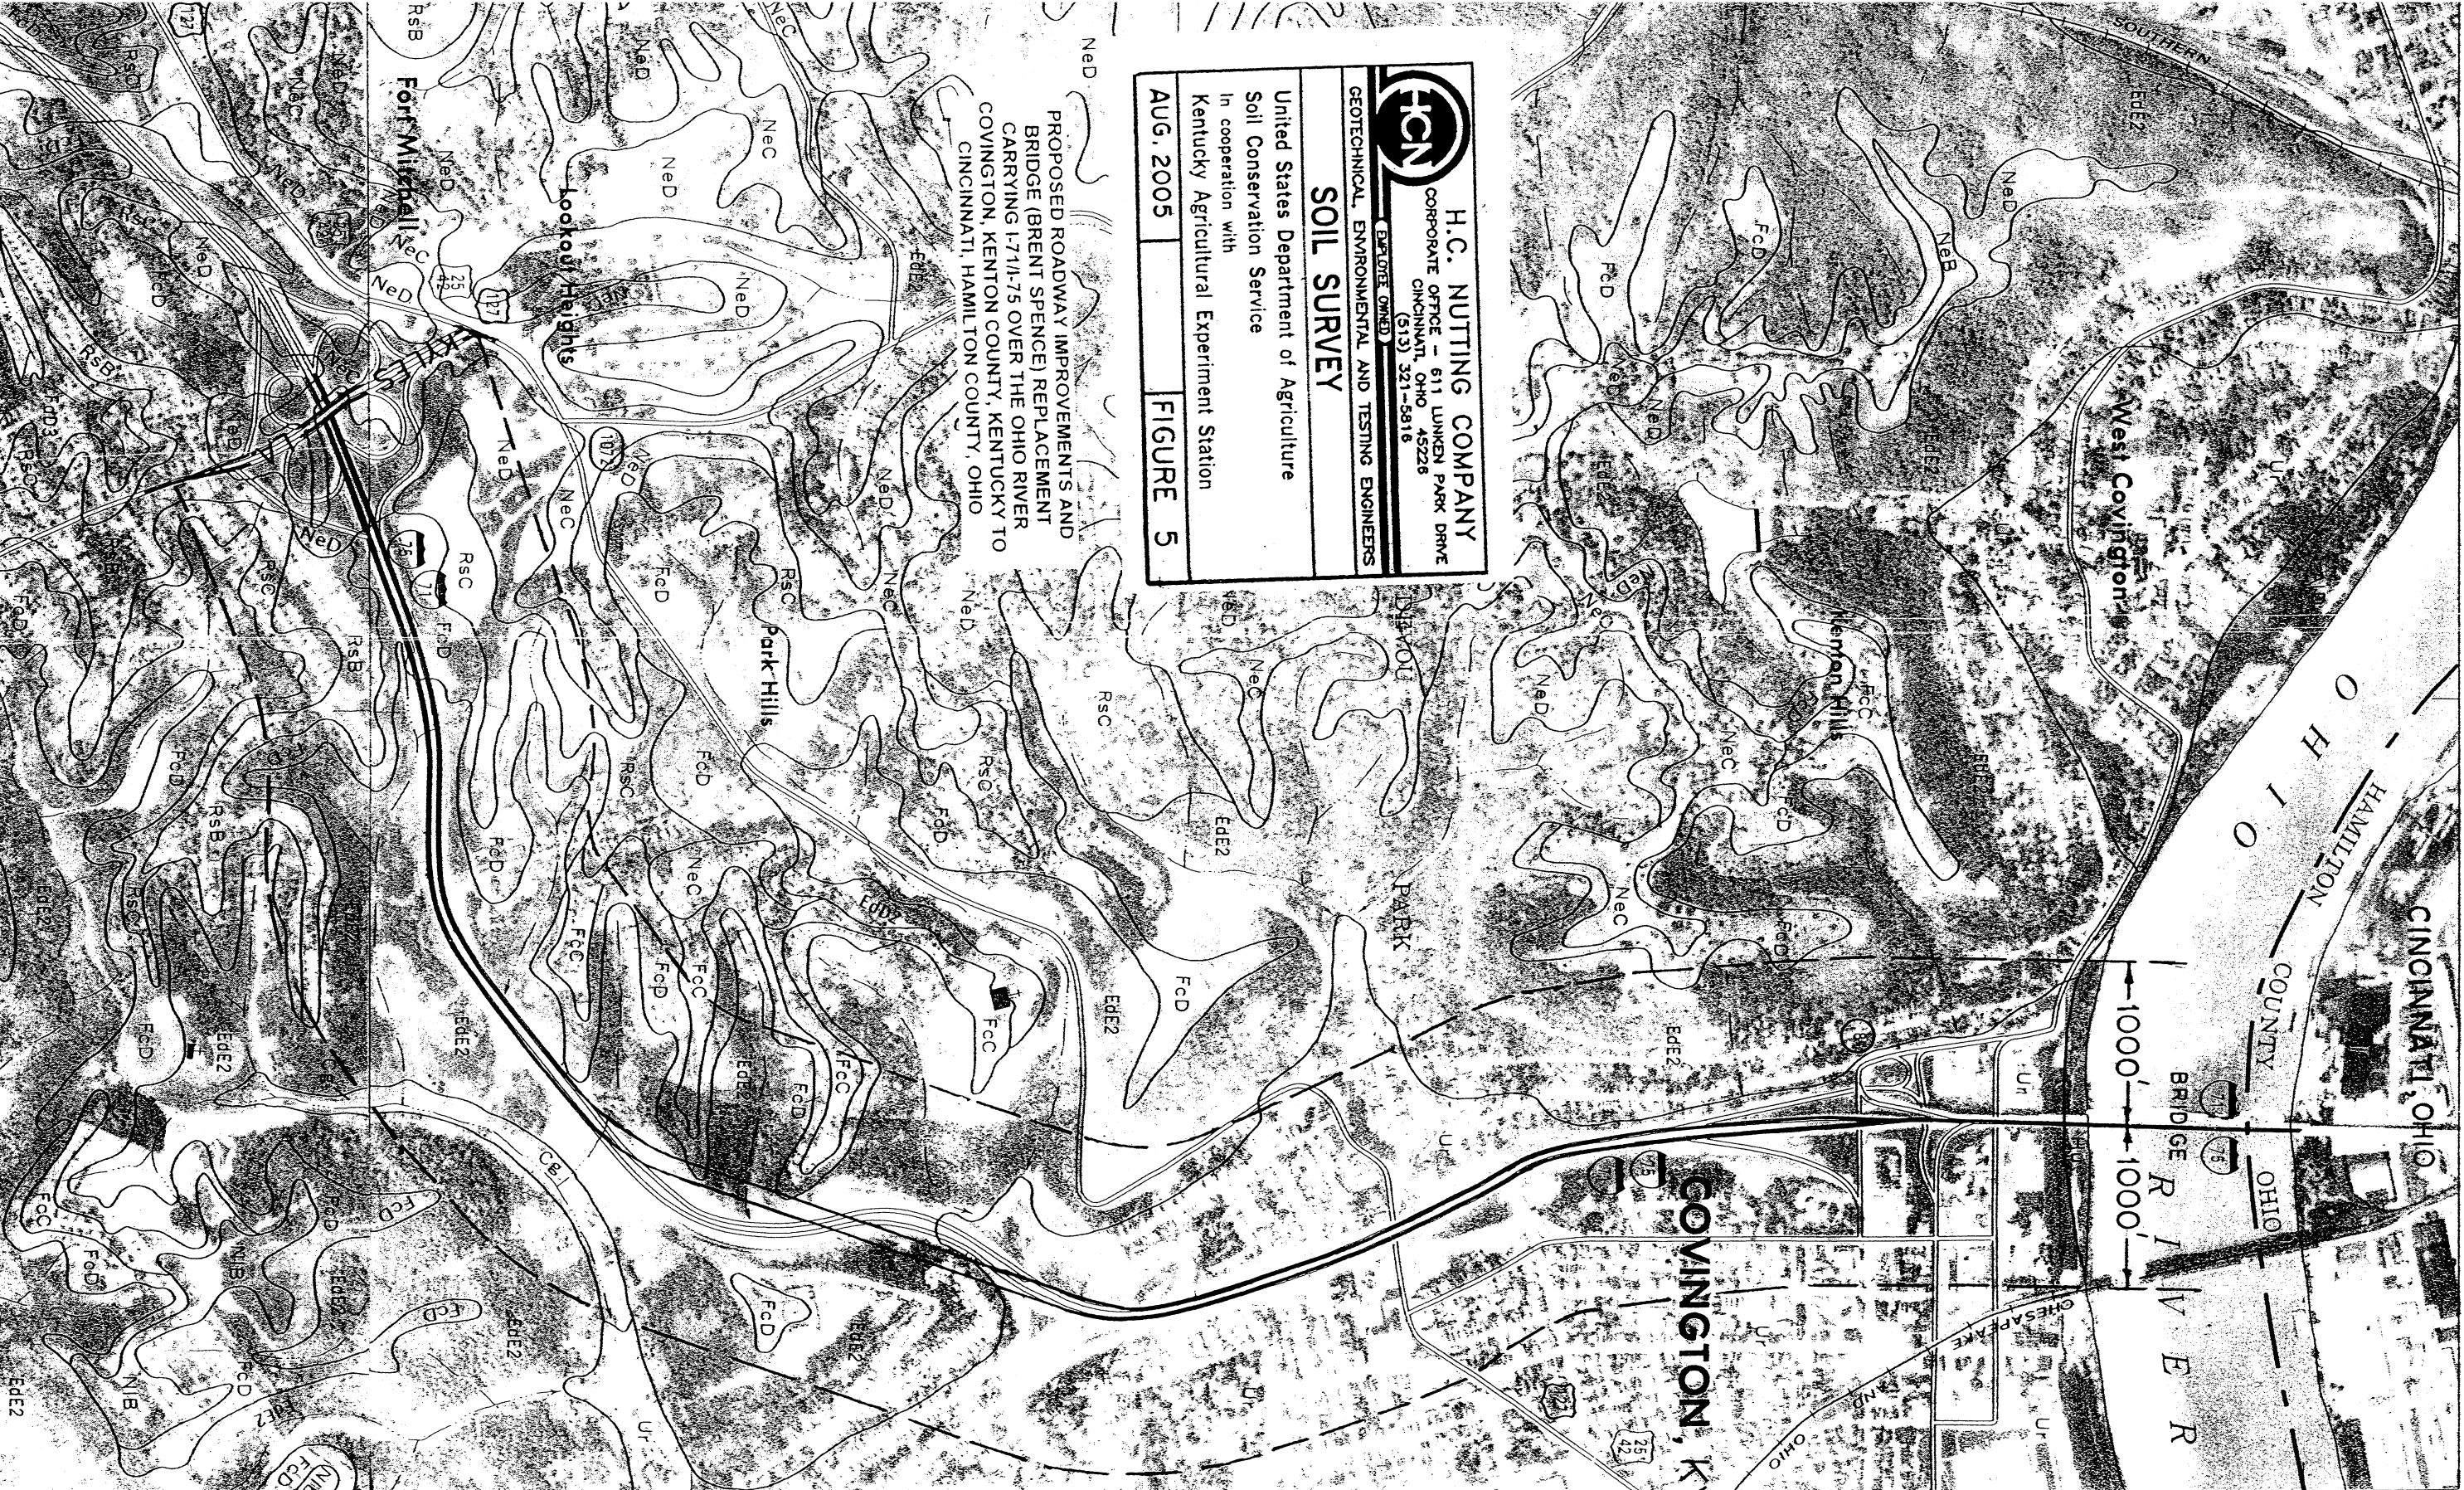
AUG. 2005 **FIGURE 5**

FIGURE 5: USDA SOIL SURVEY – KENTUCKY

PROPOSED ROADWAY IMPROVEMENTS AND
 BRIDGE (BRENT SPENCE) REPLACEMENT
 CARRYING I-71/I-75 OVER THE OHIO RIVER
 COVINGTON, KENTON COUNTY, KENTUCKY TO
 CINCINNATI, HAMILTON COUNTY, OHIO

The applicable USDA Soil Survey Maps have been reproduced as Figures 5 (Kentucky) and 6 (Ohio), and are included in the Appendix of this report.

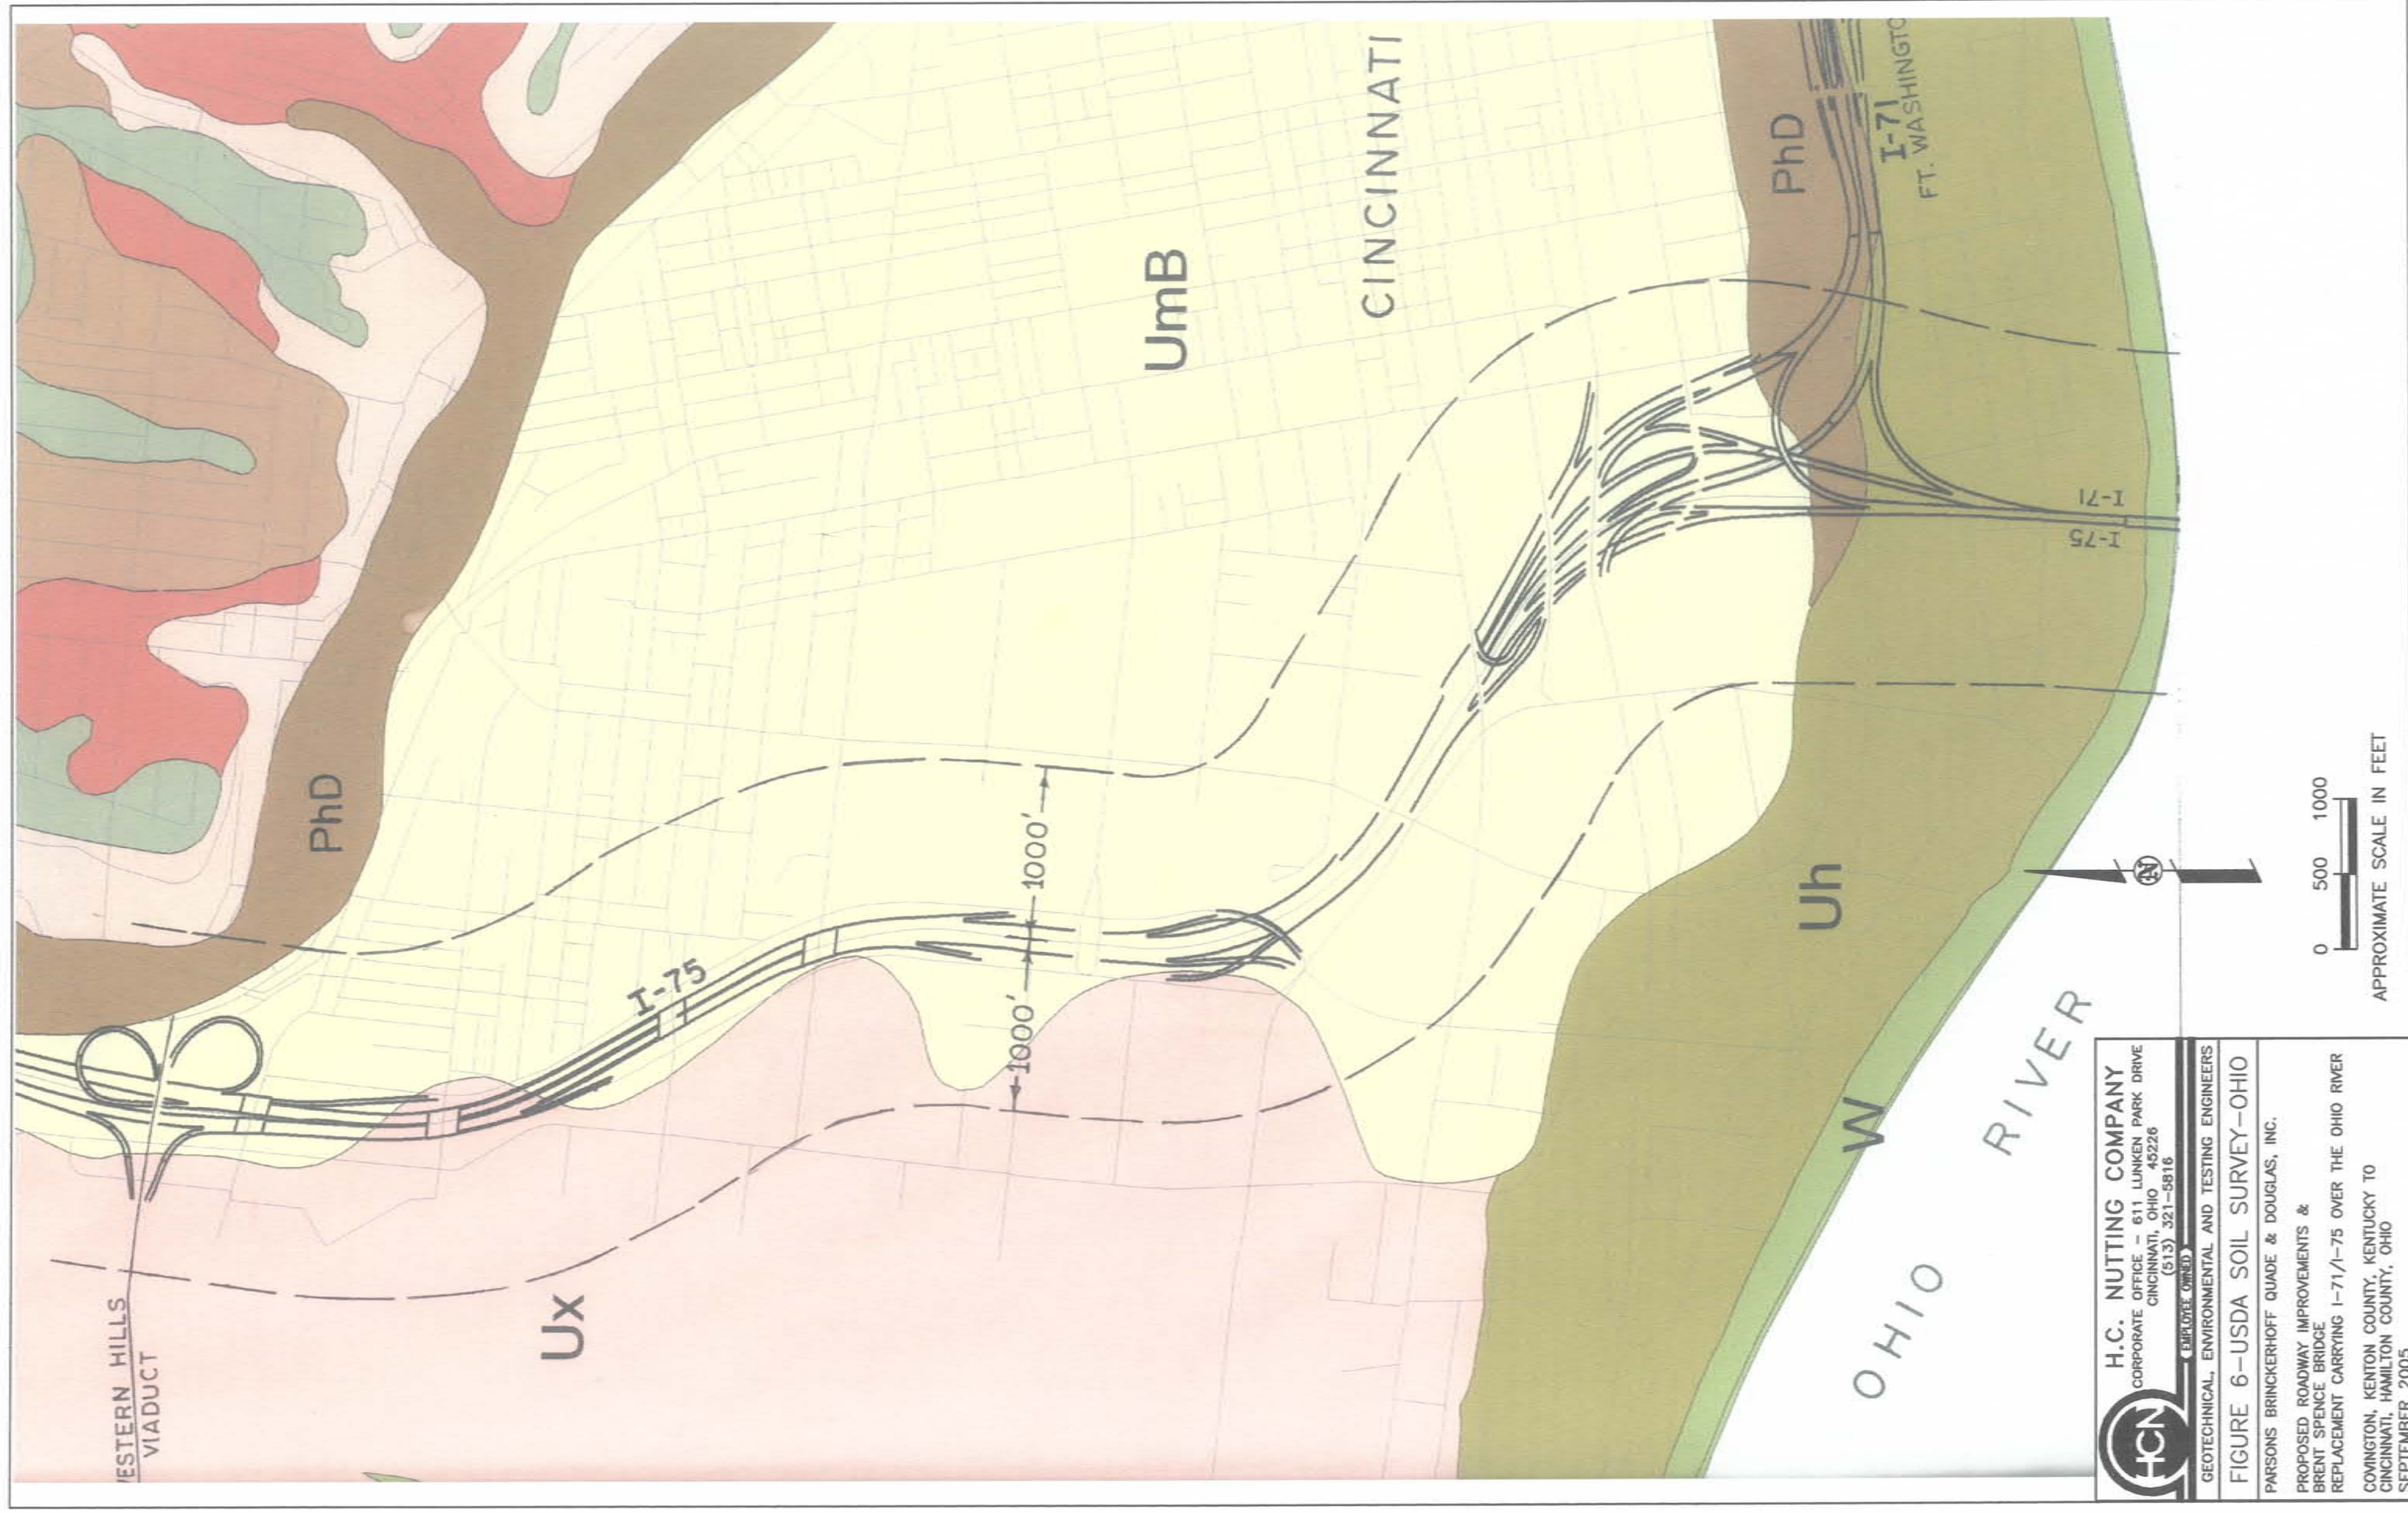
H.C. NUTTING COMPANY	
	CORPORATE OFFICE 611 LUDKIN PARK DRIVE CINCINNATI, OHIO 45226 (513) 321-5816	
EMPLOYEE OWNED		
GEOTECHNICAL, ENVIRONMENTAL, AND TESTING ENGINEERS		
LANDSLIDES IN PROJECT AREA		
PROPOSED ROADWAY IMPROVEMENTS AND BRIDGE (BRENT SPENCE) REPLACEMENT CARRYING I-71/I-75 OVER THE OHIO RIVER COVINGTON, KENTON COUNTY, KENTUCKY TO CINCINNATI, HAMILTON COUNTY, OHIO		
AUG. 2005		FIGURE 15

Areas of the greater Cincinnati and Northern Kentucky region are prone to slope movements and landslides. On the Kentucky side of the Ohio River, within the corridor area and nearby, many landslides have been reported and documented. The landslides were typically observed to occur along the western side of the corridor area and near the southern limits. Due to the hilly terrain in these areas, slope instability was more common. Landslides typically occurred after heavy rain events or during extended periods of wet weather. The landslides generally occurred above the bedrock within the overburden soils, or along the soil/bedrock interface. The approximate locations of the landslides are shown on Figure 15 in the Appendix of this report.

show signs of settlement and cracking. The distress was initial evidence of a landslide. The lane was closed for some time and eventually a large buttress embankment was built to stabilize the slope in this area. In this case, the roadway embankment was constructed on a substantial depth of colluvium, which in turn overlaid a sloping bedrock surface. The approximate location of the landslide within the I-71/I-75 roadway is shown on Figure 15 in the Appendix.

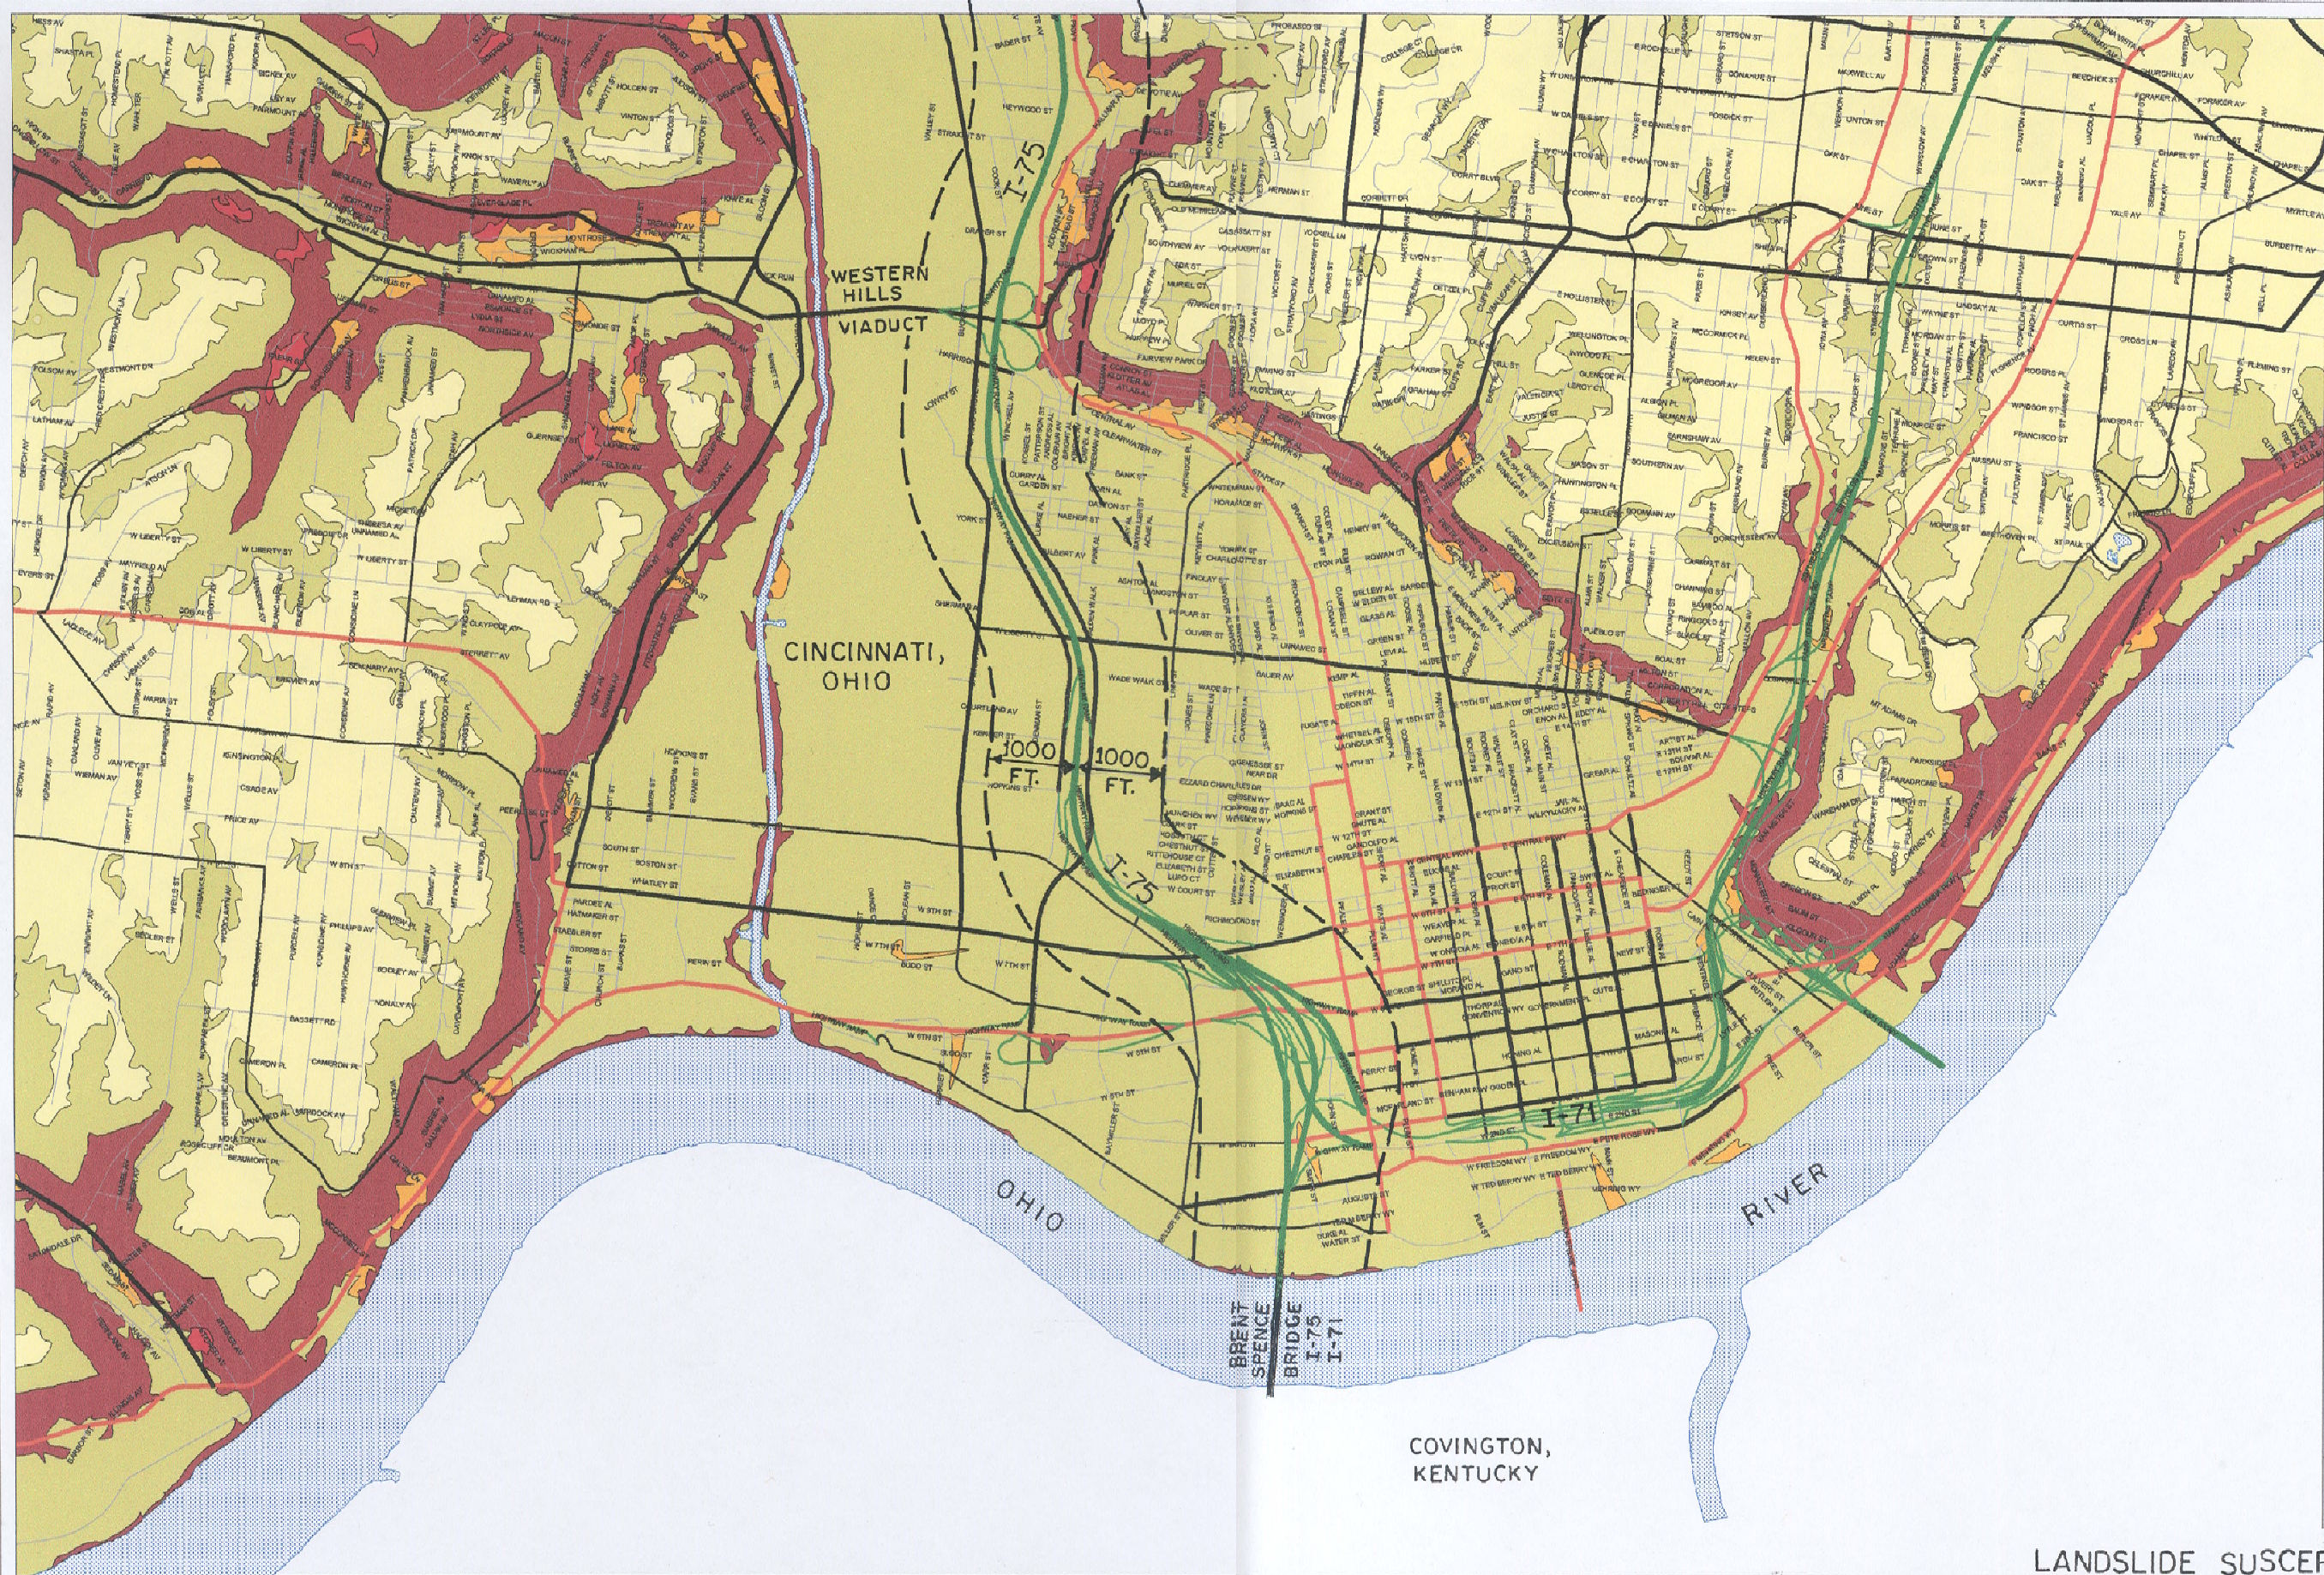
LANDSLIDE SUSCEPTIBILITY MAP

- Streetc12001.shp
- Interstate Highway
 - US & State Rts
 - Arterial Roads
 - Collector Roads
 - Local Streets
 - Highway Ramps
 - River2001.shp
- Landsct1.shp
- LOW
 - MODERATE
 - M. HIGH
 - HIGH
 - VERY HIGH
