Brent Spence Bridge Replacement/Rehabilitation Project

Longworth Hall Impact Analysis Report Part One: Physical Impact Limits

ODOT PID No. 75119
HAM-71/75-0.00/0.22
KYTC Project Item No. 6-17
June 2011

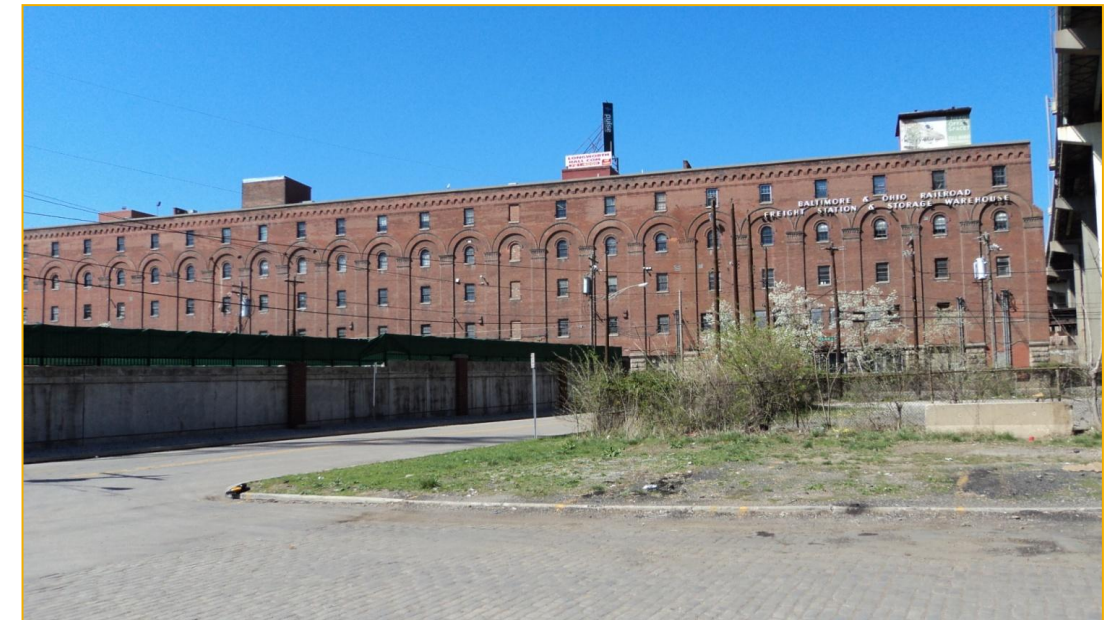
Photo 1: Longworth Hall - “Before” (The image above shows the east end of Longworth Hall “before” the introduction of the proposed Brent Spence Bridge Replacement/Rehabilitation.)

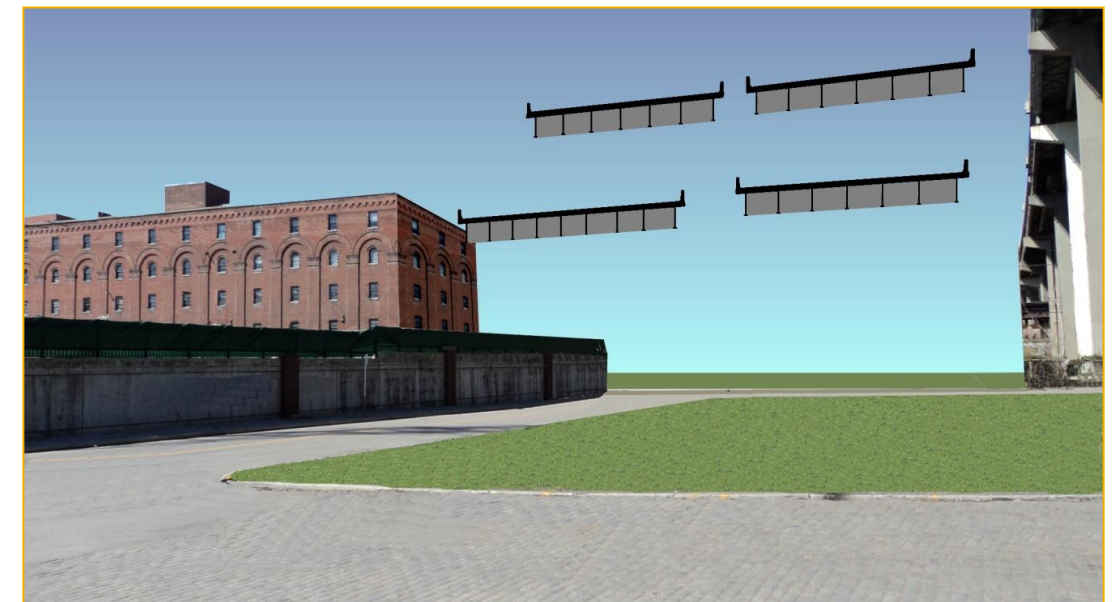
Photo 2: Longworth Hall - “After” (The image above shows how the east façade will be reconstructed as well as the bridge approach diagram.)

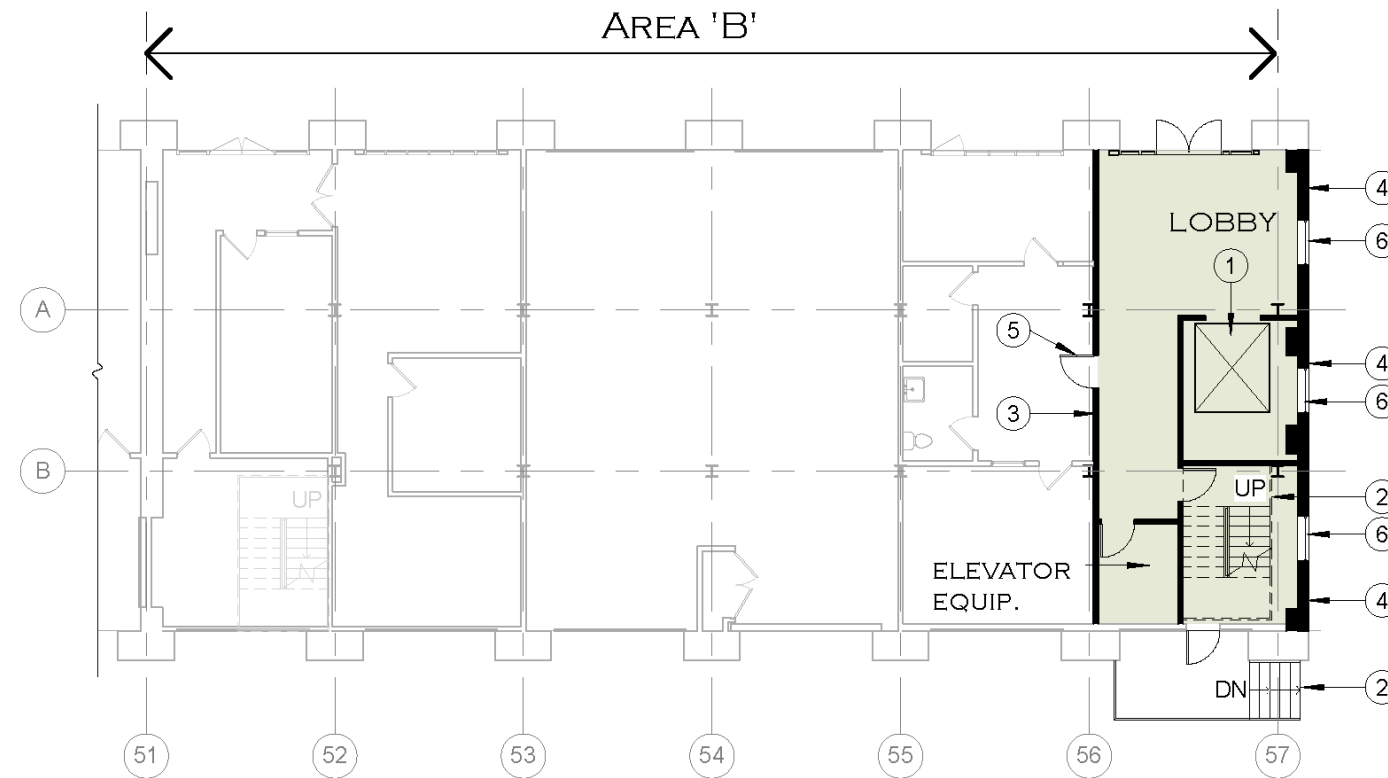
Figure 8

EXISTING BUILDING / REPAIR
1ST FLOOR PLAN - AREA 'B'

- ① NEW ELEVATOR.
- ② NEW STAIR.
- ③ NEW GYPSUM BOARD PARTITION.
- ④ NEW MASONRY SHEAR WALL.
- ⑤ NEW DOOR.
- ⑥ NEW WOOD FRAME INSULATED WINDOW.

1. The new wall to close off the exposed end of the building left by the demolition of Areas “A” and “N” will be a masonry shear wall with 12-inch fully grouted concrete masonry. Bricks saved from the demolition of Area “A” will be used to face the interior and exterior side of the concrete masonry wall. Brick pilasters, arches and corbelling will complete the end of the building (See Figures 8 thru 13 for the new wall location.)

2. A new elevator and stairs will be added to all floors to complete egress and circulation systems required by code. (See Figures 8 thru 13 for new stair and elevator location.)

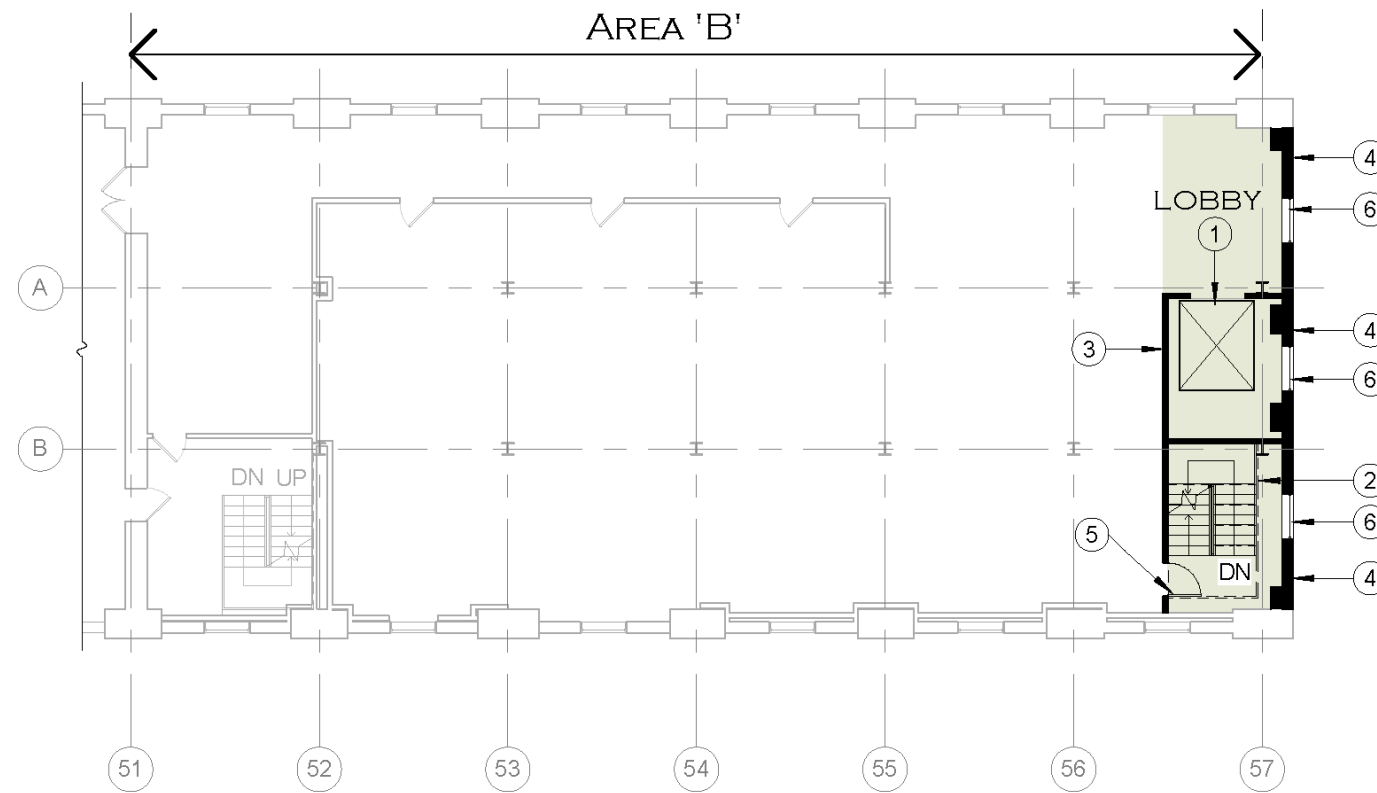
Figure 9

EXISTING BUILDING / REPAIR
2ND FLOOR PLAN - AREA 'B'

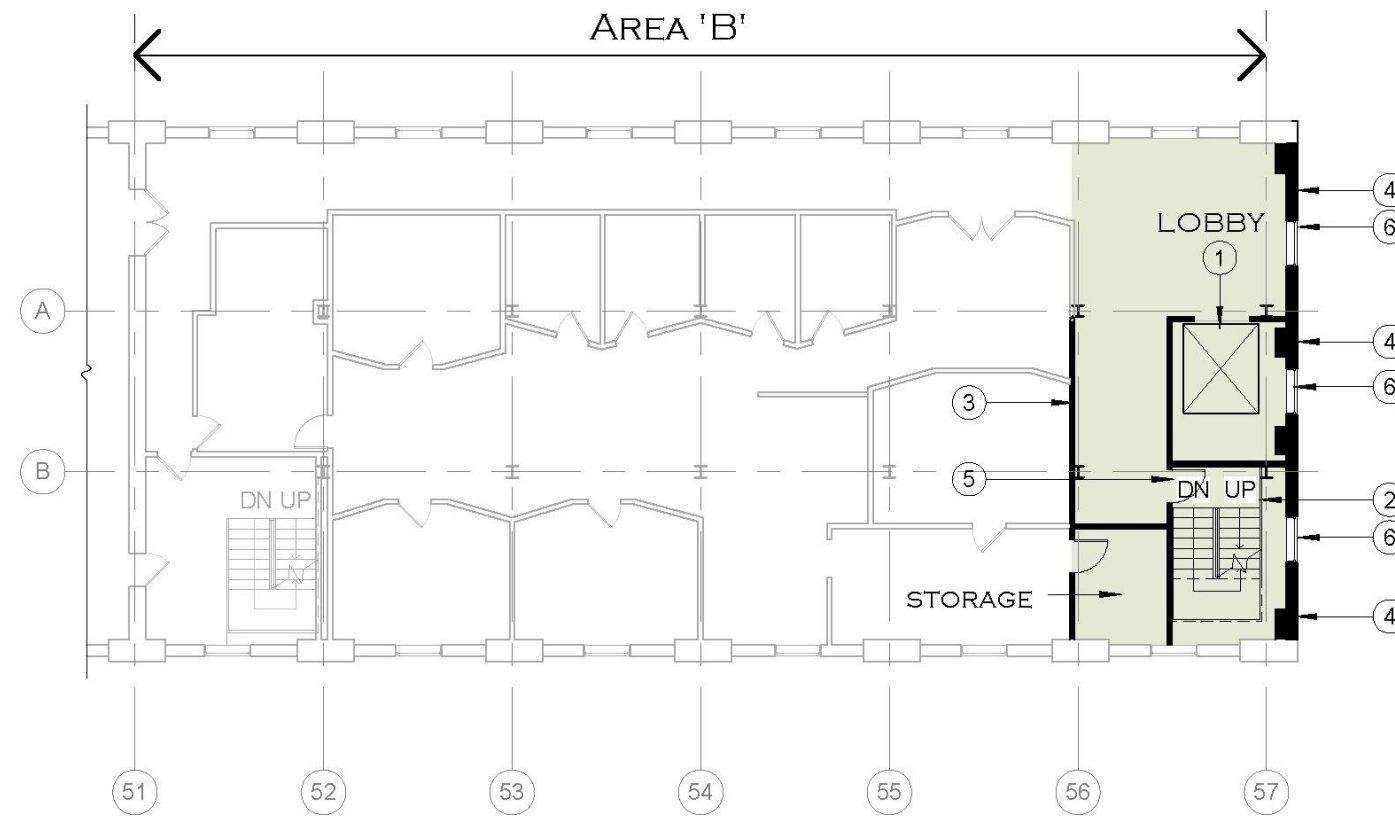
Figure 10

EXISTING BUILDING / REPAIR
3RD FLOOR PLAN - AREA 'B'

- ① NEW ELEVATOR.
- ② NEW STAIR.
- ③ NEW GYPSUM BOARD PARTITION.
- ④ NEW MASONRY SHEAR WALL.
- ⑤ NEW DOOR.
- ⑥ NEW WOOD FRAME INSULATED WINDOW.

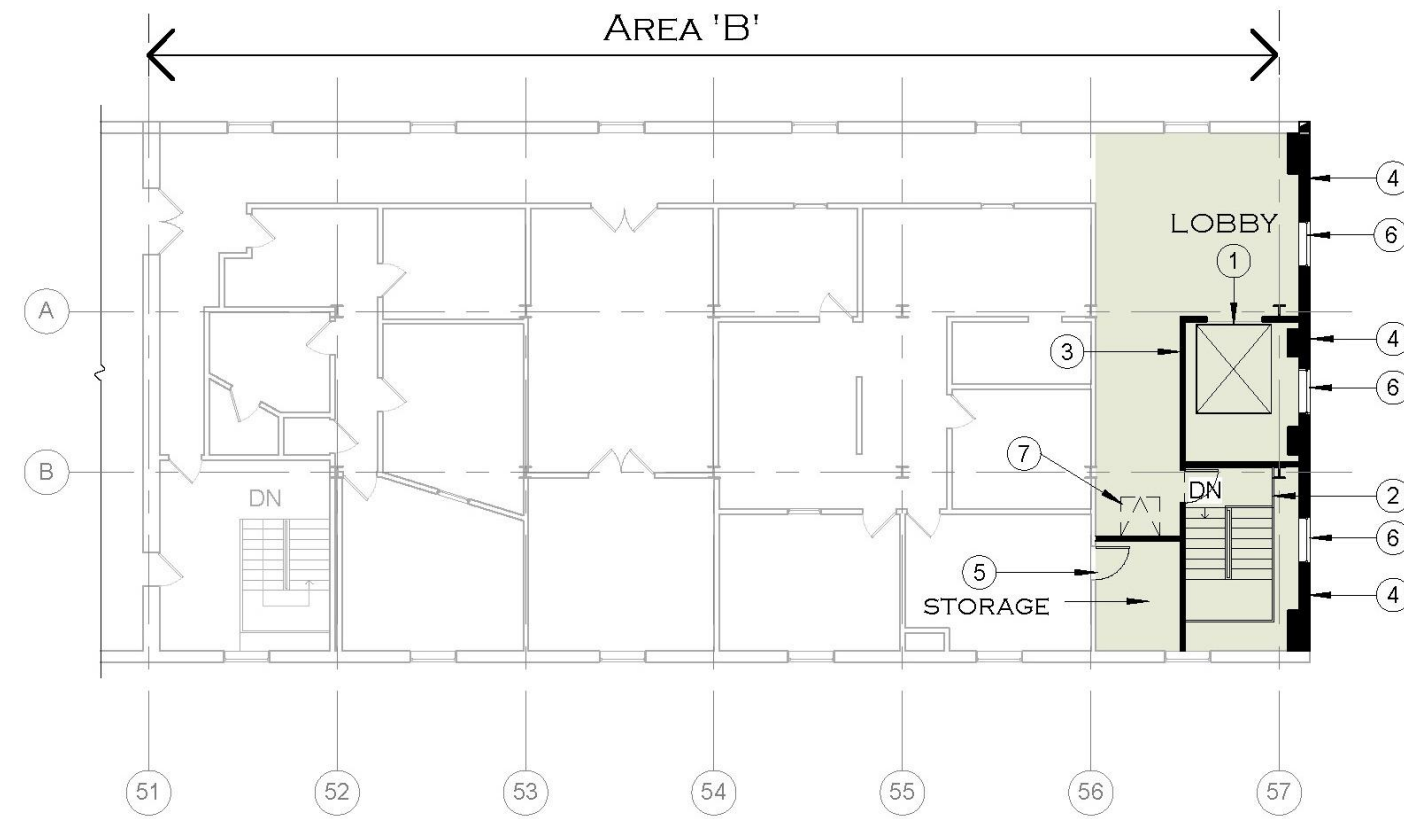
Figure 12

EXISTING BUILDING / REPAIR
5TH FLOOR PLAN - AREA 'B'

- ① NEW ELEVATOR.
- ② NEW STAIR.
- ③ NEW GYPSUM BOARD PARTITION.
- ④ NEW MASONRY SHEAR WALL.
- ⑤ NEW DOOR.
- ⑥ NEW WOOD FRAME INSULATED WINDOW.
- ⑦ NEW LADDER TO ROOF HATCH ABOVE.

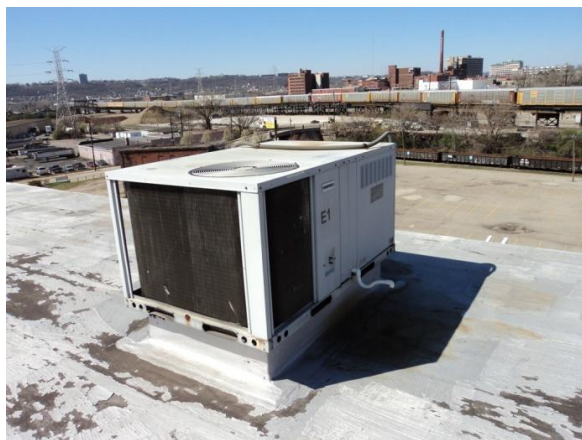
Photo 3: Typical rooftop unit

Longworth Hall's HVAC consists of dedicated tenant systems and Facility Owner (House) systems. There is not a central plant heating or cooling system. The tenants' as well as the Owner's HVAC systems are packaged self-contained units (eg. rooftop units, Photo 3) or indoor air handling units (AHU), (Photo 4), with an outdoor air cooled condensing unit (Photo 5). Cooling coils are direct expansion (DX) refrigerant-to-air coils while heating is accomplished by gas-fired heat exchangers. Ventilation air for occupants is accomplished either at the rooftop unit itself or air intake wall louvers for the AHUs. Each system is typically controlled via a single thermostat (Photo 6). There are both programmable and non-programmable thermostats throughout Longworth Hall. There is not a central building automation system (BAS). The age of the units are between 10-15 years old and in fair condition.

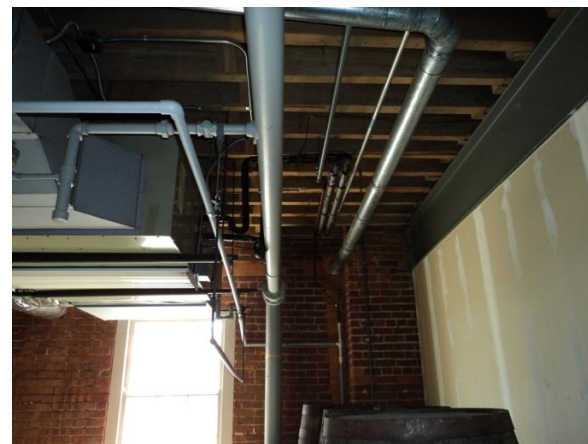
Photo 4: Typical indoor air-handling unit
(noted Photo H-2 in Figure 16)

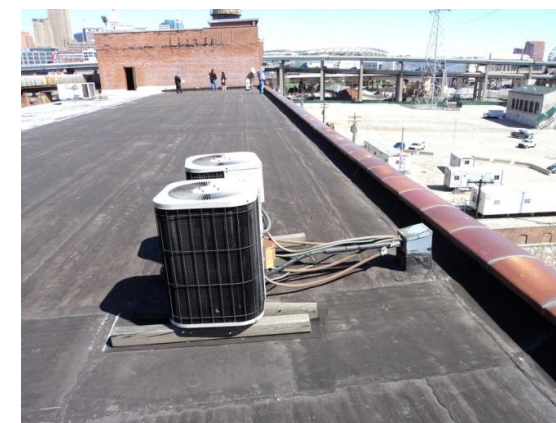
Photo 5: Typical air-cooled unit

Roof Level Impact Analysis – There are several air-cooled condensing units on the roof but there are no conflicts with refrigerant lines connecting across column line 57 to an AHU. The rooftop units condensate drain lines discharge directly on the roof surface which will remain.

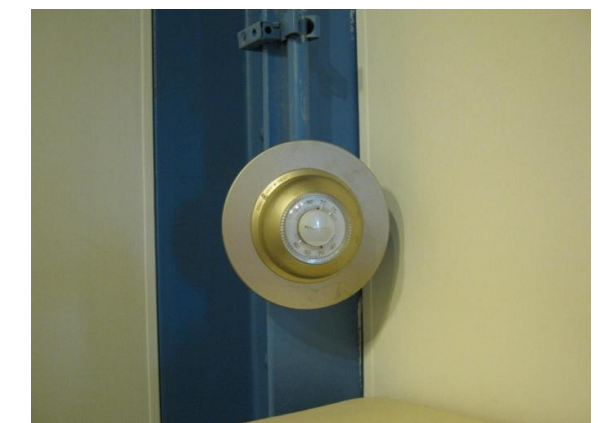
Photo 6: Typical thermostat

The thermostat is located at column line 55 in Area "B" and will not be relocated. Refrigerant lines cross column line 57 near the south wall but these are currently (during 2011 site inspection) abandoned or disconnected.

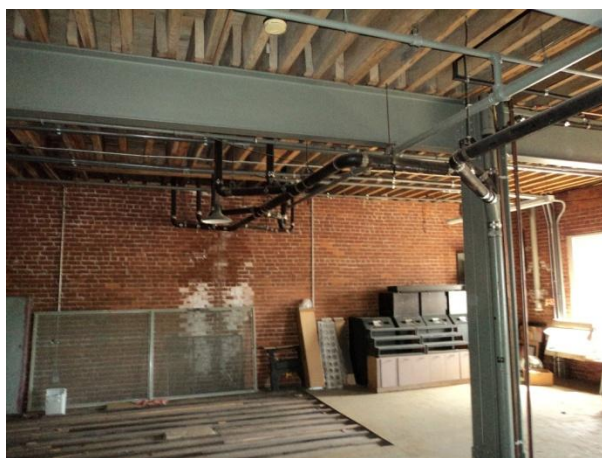
Photo 7: Area “B” Plumbing stack (noted Photo P-1 in Figure 16)

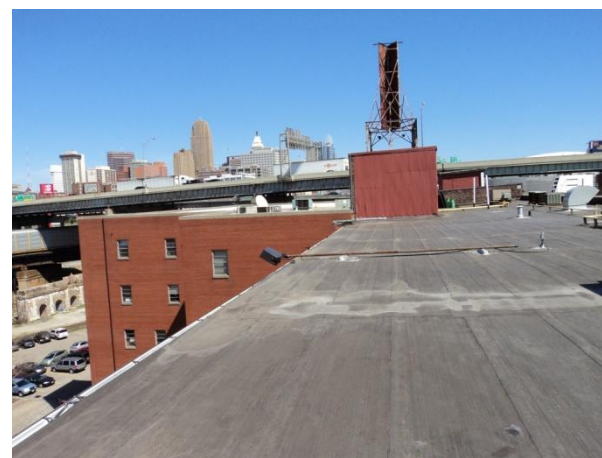
Photo 8: Gutters along north edge of roof

There are three domestic water service lines from the utility main into Longworth Hall. Points of entry are at Area “B” (column lines 62 and 63), “D” (column lines 38 and 39) and “F” (column lines 13 and 14). Each incoming line has its own meter and water usage is paid for by the Owner. Domestic water is distributed to various tenant and Owner restrooms, sinks, mop basins etc. Hot water heaters are located throughout the facility because there is not a centralized domestic hot water system. The main plumbing waste stack for Area “B” is located at column line 62. (Photo 7) The plumbing waste line leaves the building in Area “B” near column line 62 and then ties into the Metropolitan Sewer District’s sanitary sewer line. The facility roof is sloped downward towards the north to gutters and downspouts. (Photo 8)

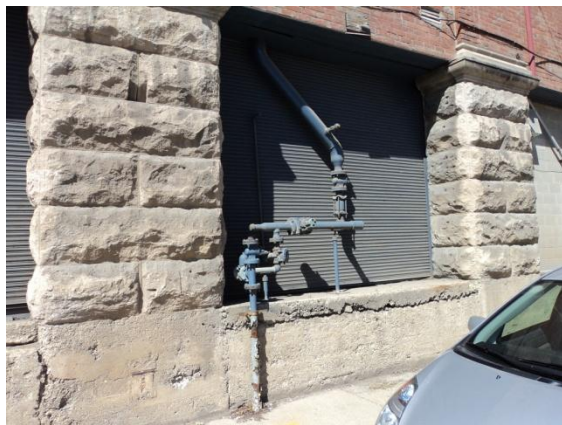
Photo 9: Area “B” incoming gas pipe (noted Photo G-1 in Figure 14)

There are three natural gas lines from the utility main into Longworth Hall. Points of entry are at Areas “B” (column lines 61 and 62, Photo 9), “D” (column lines 25 and 26, Photo 10) and “F” (column lines 5 and 6, Photo 11). The gas pressure steps down to low pressure (one pound per square inch [psi] or less) for distribution within the facility for all three lines. Gas consumption is tracked at tenant meters located at the tenant HVAC equipment.

General Impact – The existing incoming gas pipe line in Area “B” is located east of column line 57 and will be removed (Photo 9). This line serves Areas “A”, “N”, “B” and “C”. It is not feasible to serve the remaining portion of Area “B” and Area “C” with one of the two remaining facility’s low pressure gas lines. A new gas service from the utility main to Area “B” will be installed. The existing facility piping may be able to be reused if sized adequately.

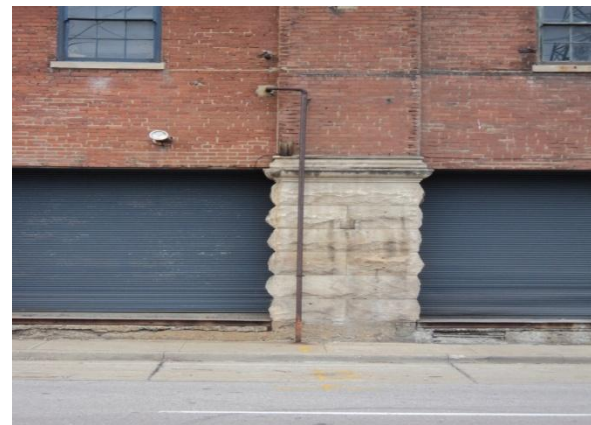
Photo 10: Area “D” incoming gas pipe

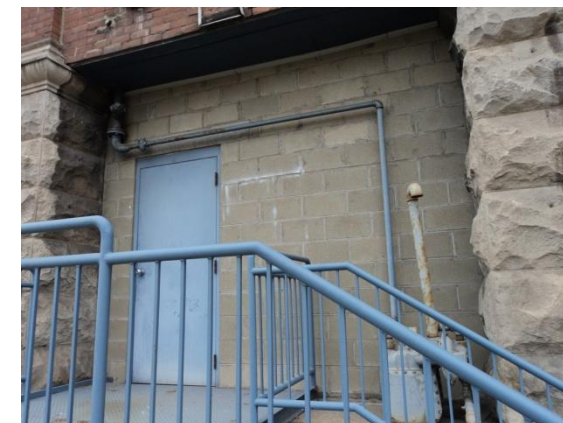
Photo 11: Area “F” incoming gas pipe

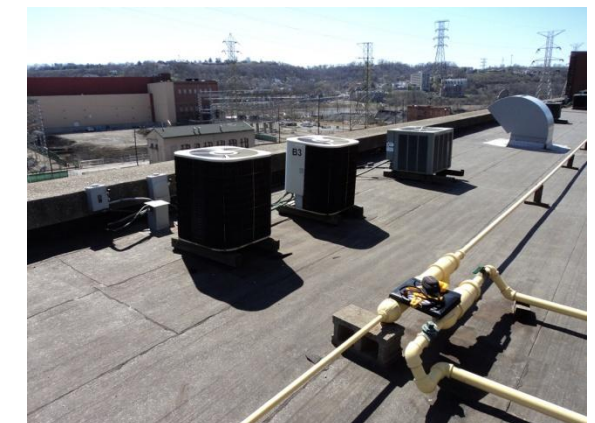
Photo 12: Area “B” gas piping on roof

Roof Level Impact Analysis – A gas pipe penetrates the roof of Area “B” near column line 61 (Photo 12). This pipe serves HVAC equipment on the roofs of Areas “A”, “B” and “N”. There are two rooftop units (RTUs) located west of column line 57 served by this gas pipe. These two RTUs will have new gas piping routed to them.

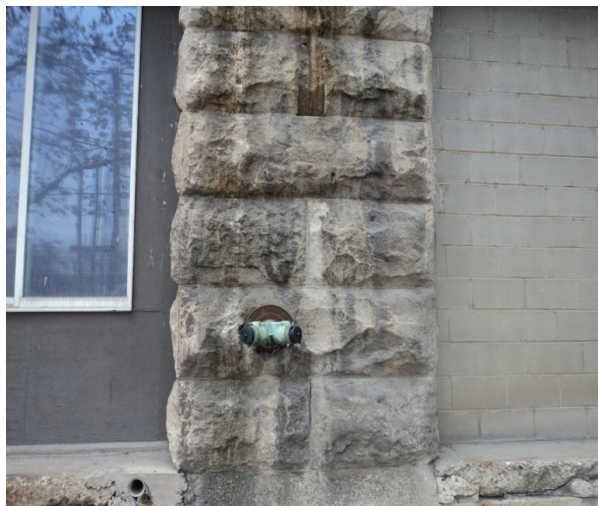
Photo 13: Fire Department Siamese connection

There are multiple fire sprinkler water piping points of entry to Longworth Hall. Each Area has its own fire sprinkler water pipe service main. Points of entry for Areas “A” through “F” are at column lines 67, 54, 42, 29, 17, and 5. Upon entering Areas “A” through “F” there are fire sprinkler valve closets on the first floor. There are two fire department Siamese connections (Photo 13) on the south elevation of the facility at column lines 67 and 5.

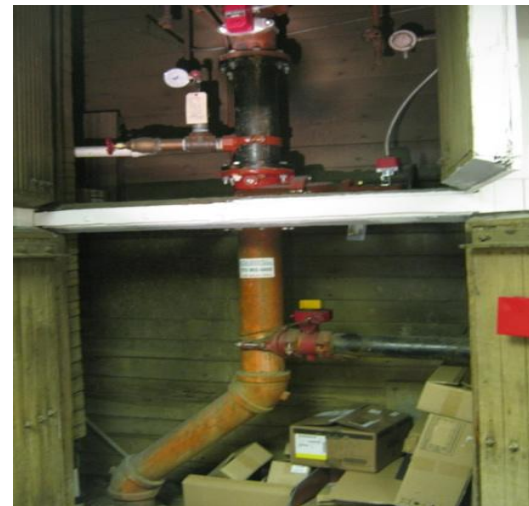
Photo 14: Area “B” valve closet (noted Photo FP-2 in Figure 14)

The valve closet for Area “B” is west of column line 57, which can remain (Photo 14). On the first floor, the sprinkler main is routed to the east and west ends, then rise to each floor and branch. The point of separation of the branch piping for each riser is along column line 57 on each floor. The sprinkler main on the first floor will be capped at column line 57 but the remaining floors will not require any changes. A new fire department Siamese connection will be installed near column line 54 of Area “B” and connect with the sprinkler piping.

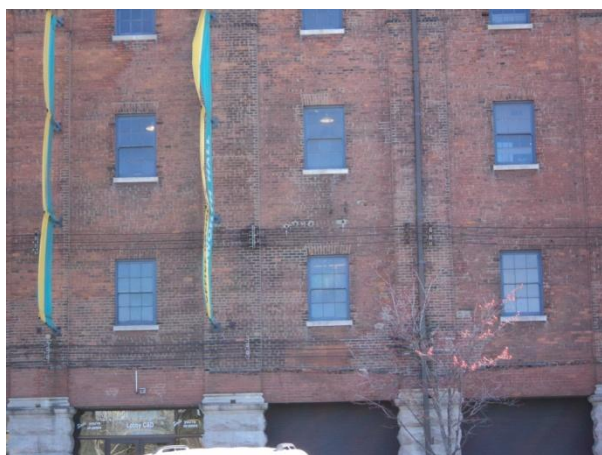
Photo 15: Elevator power lines (top set)

Multiple electric overhead utility lines feed into Longworth Hall. Service locations are at column lines 69, 67-68, 62-63, 54-55, 44-46, 31-33, 17-18 and 6-8. Electrical meter banks for the tenants and Owner are located on the exterior wall at the incoming service location. All services are 208/120V, three-phase except for one which is 480V, three-phase. The 480V, three-phase service powers the elevators and is located at column lines 17-18 of Area “E”. The 480V, three-phase lines are routed to the north exterior wall of the facility which then serve the elevators. There is a second set of abandoned power lines (below the elevator power lines, Photo 15) mounted on the north exterior wall from column line 38 to 61.

General Impact Analysis – The abandoned power lines on the north exterior wall will be removed at a minimum, from column line 61 to 56. The elevator power lines on the north exterior wall will be modified with the removal of the facility at column line 57 and a new power feed provided for the new elevator in Area “B”. The electrical incoming services at column lines 69 (serves Area “N”), 67-68 (serves Area “A”), 62-63 (serves Area “N”) will be removed. The main incoming service for Area “B” is located at column lines 54 and 55 (Photos 16 and 17) which can remain. Meter modifications will be required for tenants.

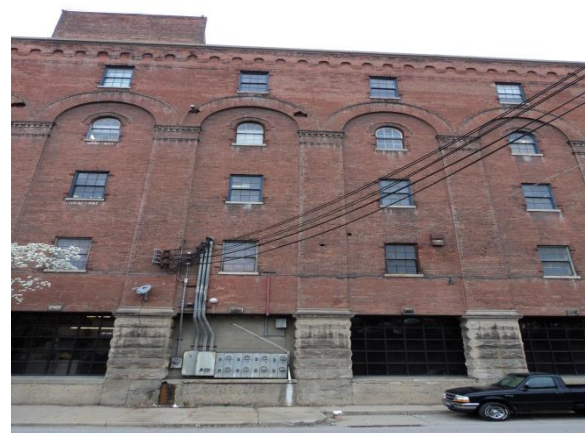
Photo 16: Area “B” incoming power (noted Photo E-2 in Figure 14)

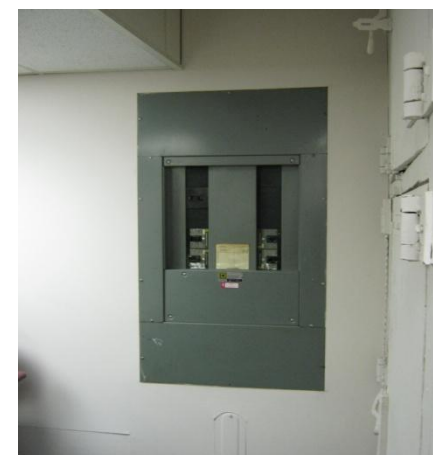
Photo 17: Area “B” main breaker panel (noted Photo E-3 in Figure 14)

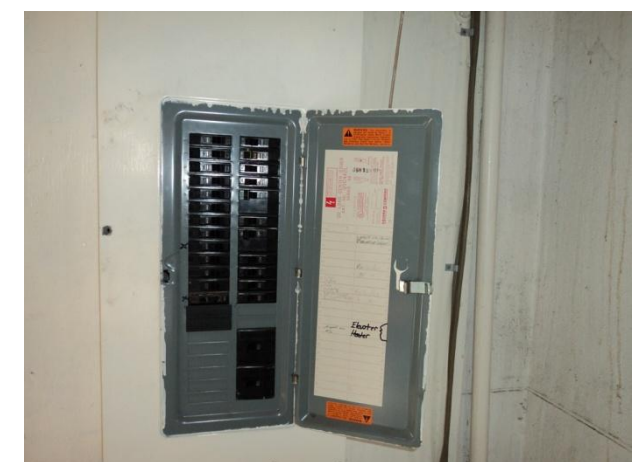
Photo 18: Area “B” 2nd floor breaker panel (noted Photo E-4 in Figure 16)

Second Floor Impact Analysis - There are multiple conduits crossing column line 57 that serve receptacles, lights etc. There is one circuit breaker panel (Photo 18) located on the south wall at column line 58 that has circuits west of column line 57. This panel will be removed. There is another circuit breaker panel located on the south wall at column line 55. A new circuit breaker panel and wiring will be installed to replace the circuiting for the panel that will be removed.

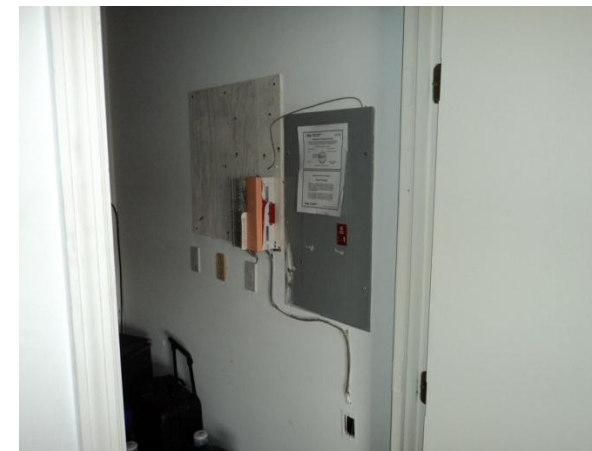
Photo 21: Area "B" 5th floor breaker panel (noted Photo E-7 in Figure 19)

Fifth Floor Impact Analysis – There is only one conduit that crosses column line 57. There is one circuit breaker panel (Photo 21) at column line 58 in Area "B" that has circuits west of column line 57. This panel will be removed. There is another circuit breaker panel located on the south wall at column line 55. A new circuit breaker panel and wiring will be installed to replace the circuiting.

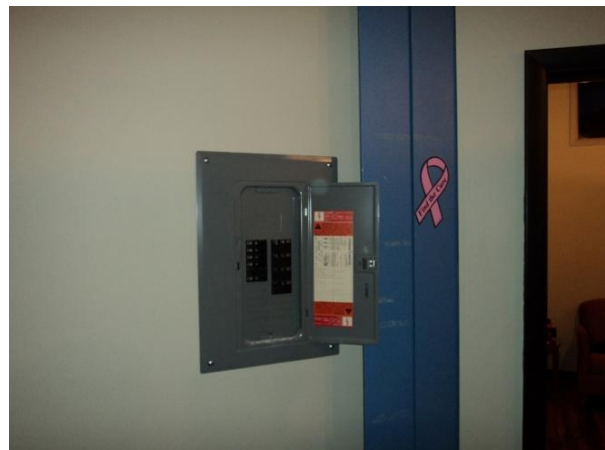
Photo 19: Area "B" 3rd floor breaker panel (noted Photo E-5 in Figure 17)

Third Floor Impact Analysis - There are multiple conduits crossing column line 57 that serve receptacles, lights etc. There is one circuit breaker sub-panel (Photo 19) located at column lines 58 and Area "A" that has circuits west of column line 57. This panel will be removed. There is another circuit breaker panel located on the south wall at column line 54. A new circuit breaker panel and wiring will be installed to replace the circuiting.

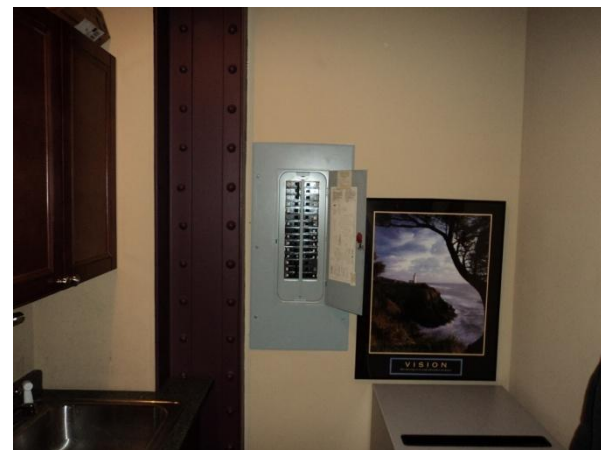
Photo 20: Area "B" 4th floor breaker panel (noted Photo E-6 in Figure 18)

Fourth Floor Impact Analysis - There are multiple conduits crossing column line 57 that serve receptacles, lights etc. There is one circuit breaker panel (Photo 20) located at column lines 58 and Area "B" that has circuits west of column line 57. This panel will be removed. There is another circuit breaker panel located at column lines 51 and Area "B". A new circuit breaker panel and wiring will be installed to replace the circuiting for the panel located at column lines 58 and Area "B" that will be removed.

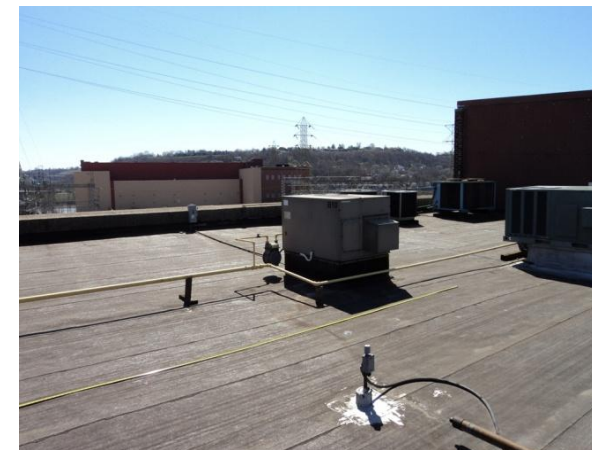
Photo 22: Area "B" power on roof

Roof Level Impact Analysis – HVAC equipment and exterior lighting power is fed from below (Photos 22 and 23). The roof penetration is typically near the equipment. No power conduits cross along column line 57. The circuit breaker panel(s) serving the equipment are located on the floor(s) below.

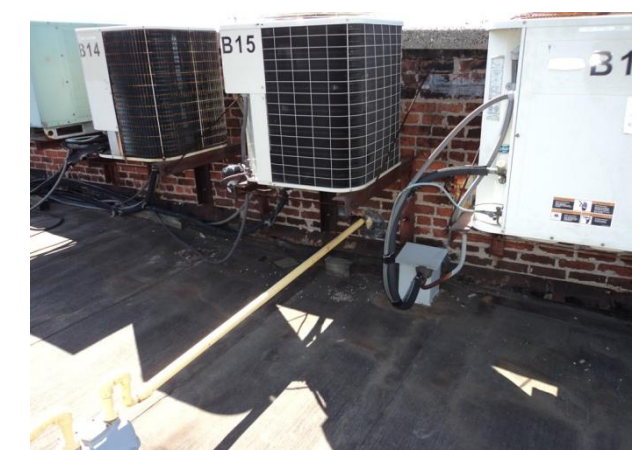
Photo 23: Area "B" power on roof

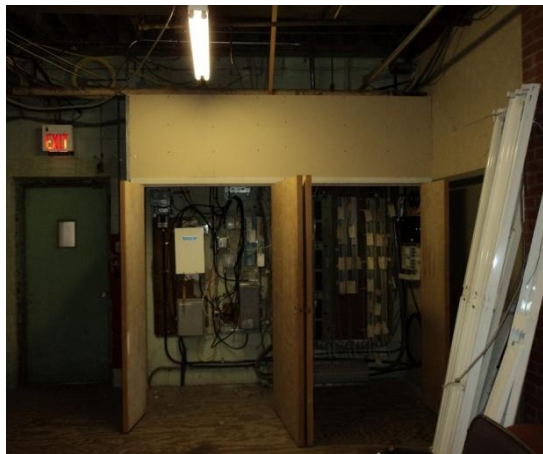
Photo 24: Main communications closet (noted Photo C-1 in Figure 15)

The main incoming voice and data communication cables and fiber optic utility feeds enter Longworth Hall in Area "A" on the second floor between column lines 64 and 65. The main communications closet (Photo 24-26) is in Area "A" near column line 67. This closet serves the entire facility and miscellaneous sub-gear closets (Photo 27). The fifth floor communications are fed from the floor below. There are two fiber optic lines that serve tenants west of column line 57. The tenants are identified as "Image Links" and "Cincinnati Arts and Technical College". The fire-alarm and security (CCTVs) systems head-end equipment is located near the lobby of Area "C".

General Impact Analysis - The main communications closet will be removed and a new main communications closet provided with new utility feeds. Modifications will be required to the fire-alarm and security systems due to the removal of the facility east of column line 57.

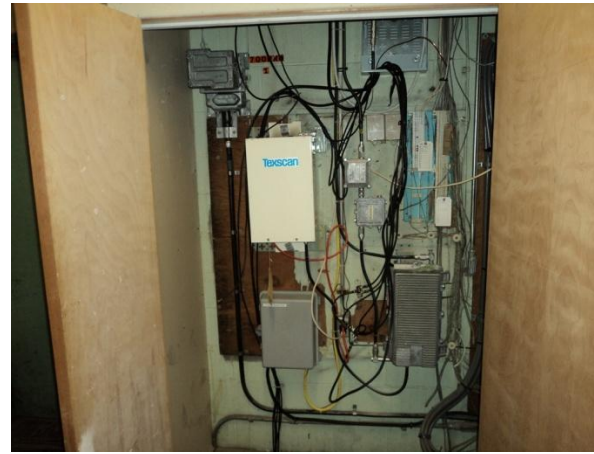
Photo 25: Main communications closet (noted Photo C-2 in Figure 15)

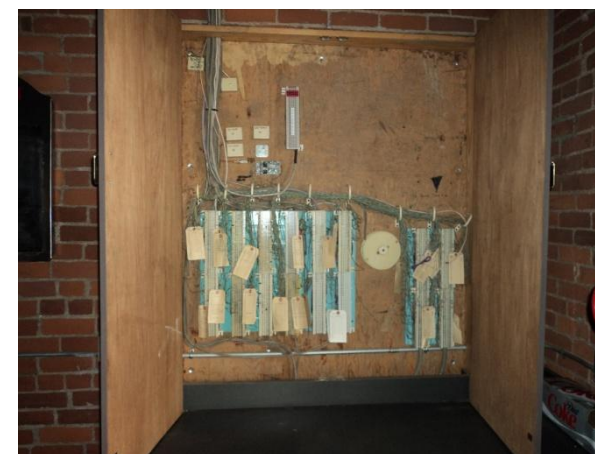
Photo 26: Main communications closet (noted Photo C-3 in Figure 15)

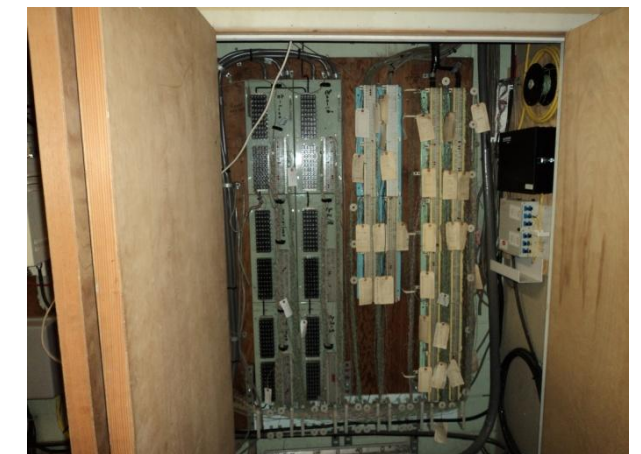
Photo 27: Sub-communications closet (noted Photo C-4 in Figure 17)

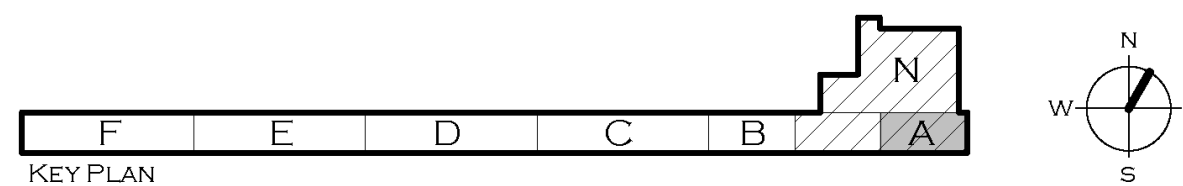
Figure 15

EXISTING BUILDING - MEP
2ND FLOOR PLAN - AREA 'A'

- ① EXISTING MAIN COMMUNICATION CLOSET.

Due to the removal of the Longworth Hall facility east of column line 57, mechanical, electrical and plumbing (MEP) systems will be modified. All MEP equipment, ductwork, piping, wiring etc. will be removed east of column line 57. Proper disposal of hazardous materials will be required along with refrigerant recovery at heating, ventilating and air conditioning (HVAC) equipment. Disposal of materials off-site will be in accordance with local, state and federal regulations. In order for the remainder of the facility to stay functional an MEP impact analysis has been done and is divided by disciplines. All existing MEP locations as described in the following sections can be found in Figures 14-20.

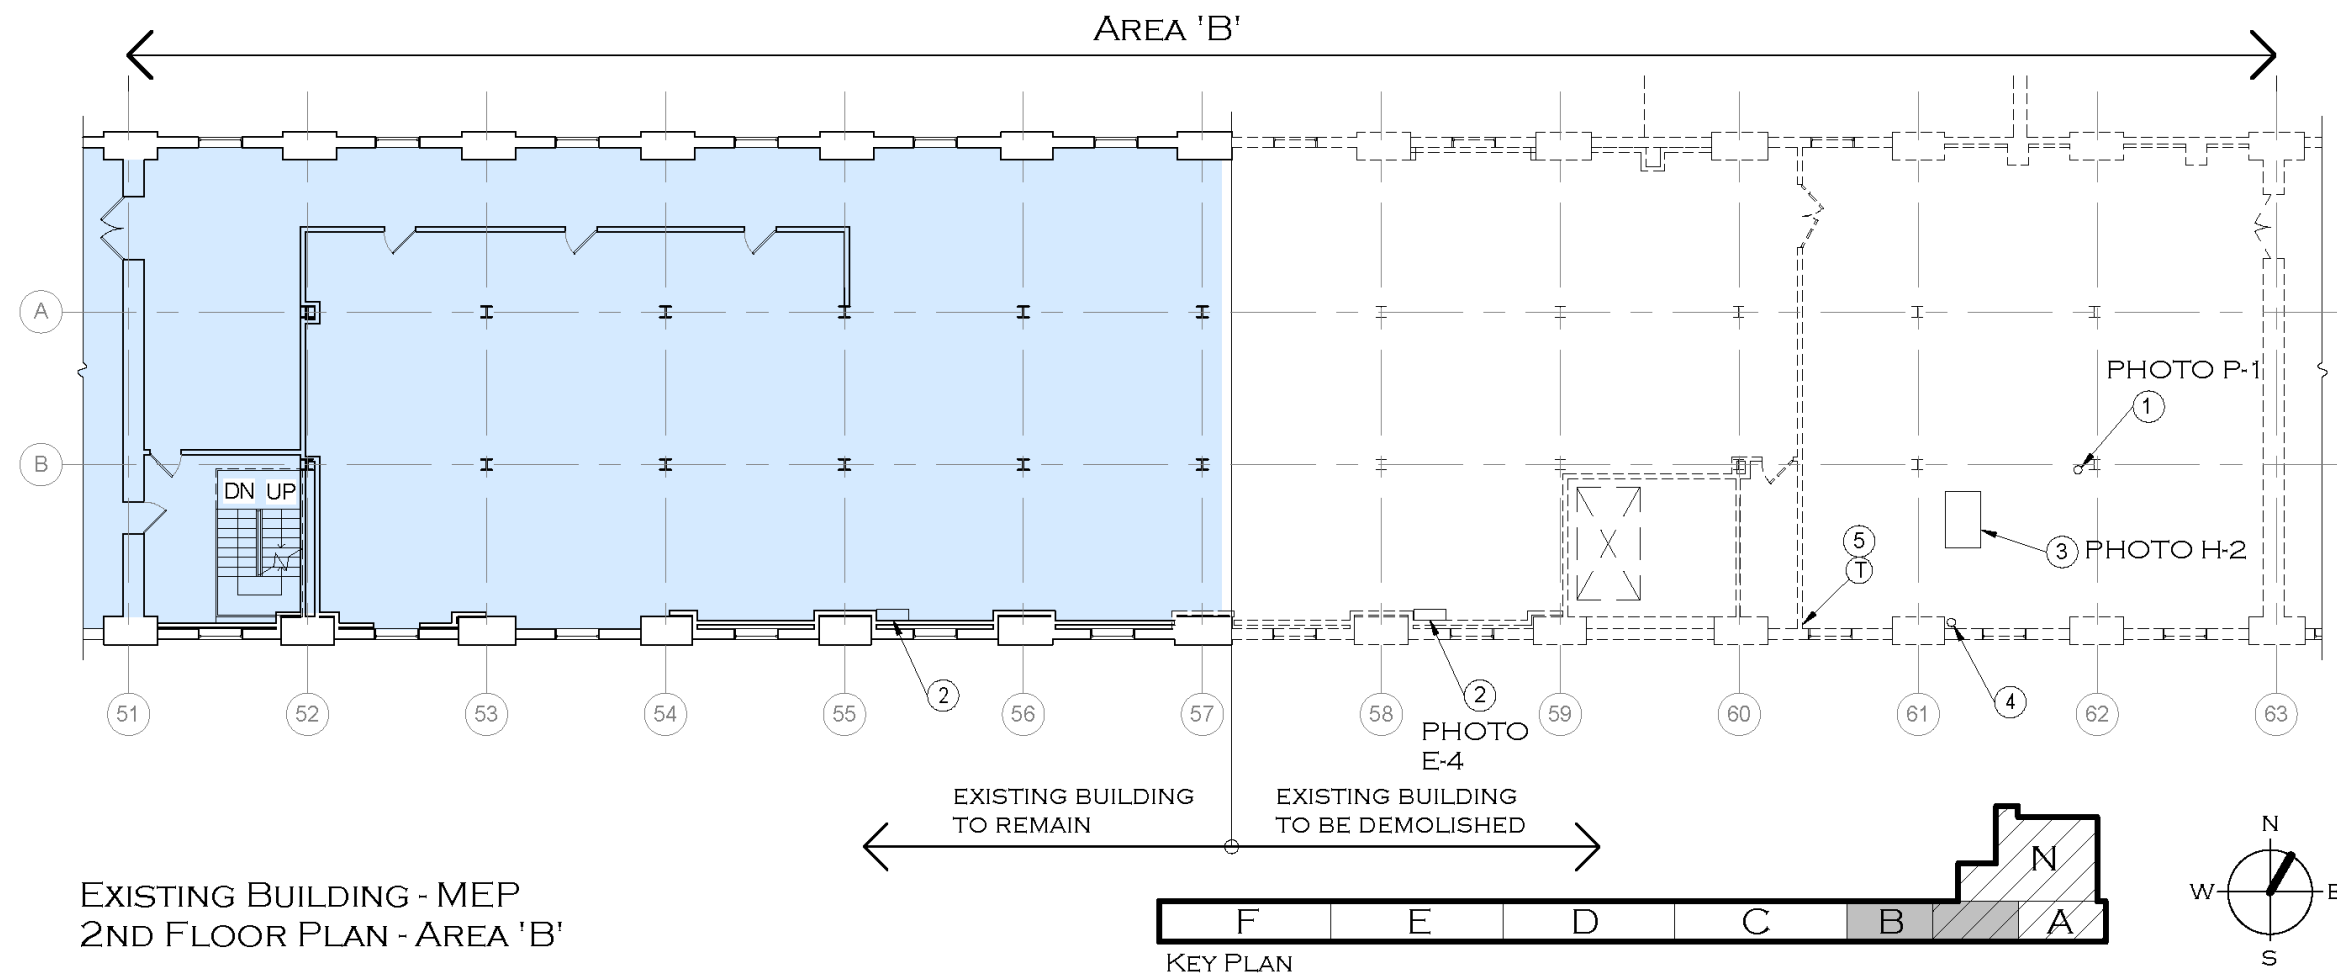
Figure 16

- ① EXISTING PLUMBING STACK FOR AREA B.
- ② EXISTING CIRCUIT BREAKER PANEL SERVING AREA B PARTIAL SECOND FLOOR.
- ③ EXISTING AIR HANDLING UNIT SERVING AREA B SECOND FLOOR VACANT OPEN SPACE.
- ④ EXISTING GAS PIPE RISER FOR AREAS A, N, B AND C.
- ⑤ EXISTING NON-PROGRAMMABLE THERMOSTAT.
